TECHNICAL SERVICE BULLETIN

400 Watt DC/AC Inverter System Inoperative With B1330:9A In The BCM

24-2020

19 January
2024

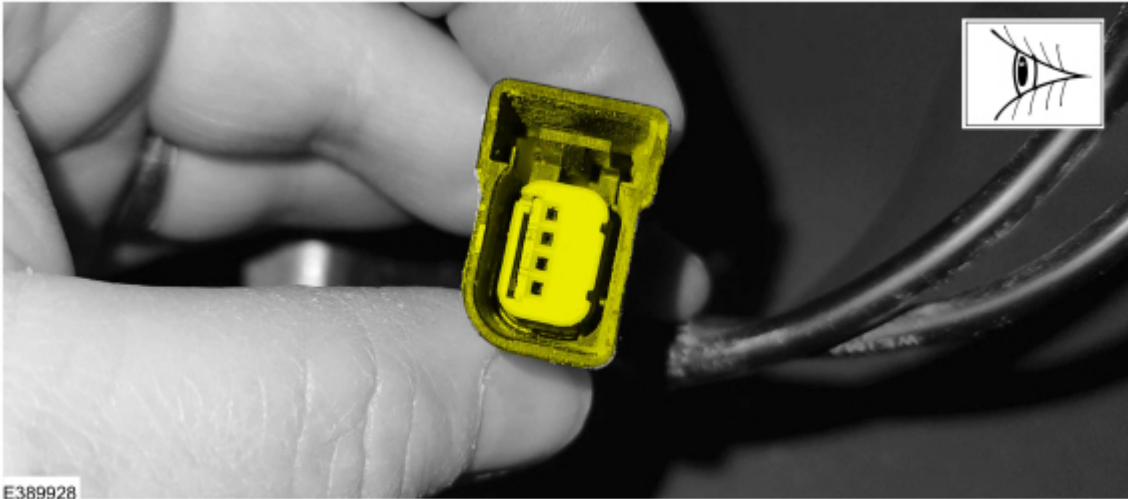
Figure 2

2. Using a suitable tool, carefully cut and remove the pickup bed AC power outlet socket harness retainer from the pickup bed AC power outlet socket harness. Discard the retainer.
3. Inspect connector C4628 for the presence of corrosion, dirt and/or damage. Is corrosion, dirt and/or damage present in connector C4628? (Figure 2)

(1). Yes - replace the pickup bed AC power outlet socket assembly. Refer to WSM, Section 414-05. Replace the body side harness assembly (13A409) of connector C4628. Proceed to Step 4.

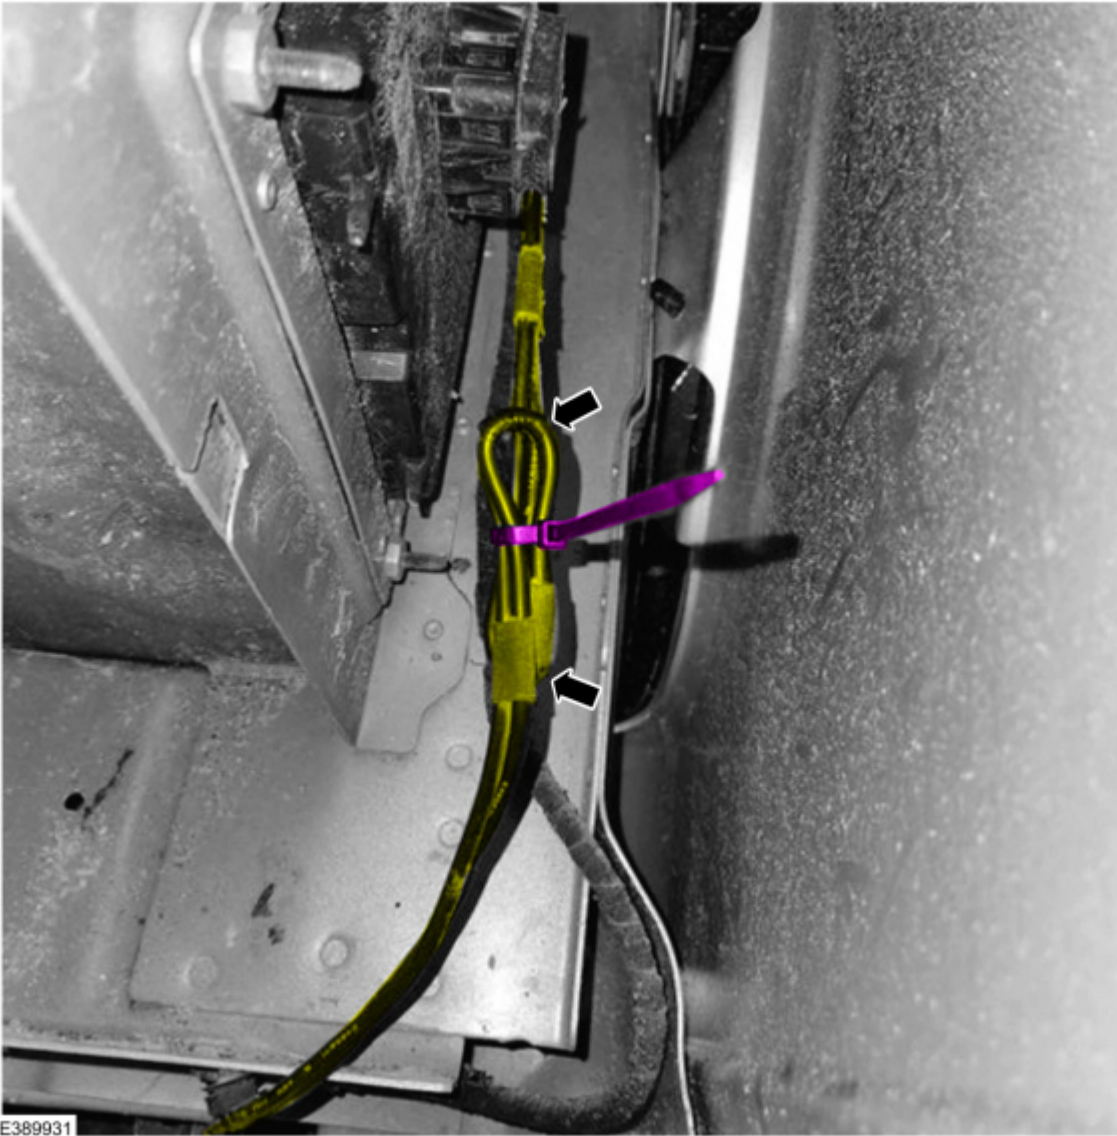
Figure 5

⚠ CAUTION: The bend radius of the pickup bed AC power outlet socket harness should be no less than 4 mm. Hard kinks and tight bends of the pickup bed AC power outlet socket harness can lead to wire damage.

6. Fold approximately 7 in. (185 mm) of the remaining/loose pickup bed AC power outlet socket harness in 2 bends just behind the pickup bed AC power outlet socket panel. Secure the folded wire with a wire tie. Inspect the routing of the harness to make sure it is not pulled too tight against the body sheet metal near the harness retainer and provides just enough length. (Figure 5)
