# TECHNICAL SERVICE BULLETIN

## Whistle Noise At Lower Left Windshield Area

**24-2021**

<b>Ford</b> 2021-2024 Bronco
---------------------------------

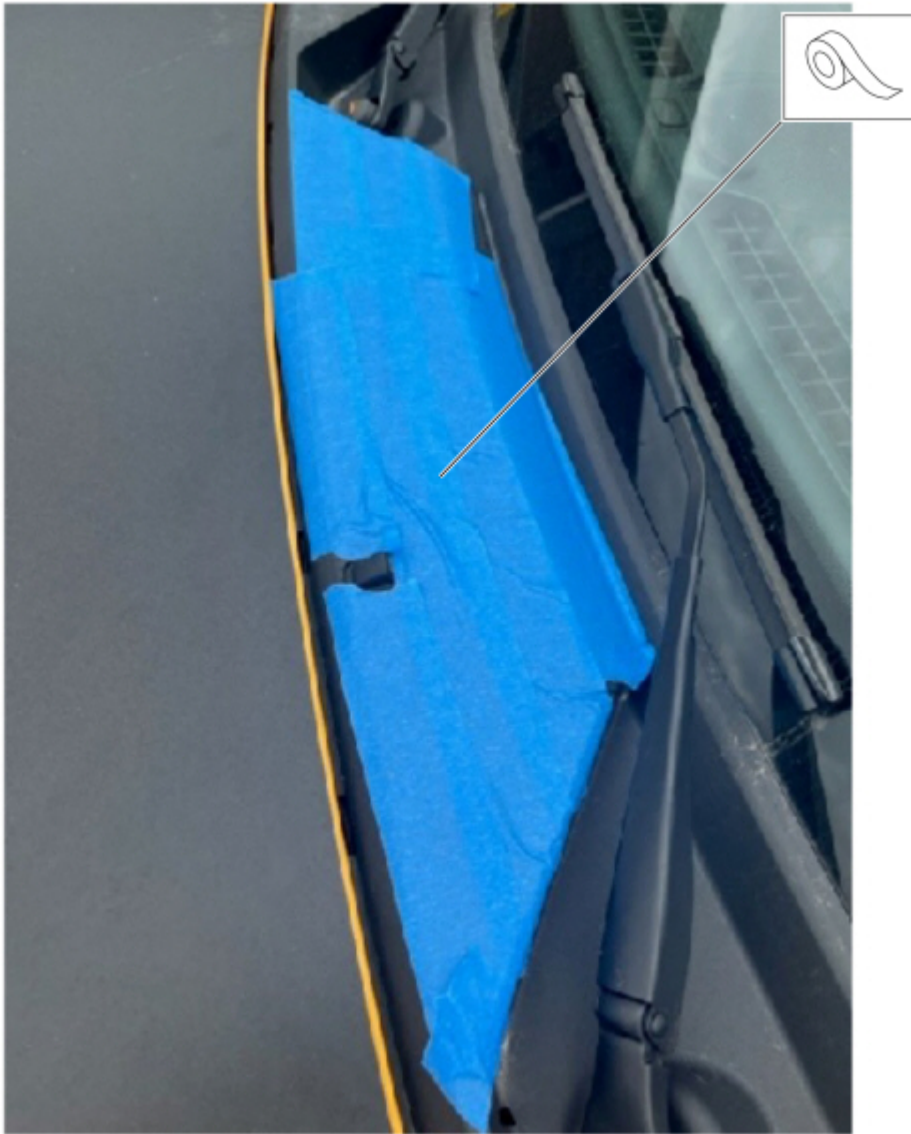
Figure 1

1. Tape off the left side of the cowl panel and drive the vehicle above 50 mph (80 km/h). Did taping off the cowl resolve the whistle noise? (Figure 1)

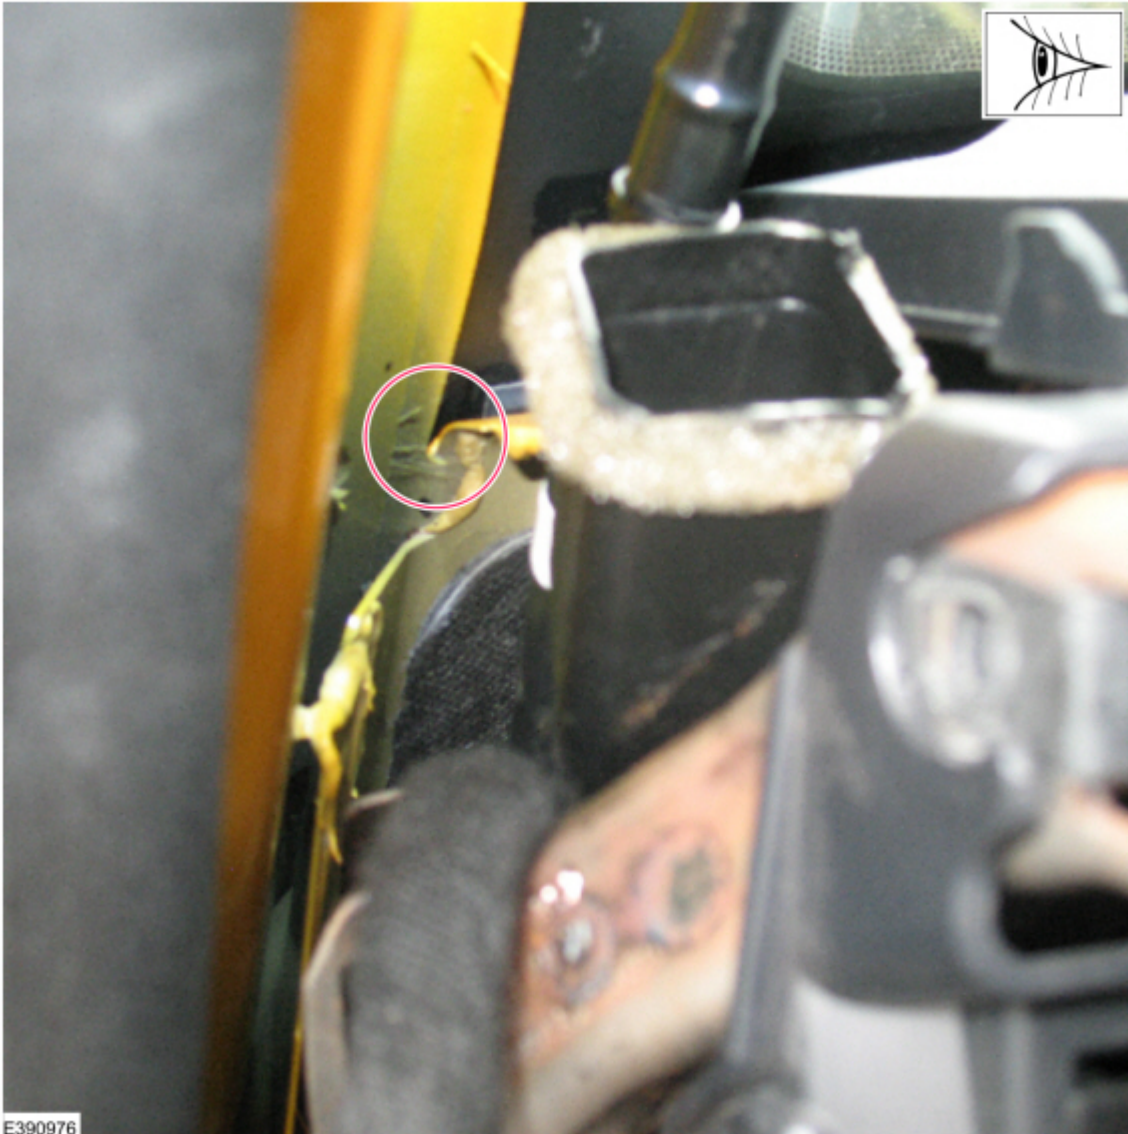
Figure 2

- (1). Yes - proceed to Step 2.
  - (2). No - this article does not apply. Refer to Workshop Manual (WSM), Section 100-04.
- 2.** Remove the left A-pillar trim. Refer to WSM, Section 501-05.
  - 3.** Visually inspect for a gap in the sheet metal at the bottom of the A-pillar where it joins the rear engine compartment wall. Is a gap present? (Figure 2)

**4.** Apply butyl to fill the gap between the two metal panels and eliminate the air entry.
