Technical Service Bulletin

SUBJECT:			No: TSB-22-55-002REV2
A/C UNINTENTIONALLY TURNS OFF, REMAINS OFF OR THE TEMPERATURE SETTING CHANGES - REVISED			DATE: January 2024
			MODEL: See below
CIRCULATE TO:	<input type="checkbox"/> GENERAL MANAGER	<input checked="" type="checkbox"/> PARTS MANAGER	<input checked="" type="checkbox"/> TECHNICIAN
<input checked="" type="checkbox"/> SERVICE ADVISOR	<input checked="" type="checkbox"/> SERVICE MANAGER	<input checked="" type="checkbox"/> WARRANTY PROCESSOR	<input type="checkbox"/> SALES MANAGER

This bulletin supersedes TSB-22-55-002REV issued March 2023. The previous flash files in TSB-22-55-002REV are no longer applicable. This bulletin revision updates from HVAC ECU reprogram to countermeasure part replacement followed by HVAC ECU reconfiguration. This revision also updates the affected models/years and warranty information. Revisions are italicized and indicated by ◀.

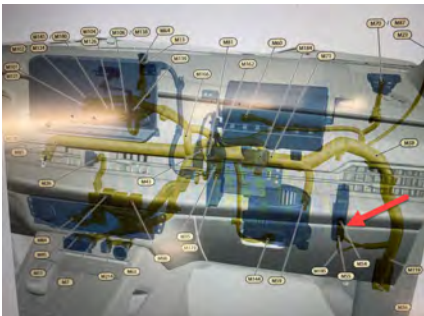
4. AC Auto Amp is on the right hand side of the HVAC Case fresh air intake and is held by "1" screw.

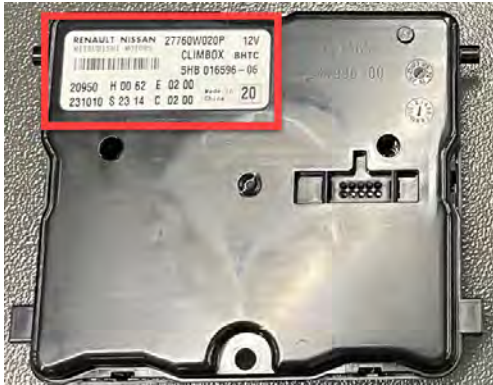
Location of AC Amp part number.
