Service Repair Bulletin SRV-SRB-24-001

We would like to inform you about the assessment criteria for identifying a genuine front fork-related defect as opposed to, for example, oozing of oil or assembly grease.

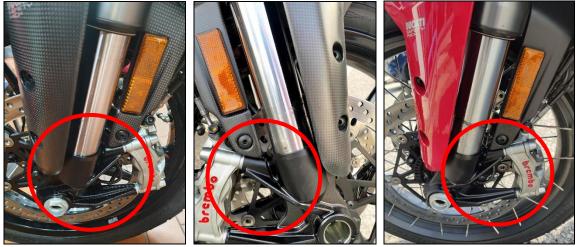
**Case 1** - clear leakage reaching the fork axle lug: if the oil ooze, as shown in the example, reaches the fork axle lug, proceed with the replacement of the seal kit (oil seal + dust seal).

Example: Oil leak that has reached the fork axle lug

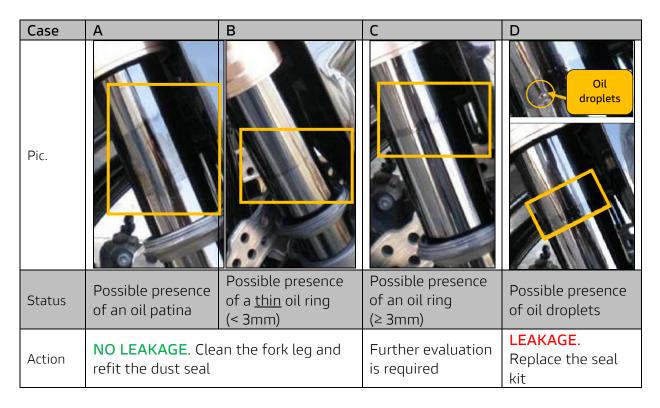
6. Analyze any oil residue on the fork leg according to the table below.

- **6.1.** If the leak is not replicated, as in *Cases A* and *B*, clean the leg and refit the dust seal inside its seat.
- **6.2.** In the case of suspected oil oozing, as in *Case C*, it is necessary to carry out a reassessment after an additional test ride.
- **6.3.** In the case of a leakage, as in *Case D*, attach pictures showing the leakage to the Youtech request and warranty claim. Then proceed with seal removal and replacement (pictures should be taken with the dust seal down) and replace the fork oil following the quantities indicated in the Workshop Manual for the respective motorcycle model (for oil reimbursement, we ask that you include 2 UL of additional labor per fork leg).

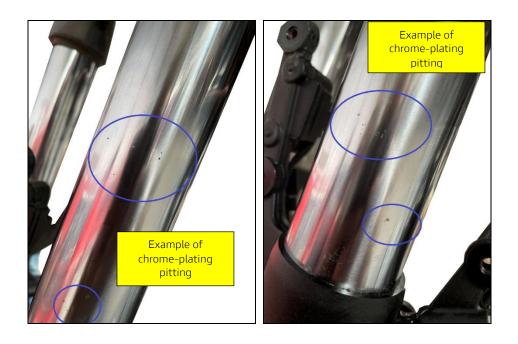
IN ANY CASE, carefully check for damage to the leg treatment coating, e.g. due to road debris (damage occurs if it can be felt with a fingernail). In the case of a damaged leg, it must be replaced together with the seals and is generally not covered by the warranty (except for rare cases of chrome-plating pitting or oxidation attributable to defects on the leg treatment, which can be generally found outside the front leading surface areas of the motorcycle. In this case take detailed pictures and specify in the Youtech).
