**992 2WD – DME Fault P310B00 – ‘Fuel Low Pressure – Implausible’**

**Vehicles Affected**

Models	Model Year	Model Type	VIN Range	Vehicle-Specific Equipment
911	2021 - 2023	992110 (Carrera) 992120 (C2S) 992140 (C2GTS) 992150 (Carrera T) 992310 (Carrera Cab) 992320 (C2S Cab) 992340 (C2GTS Cab) 992810 (GT3) 992820 (GT3 Touring)	n/a	n/a

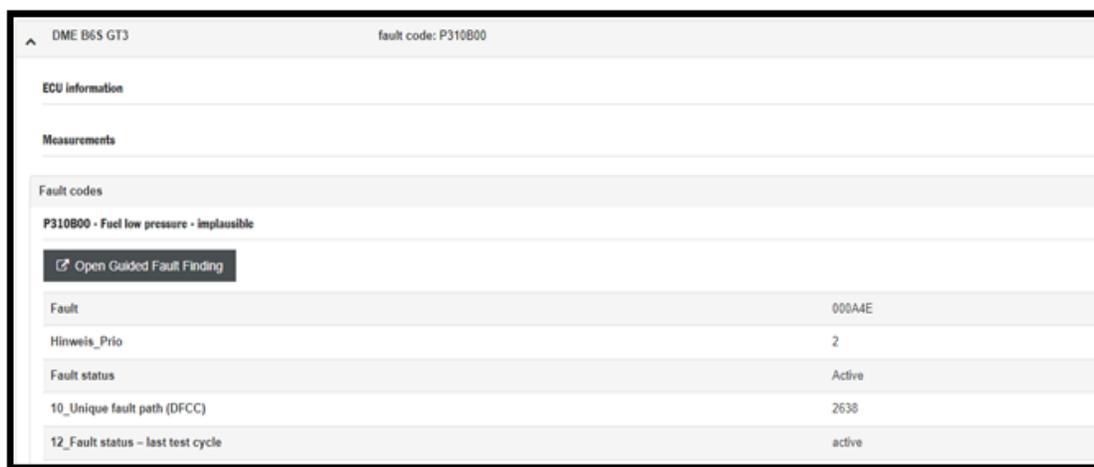
**Figure 1**

The diagnostic responsible for this fault monitors supply deviation within a finite time between the demanded or target low-pressure requested of the low-pressure fuel pump and that of the actual supplied quantity to meet the request, as correlated to pressure. In some instances, manufacturing tolerances for the low-pressure pump result in the actual supplied fuel quantity exceeding the DME's requested quantity, in other words, the pump's operation is 'too effective.' By consulting the Vehicle Analysis Log (VAL) containing the fault it is possible to see if the supplied fuel quantity exceeded the requested quantity in the low-pressure system to cause the fault.

If the fault data is consistent with the condition exemplified in Figure 1, please replace the fuel pump, **NOT** the fuel pressure sensor.
