**Transmission Symptom - Oil Leakages on Transfer Box (SY 163/23)**

Model Line: **Macan (95B)**

Model Year: **2023**

Concerns: **Transfer box**

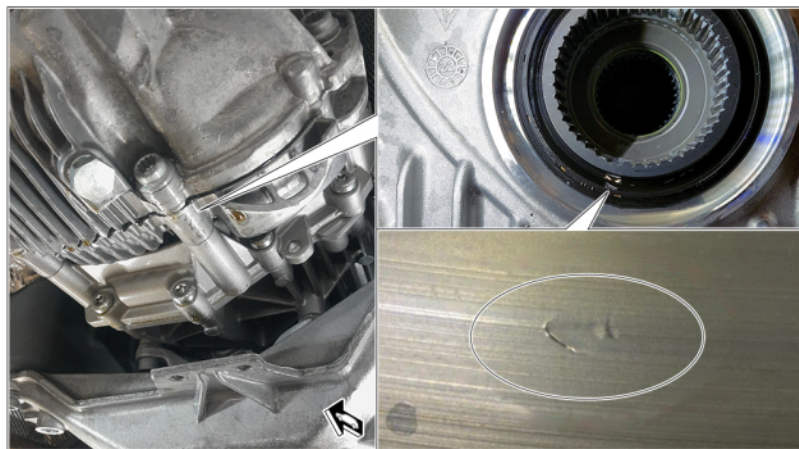
Symptom: Oil leakage is found on the vehicle in the area of the transfer box and at the transition to the double clutch transmission.

Cause: A temporary manufacturing error might have caused mechanical damage to the transmission input shaft in the area of the running track of the radial shaft seal ⇒ *Oil leakage on the transfer box*. This damage can lead to a leak on the radial shaft sealing ring of the transmission input shaft and thus to oil leakage on the transfer box.

*Oil leakage on the transfer box*

Remedial Action: If an oil leakage is detected in the area of the transmission input shaft of the transfer box, check the production date of the vehicle and replace the transfer box depending on the test result. Replacing the radial shaft sealing ring is not sufficient for a damaged transmission input shaft.
