## Technical product information

<b>Topic</b>	Rear doors do not fully open (Left and/or Right) Or the soft close function is not operating to specification
<b>Market area</b>	Australia E04 Bentley rest Asia and Australia (6E04),China 723 Volkswagen (Anhui) Automotive CO (6723),China 796 VW Import Comp. Ltd (Vico), Beijing (6796),Germany E02 Bentley rest Europe (6E02),Japan E03 Bentley Japan (6E03),Korea, (South) E08 Bentley South Korea (6E08),United Arab Emirates E06 Bentley Middle East and Africa (6E06),United Kingdom E01 Bentley UK (6E01),United States E05 Bentley USA and rest America (6E05)
<b>Brand</b>	Bentley
<b>Transaction No.</b>	2068866/4
<b>Level</b>	EH
<b>Status</b>	Approval
<b>Release date</b>

### Bentayga EWB

Rear doors do not fully open (Left and/or Right) Or the soft close function is not operating to specification

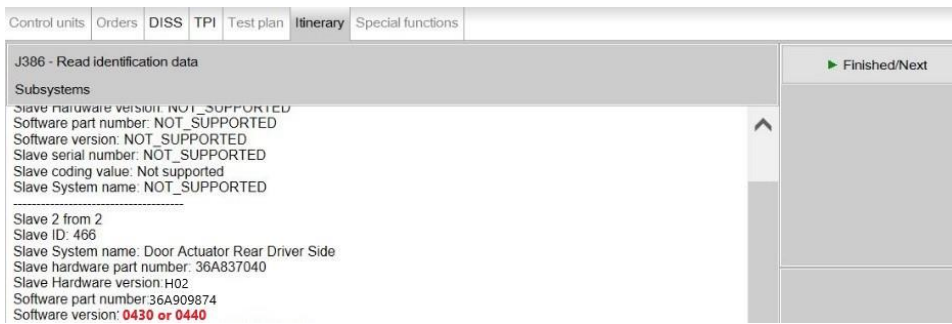
Figure 1

In the event the software version is **0430 or 0440** (Figure 1) the operative MUST raise a Technical DISS query stating the following:

- The software version of J386 and J387 is **0430 or 0440**
