TECHNICAL SERVICE BULLETIN

NTB20-046G

VOLUME KNOB DOES NOT FUNCTION PROPERLY

APPLIED VEHICLES: 2019-2020 Altima (L34)
2018-2020 Kicks (P15) – SV and SR
2019-2020 Murano (Z52)
2019 Sentra (B17) – SV, SR, SR Turbo, SL, and NISMO
2020 Versa (N18) – SV and SR

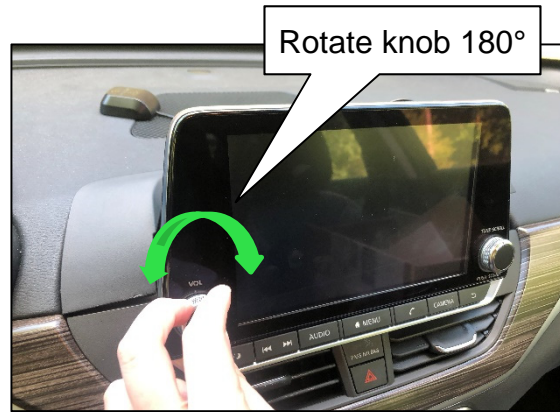
Figure 1

The customer states the speaker volume does not change or changes erratically when rotating the volume knob.

IMPORTANT: To ensure a successful repair, steps 2, 3, and 4 MUST be performed to remove contaminant build-up on the full 360° radius of the electrical components internal to the volume knob.

1. Turn the audio and the ignition OFF.
2. Rotate the volume knob clockwise and counterclockwise approximately 180° as rapidly as possible for 30 seconds (Figure 1).
3. Rotate the volume knob 180° from its current position to remove the contaminant from the opposite side of the electrical component internal to the volume knob.
4. Rotate the volume knob clockwise and counterclockwise as rapidly as possible for another 30 seconds.
