# TECHNICAL SERVICE BULLETIN

Classification: BT21-020B	Reference: NTB21-097B	Date: January 22, 2024
------------------------------	--------------------------	---------------------------

## WATER LEAK AT TOP FRONT CORNERS OF WINDSHIELD

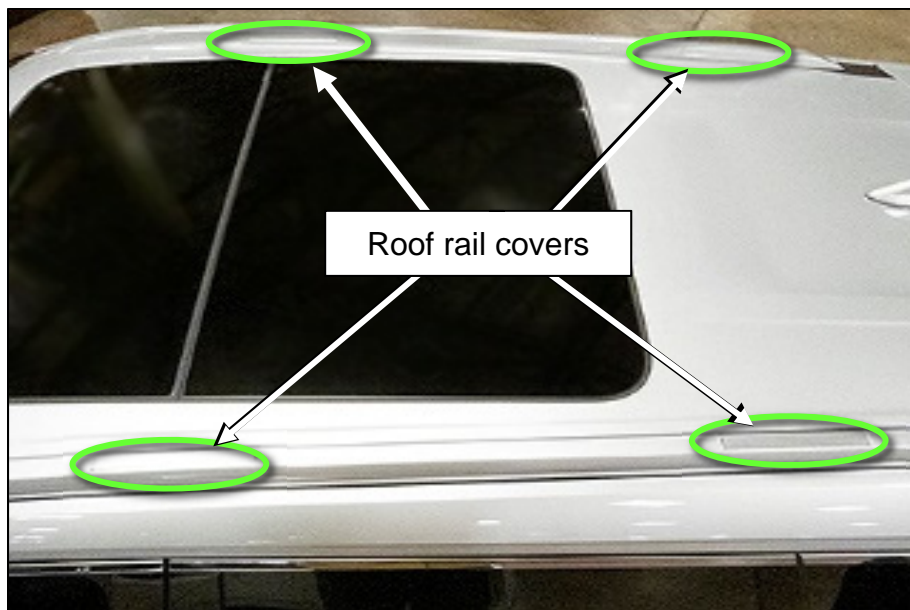
Figure 1

**HINT:** Vehicles that do not have cross bars will have roof rail covers over the bolts that are intended to hold the cross bars, as shown in Figure 1, Figure 2 and removed in Figure 3.

1. For "S" and "SV" grade vehicles that are equipped with roof side moldings (lay flat and do not have cross bar mounting bolts), skip to step 3.
2. Access the cross bar (roof rack) mounting bolts.
  - If cross bars are mounted, remove all eight (8) cross bar mounting bolts on the LH and RH sides of the vehicle, and then remove both cross bars from the vehicle.
  - If cross bars are not mounted, as shown in Figure 1, remove the four (4) roof rail covers and then all eight (8) bolts.
