Complaint - Battery Low and Yellow Warning Message "Battery low _ Service necessary" in Instrument Cluster: Re-Programming Gateway Control Unit (Battery Sensor) (168/18)

Revision: This bulletin replaces bulletin Group 2 168/18, dated February 7, 2019.

Model Line: **Cayenne (9YA)**

Subject: **Gateway control unit** (battery sensor)

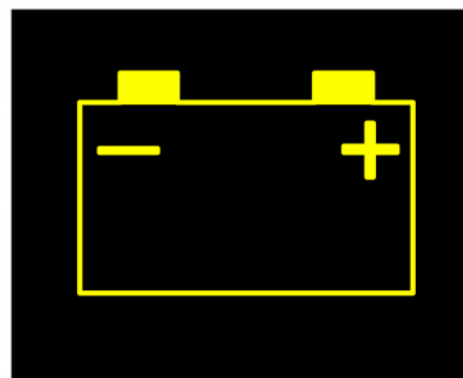
In the event of a customer complaint about a **flat battery** and if the yellow warning message **"Battery low _ Service necessary"** (⇒ *Yellow warning message: Battery low _ Service necessary*) appears in the instrument cluster, the following points must be observed before doing any other work:

- A chain of different factors can cause an increased closed-circuit current (greater than 1.0 A) after charging.
- A **battery sensor software version lower than "1000"** can bring about this symptom.
- In the event of a customer complaint and if the **battery sensor software version in the gateway control unit is lower than "1000"**, **re-program the gateway control unit** as described in the "Procedure" section.

Yellow warning message: Battery low _ Service necessary
