Oil Leakage on Cylinder Head Cover: Insert Micro-Self-Locking Screw (166/21)

Revision: This bulletin replaces bulletin Group 1 166/21, dated December 10, 2021.

Model Lines: **Panamera (971)**

Equipment: **8-cylinder Otto engine (engine type: CVD)**

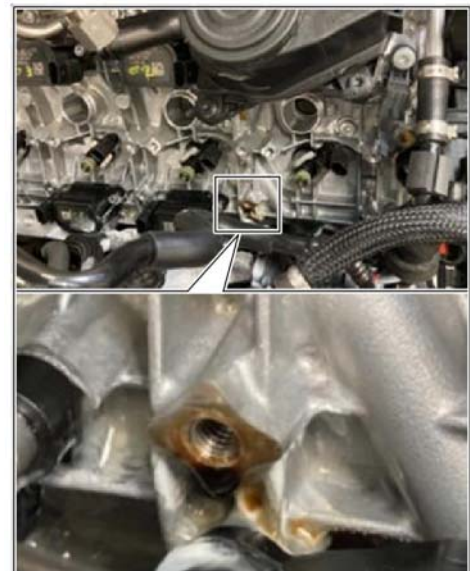
Cause: The customer complains about an oil leakage in the engine compartment. "Oil sweating" or drops of oil forming in the cylinder head cover area is detected in the workshop.

Example of an oil leakage

Action required: Clean the affected area thoroughly and replace the affected screws and adjacent screws with micro-self-locking screws.
