Oil Leakage on Cylinder Head Cover: Insert Micro-Self-Locking Screw (166/21)

Revision: This bulletin replaces bulletin Group 1 166/21, dated December 10, 2021.

Model Lines: **Cayenne (9YA / 9YB)**

Equipment: **8-cylinder Otto engine (engine type: CVD)**

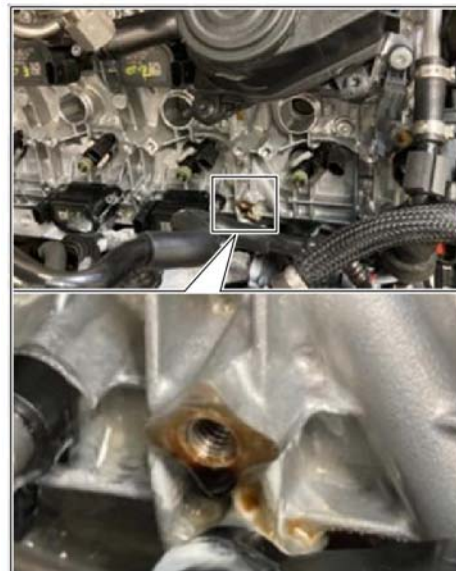
Cause: The customer complains about an oil leakage in the engine compartment. "Oil sweating" or drops of oil forming in the cylinder head cover area is detected in the workshop.

Example of an oil leakage

Action required: Clean the affected area thoroughly and replace the affected screws and adjacent screws with micro-self-locking screws.

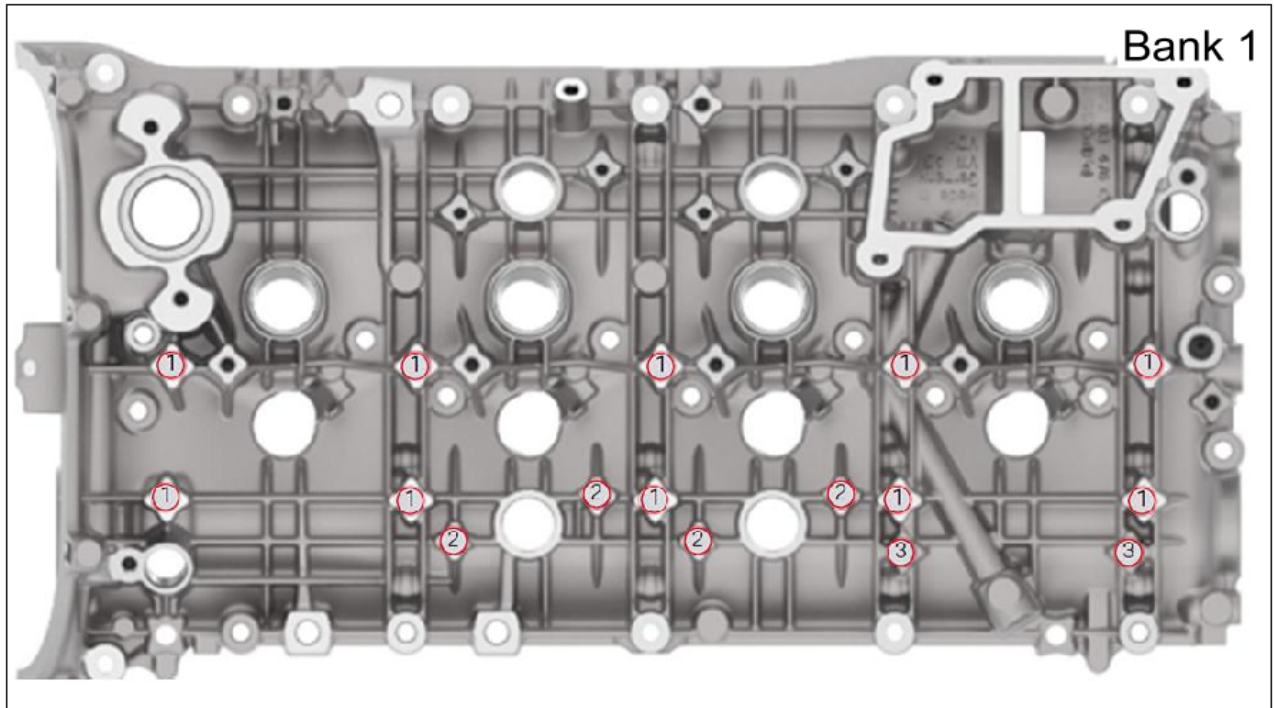
Overview of potentially affected screw points, bank 1

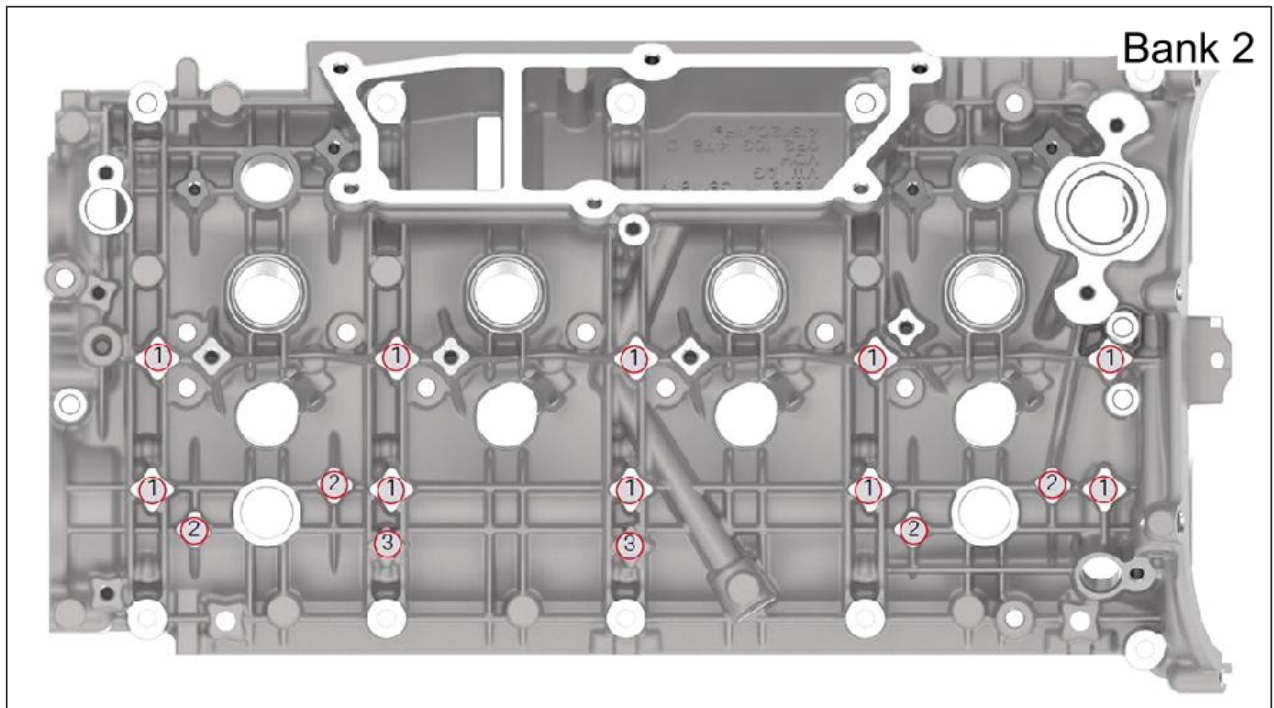
Overview of potentially affected screw points, bank 2

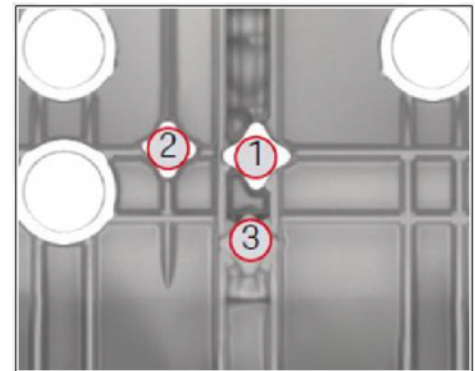
Example of "adjacent screws"

The surrounding screws around the leakage must in principle also be replaced with microencapsulated screws analogous to the example shown in the graphic
⇒ *Example of "adjacent screws"*.

- Work Procedure: 1 Unscrew the affected and adjacent screws.
- 2 Clean the affected area thoroughly.
 - 3 Blow out bores using compressed air.
 - 4 Screw in and tighten new micro-self-locking screws at the relevant position.
Check the following while doing this:
 - Screws for fuel collection pipe (item 1) **Initial tightening 7 Nm (5.2 ftlb.) Final tightening 10 Nm (7.4 ftlb.)** Also observe screw sequence. For instructions, see: ⇒ *Workshop Manual '243019 Removing and installing fuel collection pipe (V8 biturbo)'*
 - Screw for solenoid hydraulic valve VHS (item 2) **Tightening torque 5 Nm (3.7 ftlb.)**
 - Screws for pressure converter holder (item 3) **Tightening torque 10 Nm (7.4 ftlb.)**
