**9YA/9YB - Front Turn Signal/ Auxiliary Headlight Incorrect Operation**

**Vehicles Affected**

Models	Model Year	Model Type	VIN Range	Vehicle-Specific Equipment
Cayenne	2022 - 2023	All	n/a	I-Numbers: 8IT (Basic LED Headlights) & JOB (92 Ah AGM battery)

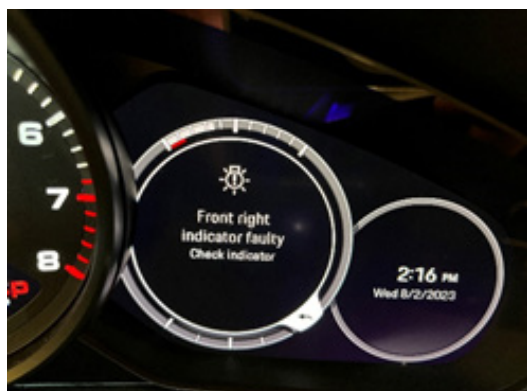
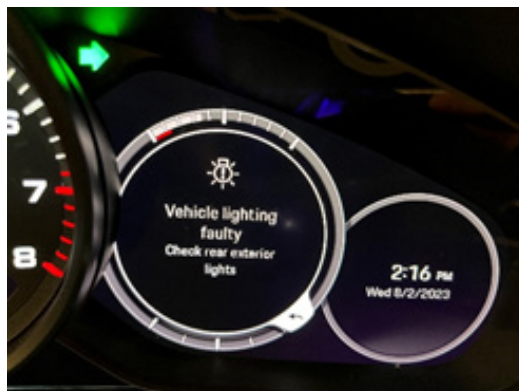
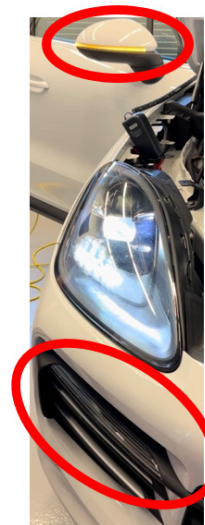
The customer complains of warning(s) in the instrument cluster for "Front (left or right) indicator fault" and possibly "Vehicle lighting fault". Visible symptoms for this concern involve a combination of the turn signal indicator in the instrument cluster rapid blinks and the turn signal stops blinking orange. Fault code "**C11A401 Turn signal bulb, electrical malfunction**" will be present in at least one headlight.

Possibly "**B182700 – Feedback, blinking status, impl. Signal**" will also be present. B182700 is a consequential fault in the rear BCM.
