GROUP	MODEL
ELE	2023MY Telluride (ON)
NUMBER	DATE
302	February 2024

## TECHNICAL SERVICE BULLETIN

SUBJECT: **SMART KEY OPERATION LOGIC IMPROVEMENT**

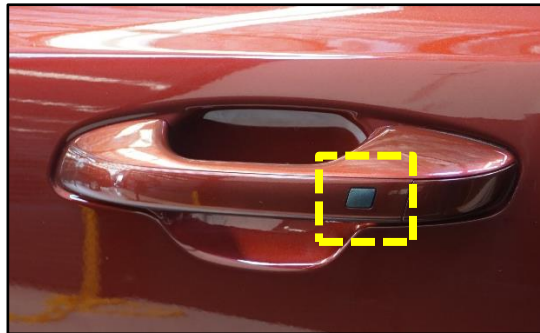
Button (PIC) Type

This bulletin provides the procedure to upgrade the software of the Integrated Body Control Unit (IBU) system on some 2023MY Telluride (ON) vehicles produced from January 3, 2023 through June 5, 2023 equipped with Personal Identification Card (PIC) handles. The affected vehicles may exhibit an inoperative lock/unlock function with a potentially drained 12V battery. Follow the procedure outlined in this publication to upgrade the software of the 'IBU' system using the KDS ECU Upgrade function in Manual Mode only as described in this bulletin. For confirmation that the latest reflash has been applied to a vehicle you are working on, verify the ROM ID using the table on page 3 of this bulletin.
