# TECHNICAL SERVICE BULLETIN

Classification: DA23-007	Reference: NTB24-005	Date: January 18, 2024
-----------------------------	-------------------------	---------------------------

## ENGINE RPM HIGHER THAN EXPECTED WHEN USING INTELLIGENT CRUISE CONTROL

**APPLIED VEHICLES:** 2022-2023 Frontier (D41)  
**APPLIED DATES:** Built on or before June 13, 2023

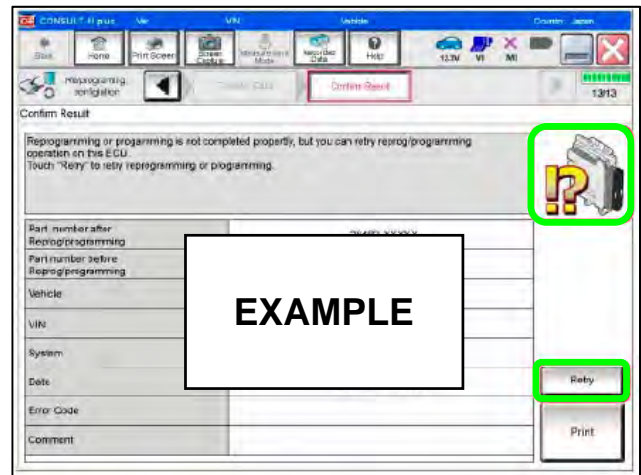
Figure 14

If reprogramming does not complete and the “!?” icon displays, as shown in Figure 14:

- Check battery voltage (12.0 - 15.5 V).
- Ignition is ON, engine OFF.
- External Bluetooth® devices are OFF.
- **All** electrical loads are OFF.
- Select **Retry** and follow the on screen instructions.
- Retry may not go through on first attempt and can be selected more than once.

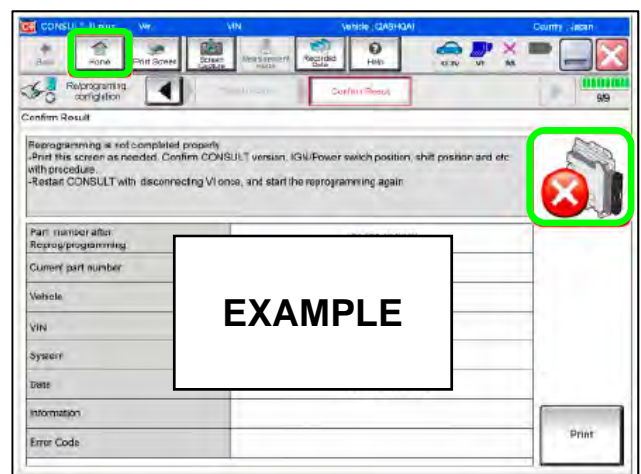
Figure 15

If reprogramming does not complete and the “X” icon displays, as shown in Figure 15:

- Check battery voltage (12.0 - 15.5 V).
- CONSULT A/C adapter is plugged in.
- Ignition is ON, engine OFF.
- Transmission is in Park.
- All VI cables are securely connected.
- All C-III plus updates are installed.
- Select **Home**, and restart the reprogram procedure from the beginning.
