TECHNICAL SERVICE BULLETIN

Classification: BT23-015	Reference: NTB24-006	Date: January 19, 2024
-----------------------------	-------------------------	---------------------------

MOONROOF CENTER BRACKET ADJUSTMENT

APPLIED VEHICLES: 2023 ARIYA (FE0)
APPLIED DATES: Built on or before May 10, 2023
APPLIED GRADES: EVOLVE+, EMPOWER+, PLATINUM+

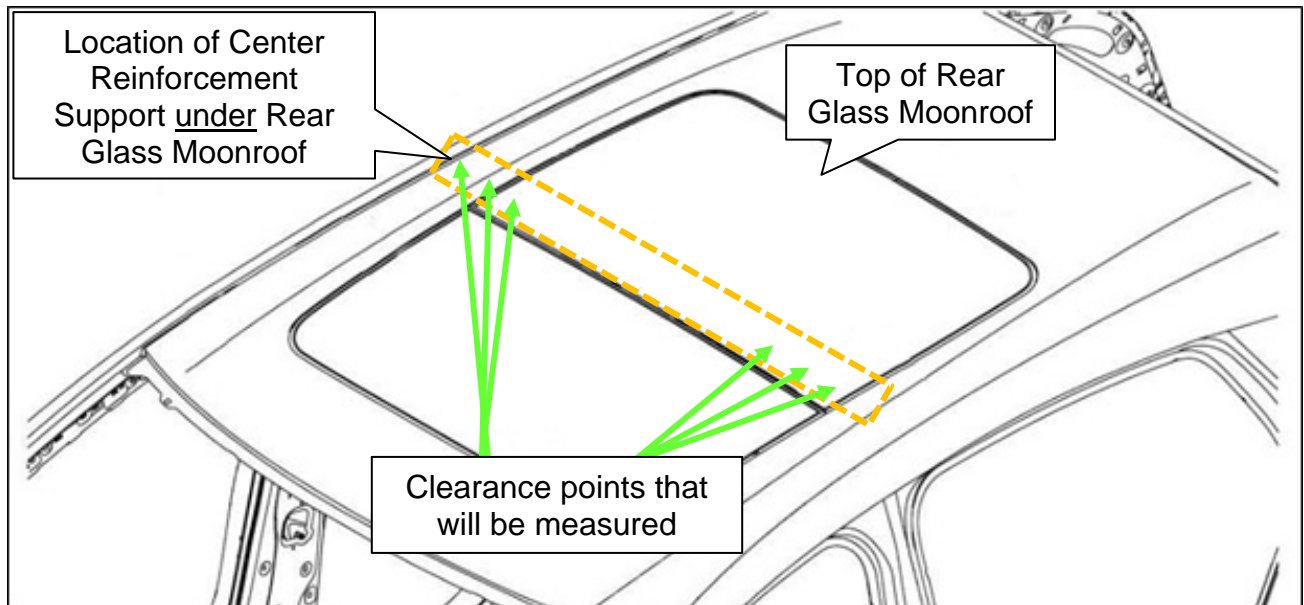
Figure 1

1. Remove the vehicle Headlining and rest it gently on the vehicle headrests.
 - Refer to the ESM: **BODY INTERIOR > INTERIOR > REMOVAL AND INSTALLATION > HEADLINING**
2. Using a 0.5 mm (0.020 in.) thick plastic feeler gauge, measure the clearances at the six (6) points shown in Figure 1. Refer to the following bullet points and Figure 2, Figure 3 and Figure 4 on page 3 for more detail.

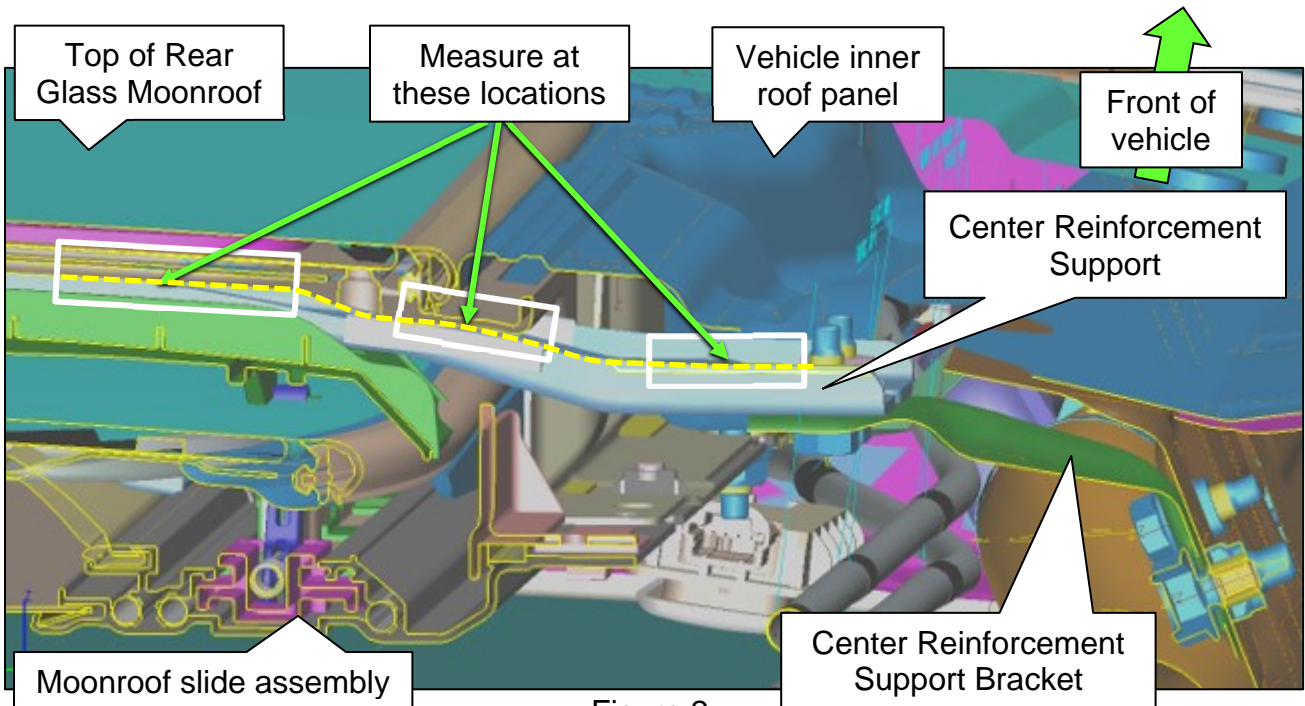
Figure 2

- Measure the gaps from the top of the Center Reinforcement Support (Yellow dashes in Figure 2), to the underside of the roof and the Rear Glass Moonroof, where felt tape is present. See Figure 3 and Figure 4 for pictures of the felt tape.

HINT: Figure 3 shows only three (3) points on one side. The other side is similar.

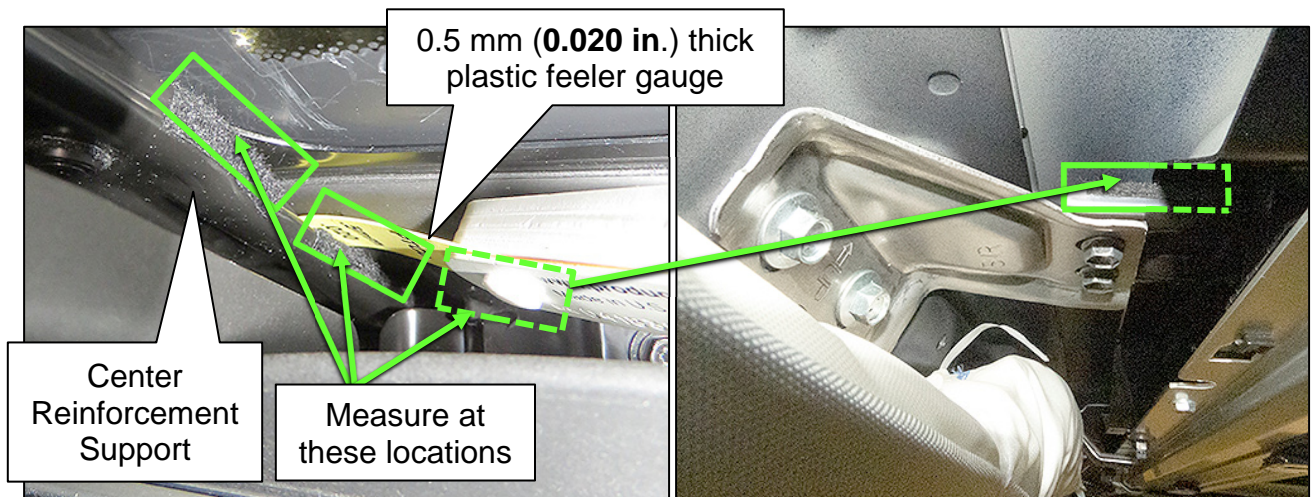
Figure 3

- Measure above where each piece of felt tape is attached and move the plastic feeler gauge side to side along the felt tape.

HINT: At least 0.5 mm (**0.020 in.**) of clearance should be present at all points along the top length of each piece of felt tape.
