GROUP	MODEL
BOD	2023-2024MY K5 (DL3a)
NUMBER	DATE
322 (Rev 1, 02/02/2024)	November 2023

## TECHNICAL SERVICE BULLETIN

### SERVICE ACTION: TRUNK LID AND C-PILLAR GARNISH INSPECTION & REPLACEMENT (SA552)

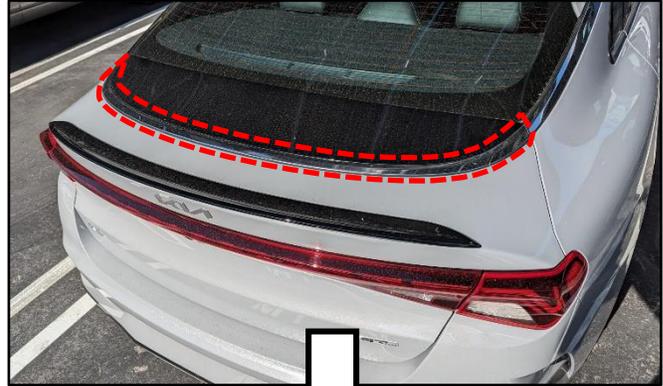
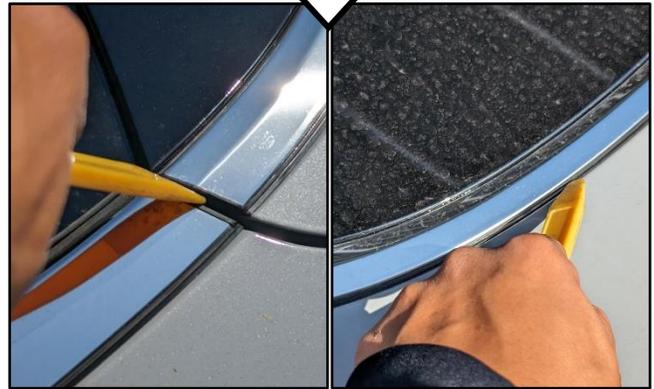
- If the rear chrome trunk lid garnish is not separated (loose) when inspected **(OK)**, then proceed to step 2.
- If the rear chrome trunk lid garnish is separated (loose) when inspected **(NG)**, then refer to the rear trunk lid garnish by referring to the 'Replacement Procedure' on page 3 and proceed to step 2.

- Using a non-marring plastic trim tool, carefully pry with 'light' upward pressure in between the rear chrome trunk lid garnish rubber and the trunk lid.

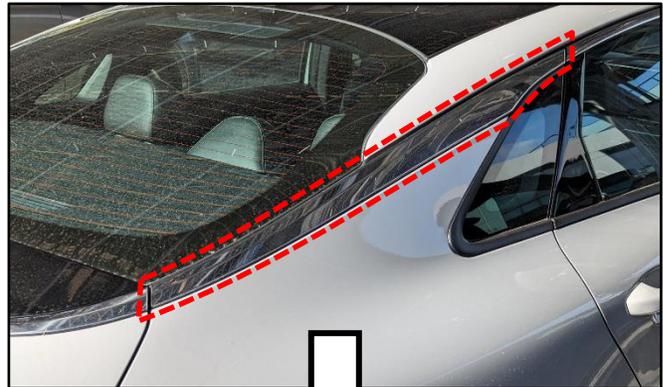
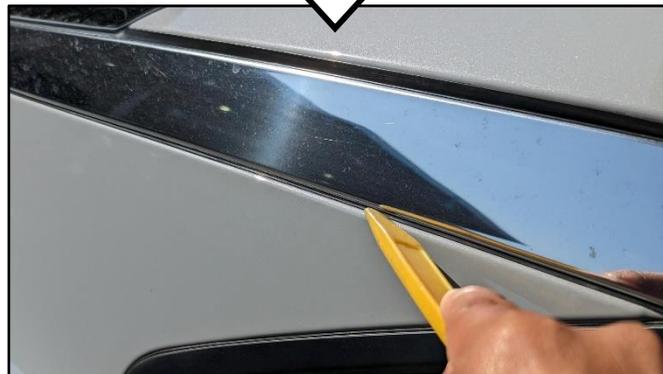
- If the rear chrome C-Pillar garnish is not separated (loose) when inspected **(OK)**, then no further action is required unless the rear trunk lid garnish requires replacement.
- If the rear chrome C-Pillar garnish is separated (loose) when inspected **(NG)**, then replace the rear trunk lid garnish by referring to the 'Replacement Procedure' on page 4.

- Using a non-marring plastic trim tool, carefully pry with 'light' upward pressure in between the rear C-Pillar chrome garnish rubber and the body.
