# Service Bulletin

Bulletin No.: 24-NA-008

**Subject:** Hesitation, Reduced Power, Engine Stalling, Poor Transmission Performance, Door Locks Cycling, No Start, Erratic Activity with Interior Lights and Gauges, Engine Revving without Input, HVAC Erratic HVAC Control Inoperative or Erratic, Smoke, Loss of Power Steering

Brand:	Model:	Model Year:		VIN:		Engine:	Transmission:
		from	to	from	to		
Chevrolet	Colorado	2015	2022			LCV	
GMC	Canyon

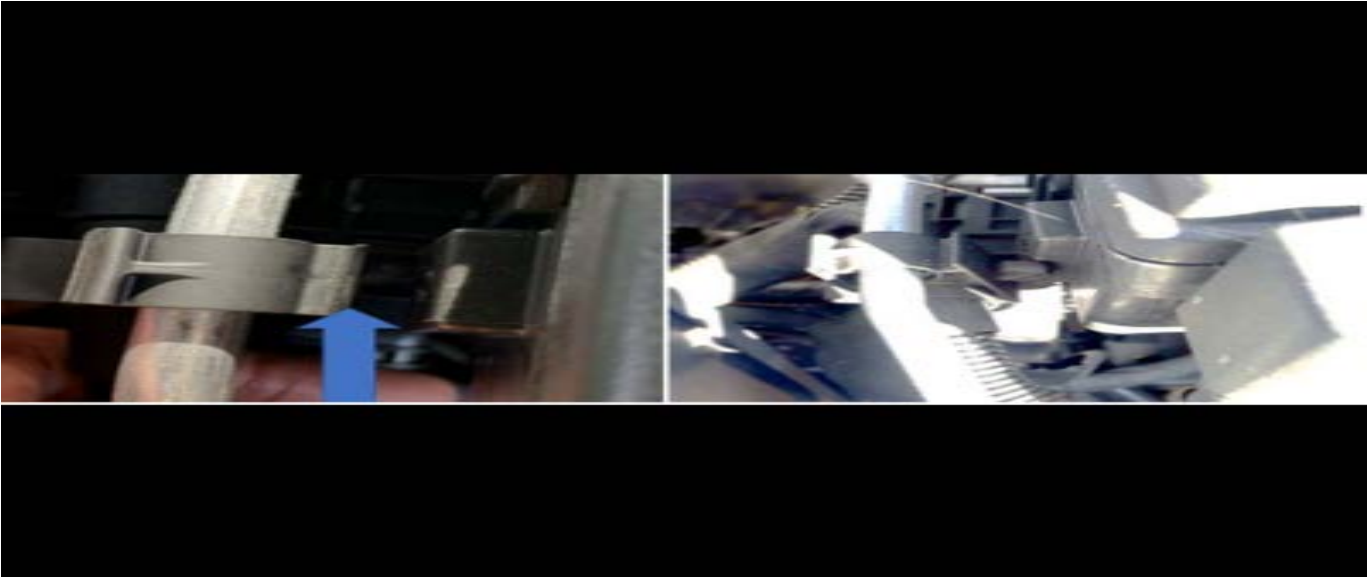
For this example, it was found that the cable harness clip was not installed in the housing properly adding stress to the cable and A/C line.

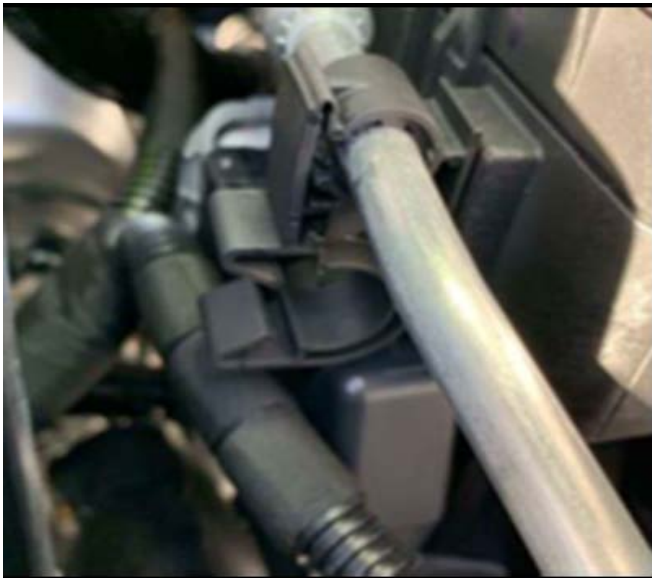
6518127

For this example, it was found that the cable harness was not installed in the clip properly which resulted in the harness sagging downwards and contacting the pump pulley.

⇒ If damage to the clip is found. Replace the clip.

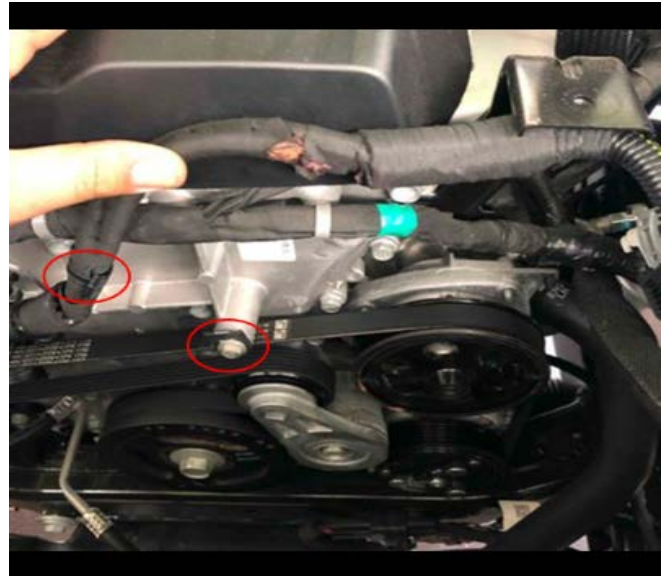
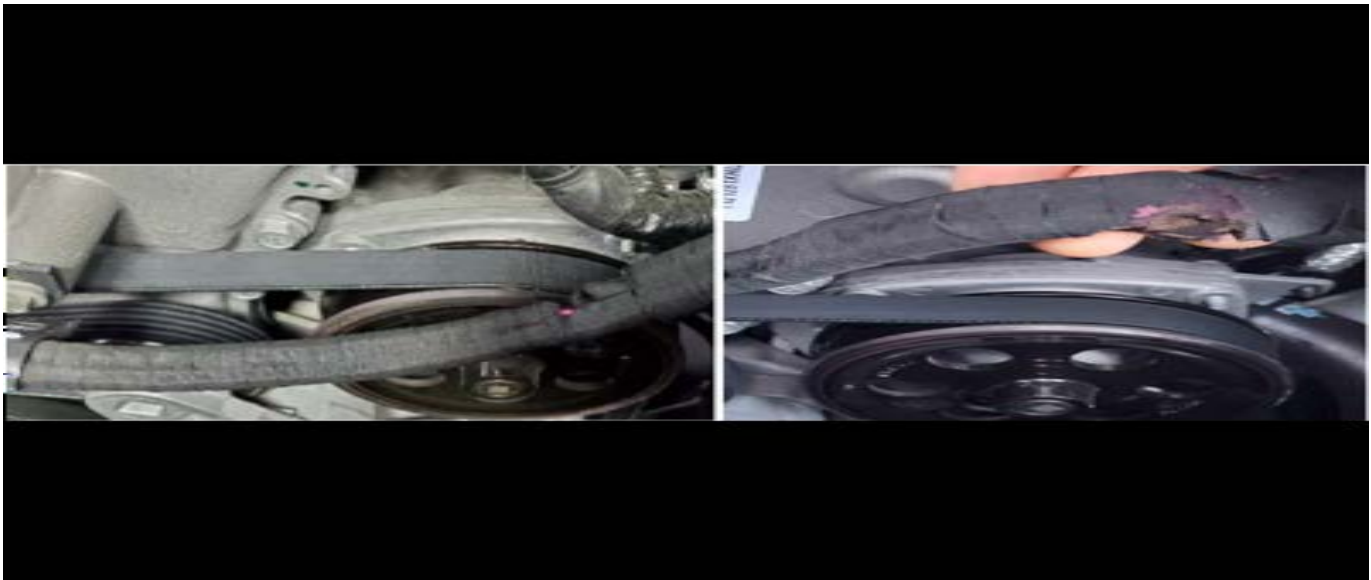
6517526

As shown in the graphics above, it was found that the cable harness retainer was damaged which resulted in the harness contacting the pump pulley.

⇒ If no damage to the harness is found, replace the retainer.

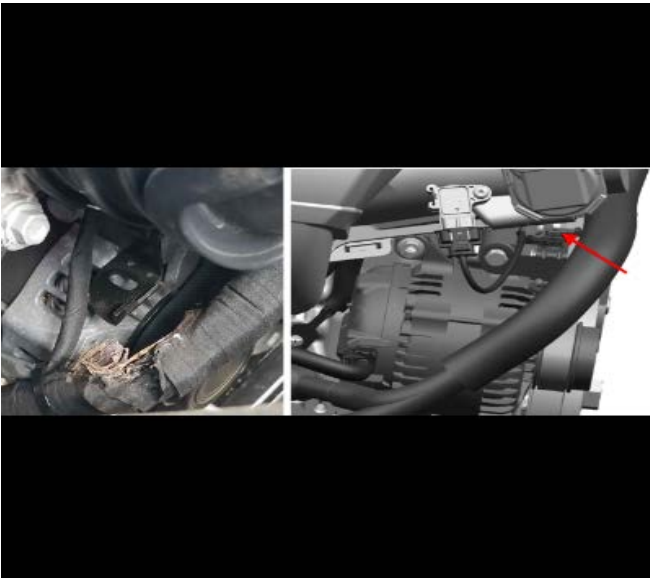
6518108

The retainer was damaged causing the cable harness to contact the alternator.

⇒ If no damage to the harness is found, replace the retainer.
