Preliminary Information

PIC6293H Installation Of the GM Accessory Interior Spectrum Lighting Kit

Brand:	Model:	Model Years:	VIN:		Engine:	Transmissions:
			from	to		
Chevrolet	Camaro	2016 - 2024	All	All	All	All

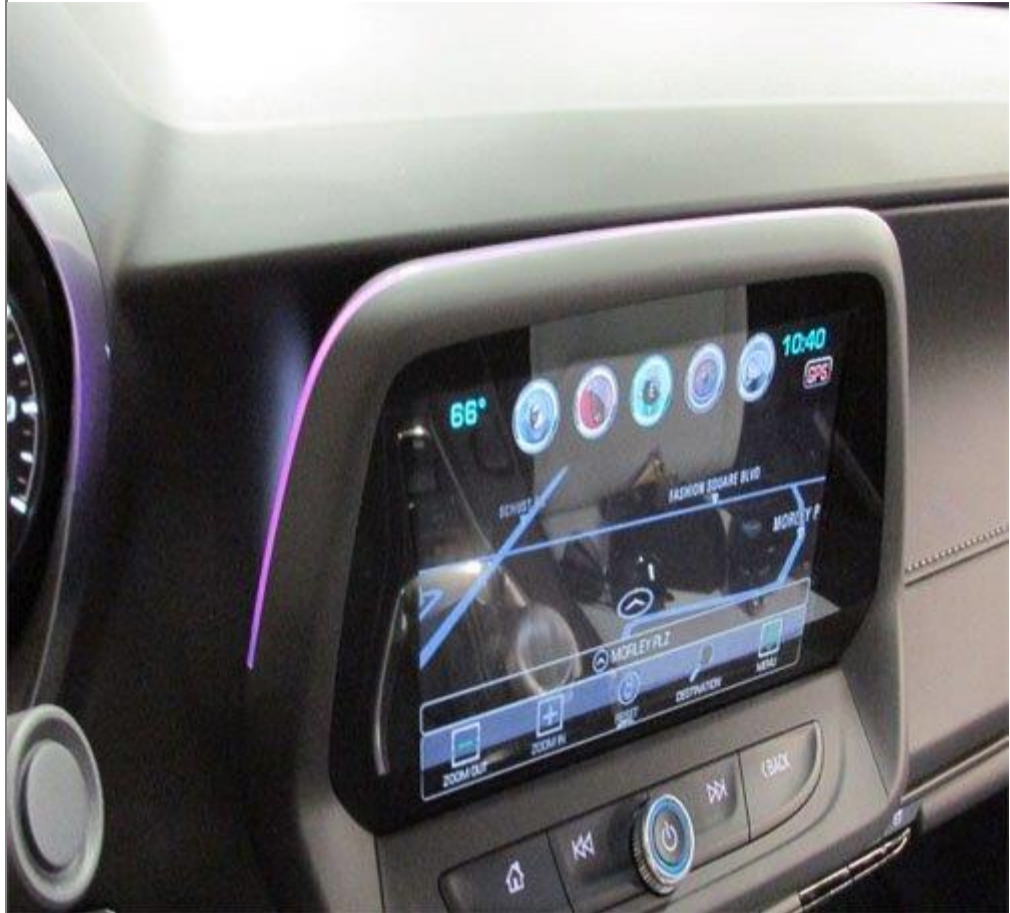
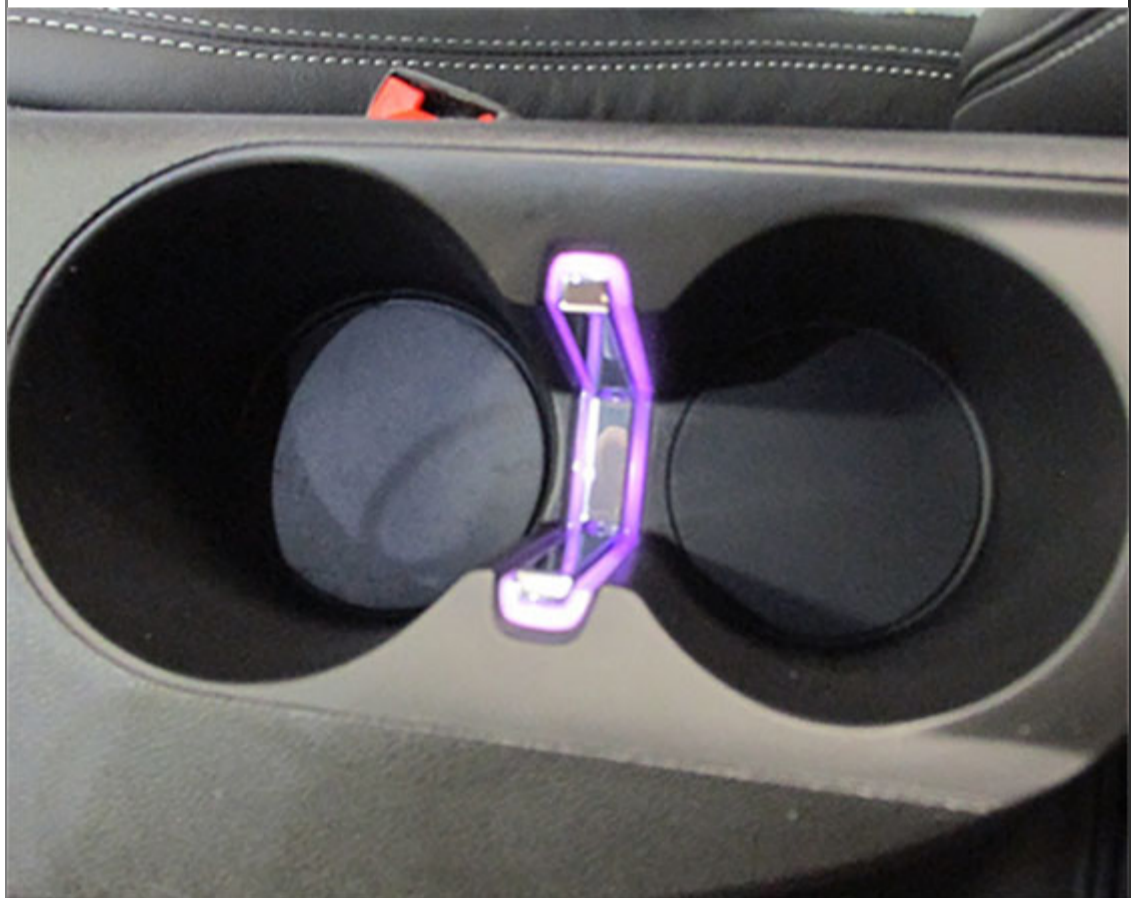
IMPORTANT: All Camaros have a light pipe around the radio display, as seen in the photo below. When installing a GM Accessory Lighting Kit on a vehicle that is NOT equipped with the factory C70 RPO, the light strip around the radio display will illuminate white, and it can not be changed or controlled. This is normal. There will not be a color changing light in this kit for the center cupholder either. The only way to get these two lights to operate in a controlled manner is to purchase the vehicle with the factory C70 RPO.

Again, the GM Accessory Interior Spectrum Lighting kit will not provide illumination for the cupholders, nor will the built-in light pipe that surrounds the radio display be able to be changed or controlled

as far as color goes. It will illuminate with a white appearance, no matter what.

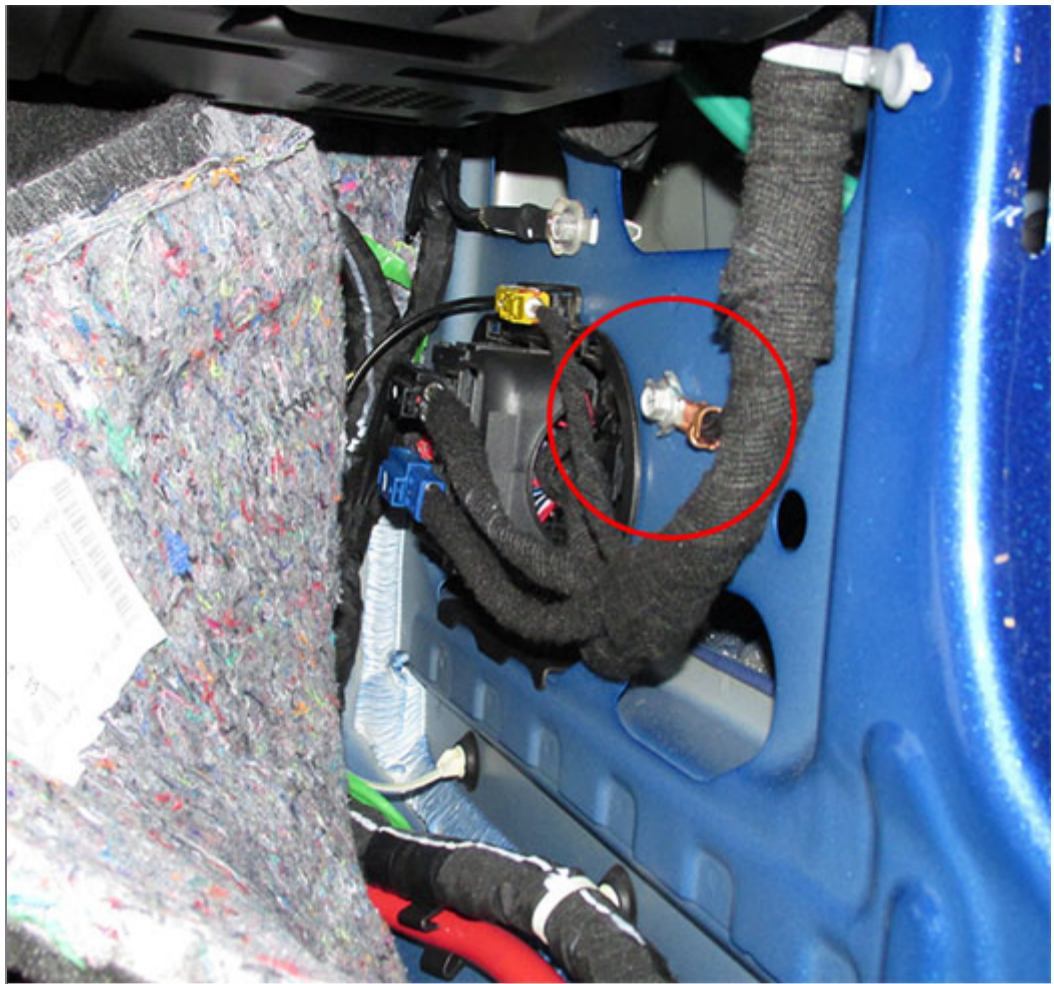
- If the entire kit has been installed and the lighting is entirely inoperative, there are a few things to go back and check. The most common area for concern is G202, which is located at the right hand kick panel. Typically, this ground has paint on it when the kit's eyelet is installed. Just tightening the fastener does not provide a good ground path if there is still paint covering the sheet metal. The fastener will have to be removed, the paint needs to be cleaned or ground off, and the ground path verified.

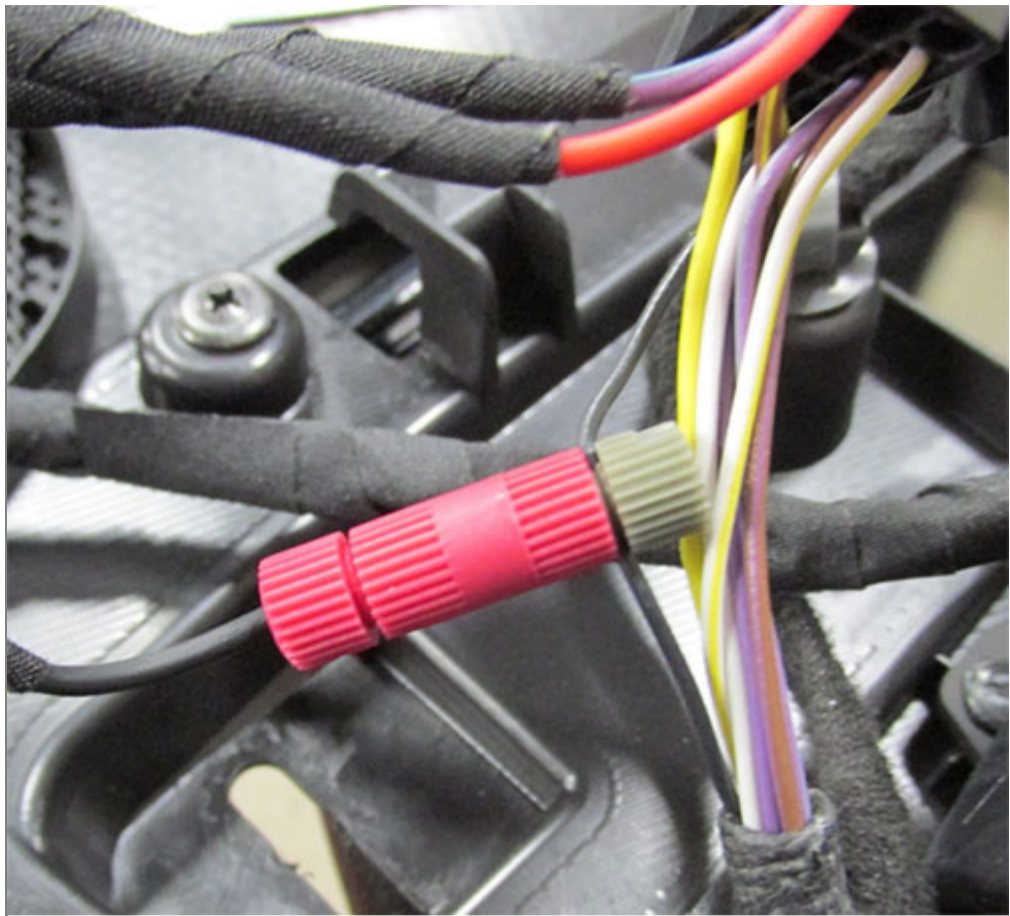
- **Another common issue that is seen relates to the Posi-Tap connectors used in the kit. These connectors are used to splice the accessory harness to the vehicle's wiring harness. Dealership technicians are to go back through the installation and verify that each connector is tight. If one or more of these connectors is/are loose, this will cause any number of performance issues with the kit. The connector shown in the photo below does not have tape or a zip tie covering it for clarity. Once the connector is properly installed, the instructions have the technician tape back the splice to the main harness using cloth tape. This will prevent the connector from loosening up over time.**

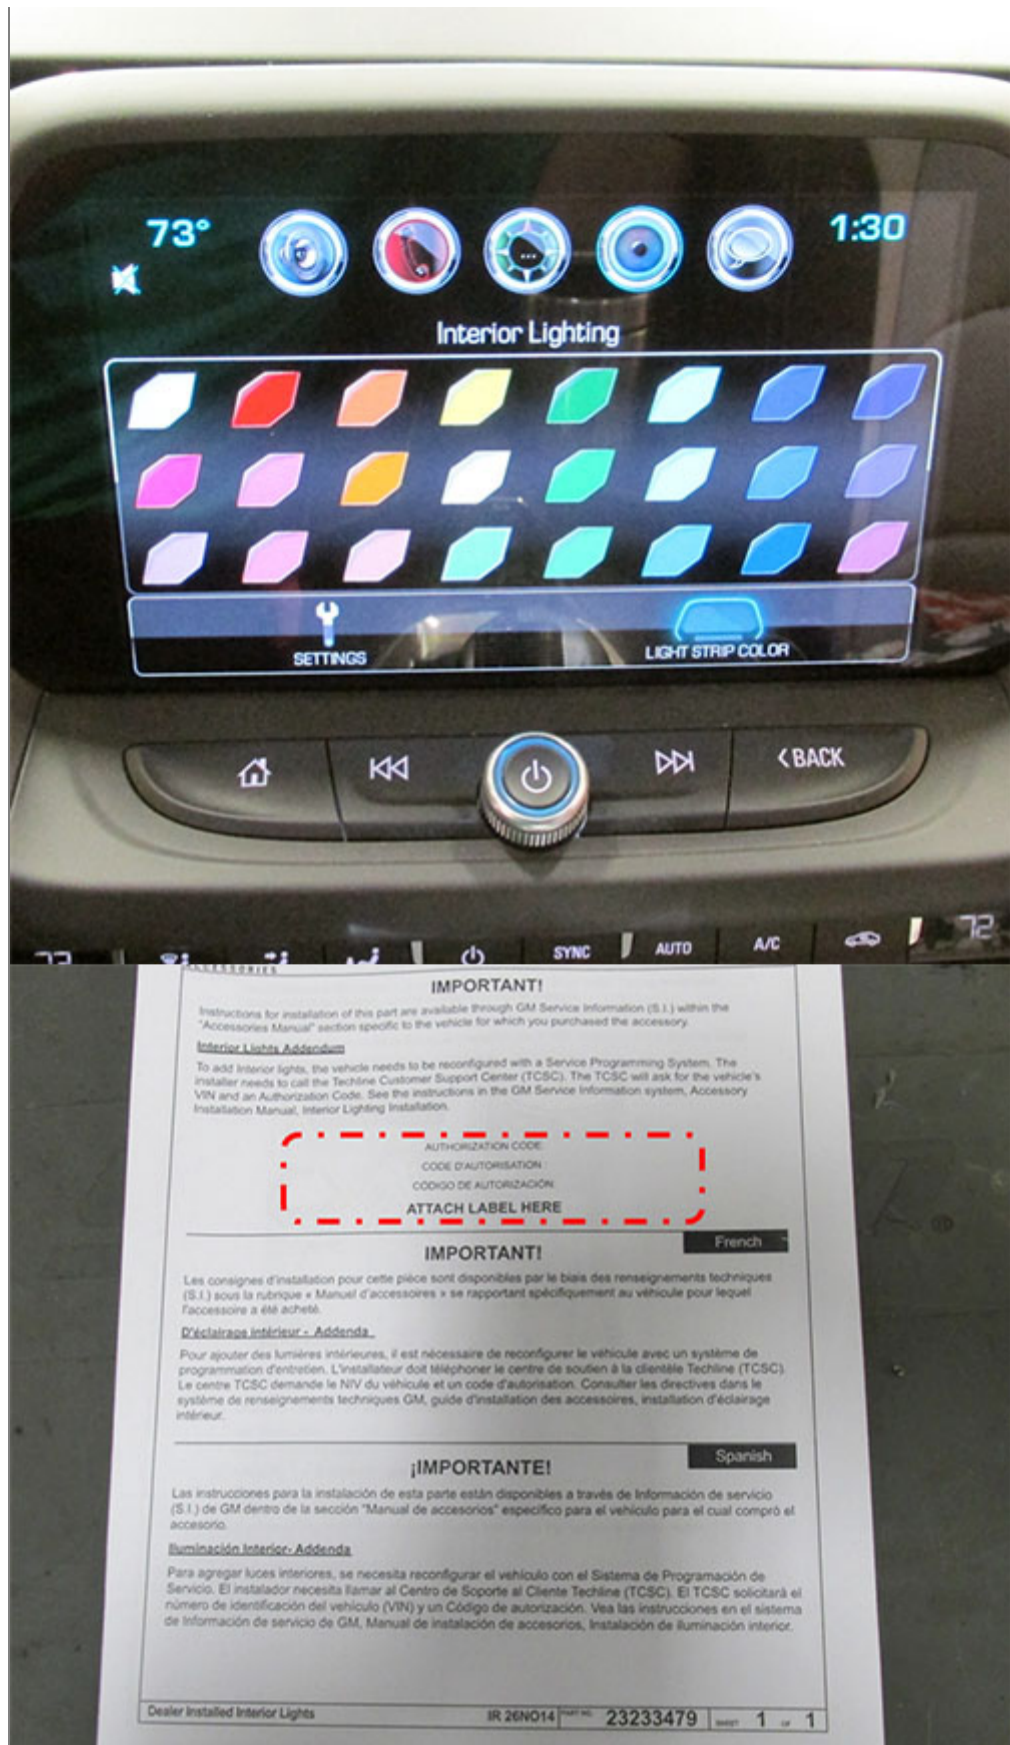
- If the vehicle is equipped with an "uplevel" radio (RPOs IO5, IO6, IOS, or IOT) various modules will require reprogramming through Techline. This programming allows the customer to select the various lighting colors on the radio's touchscreen, as seen in the color palette photo below. As seen in the second photo below, there will also be a sheet of paper included in the kit that has an authorization code printed on it. Once that code is provided to Techline, they will be able to assist in correctly programming the vehicle.

For the 2016 - 2018 models with the IO5 or IO6 radio, the HMI and the BCM will require SPS programming.

For the 2019+ models with the IOS or IOT radio, the radio and BCM will require SPS programming.

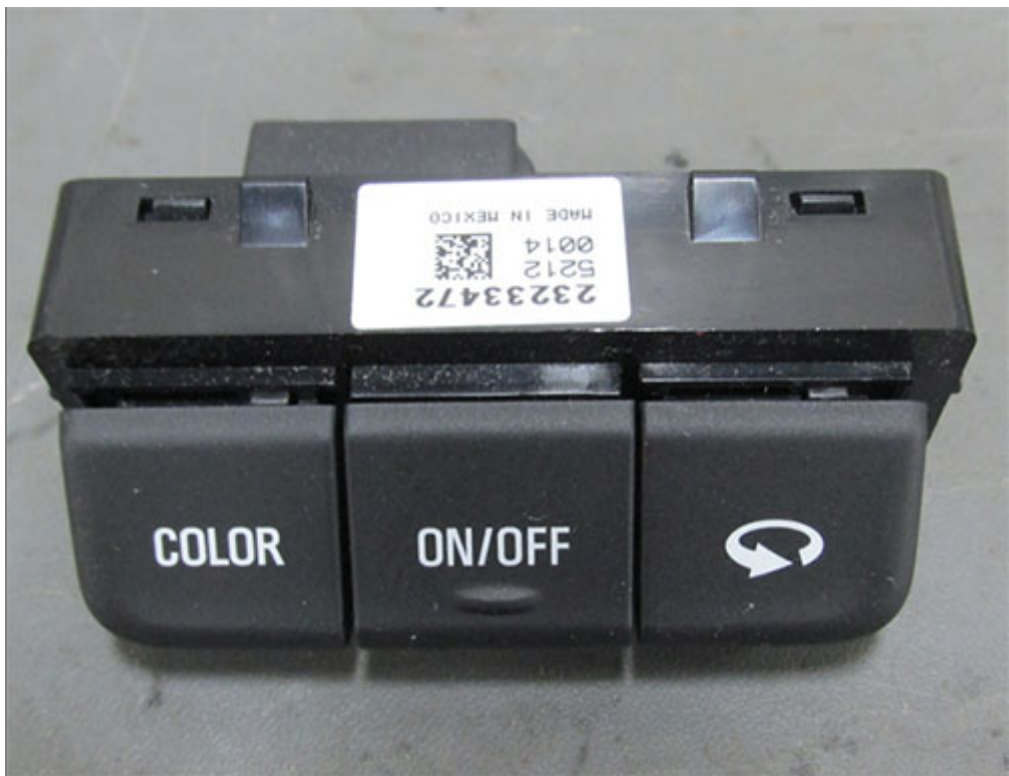
- Vehicles equipped with the base radio (RPO IOB or IOR) do not require any programming. That is why the color selections are not available on the radio screen. This system uses a dash-mounted switch to change the system's lighting colors. It is installed on the left hand side of the steering column. This switch can be seen in the photo below.

If a kit is being installed on a vehicle with either the IOB or the IOR base level radios, and TCSC has provided any type of a calibration for the kit, STOP, and do not proceed any further. Contact TCSC again and request all cal's be returned to OEM configuration as it relates to this kit. Under no circumstances should BCM, HMI, or radio calibrations be changed from factory cal's in regards to the installation of this Interior Spectrum Lighting kit.
