PIP5911A SES LIGHT ON – P066A P066C P066E P067A P067C P067E P068C P068E

Brand:	Model:	Model Years:	VIN:		Engine:	Transmissions:
			from	to		
Chevrolet	Silverado 2500HD 3500HD	2024	All	All	6.6L (RPO L5P)	All
GMC	Sierra 2500HD 3500HD	2024	All	All	6.6L (RPO L5P)	All

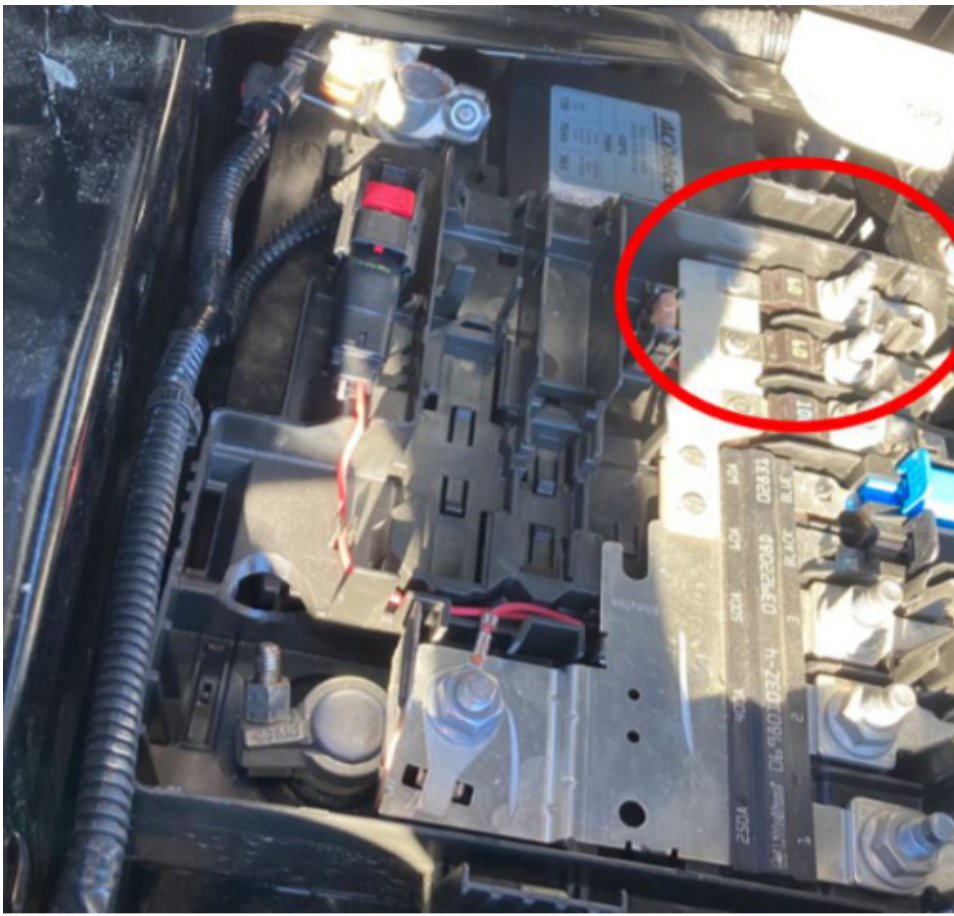
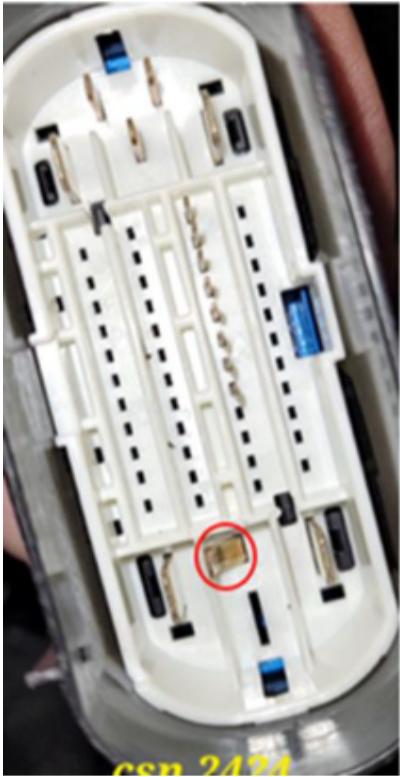
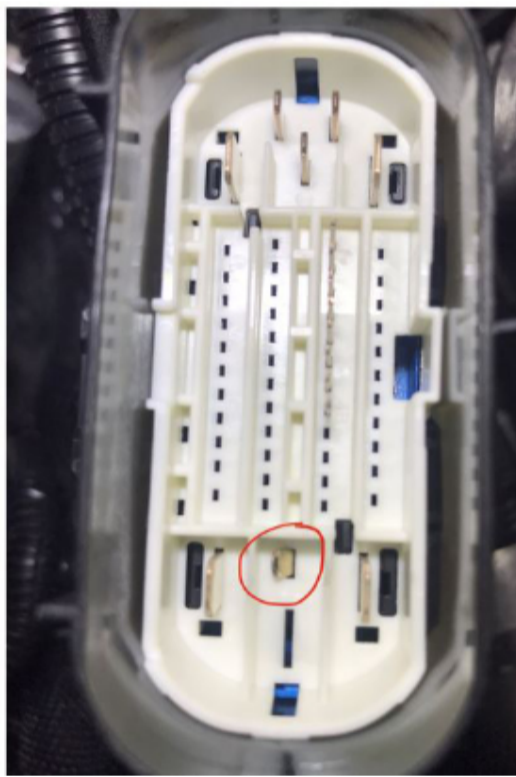
Involved Region or Country	North America
Condition	SES LIGHT ON – P066A P066C P066E P067A P067C P067E P068C P068E
Cause	<p>Blown fuse F5 (F5BA) will result in Cylinder 1, 4, 6 & 7 all setting DTCs simultaneously</p> <p>Blown fuse F6 (F6BA) will result in Cylinder 2,3,5 and 8 all setting DTCs simultaneously</p> <p>Terminal damage in X950D 55-way connector will result in individual P0671 P0672 P0673 P0674 P0675 P0676 P0677 P0678 DTCs setting.</p>

Some blown fuse conditions will intermittently make contact.

Look for bent terminals in X950D that may result in individual P0671 P0672 P0673 P0674 P0675 P0676 P0677 P0678 DTCs setting.

Do not replace or disturb glow plugs before checking BDU (Battery Distribution Unit Fuse Assembly) and for bent terminal in X950D 55-way connector.

Be sure to check for 12V on BDU ring terminal while wiggling the cable.

If fuse is intermittent or blown, replace the BDU assembly.

DO NOT OVERTORQUE OR STRESS BDU FUSE.

10 mm nut is torqued to 6 Nm ; 13 mm nuts torqued to 15 Nm.

X950D connector can be separated by disengaging the red CPA and squeezing the corners of the connector.
