Published date: 01/8/2024

Preliminary Information

PIP5548B Diagnostic Aid For CVT7 Transmission Fluid Pan Magnet Inspection To Avoid Unnecessary Transmission Replacement

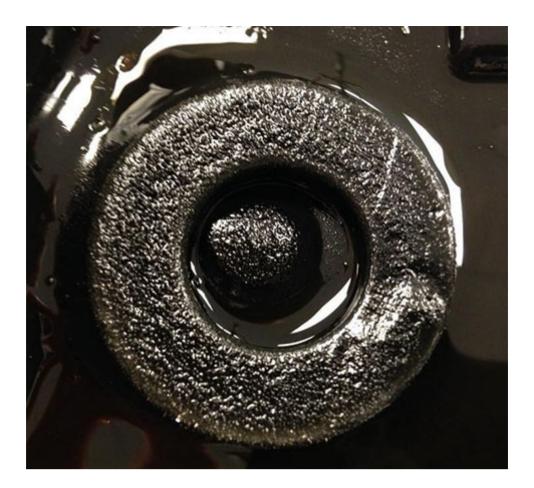
The following picture shows normal appearance of metallic dust. Please continue with diagnostics.

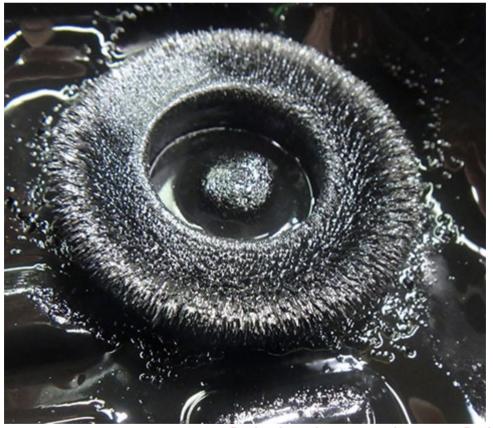
The following picture shows particle buildup that may appear as fuzz, strands or chips.

Using gloves, rub a small amount of the magnetic debris between your fingers or onto a hard surface. If the debris breaks down and feels almost smooth, please continue diagnosis.

If there are actual chips in the debris, the transmission should be replaced.
