Bulletin No.: PIC6536
Published date: 01/10/2024

PIC6536 Diagnostic Tip for No Crank No Start condition and/or Loss of Power Steering

Brand:	Model:	Model Years:	VIN:		Engine:	Transmissions:
			from	to		
Cadillac	CT4	2020 - 2024	All	All	All	All
Cadillac	CT5	2020 - 2024	All	All	All	All

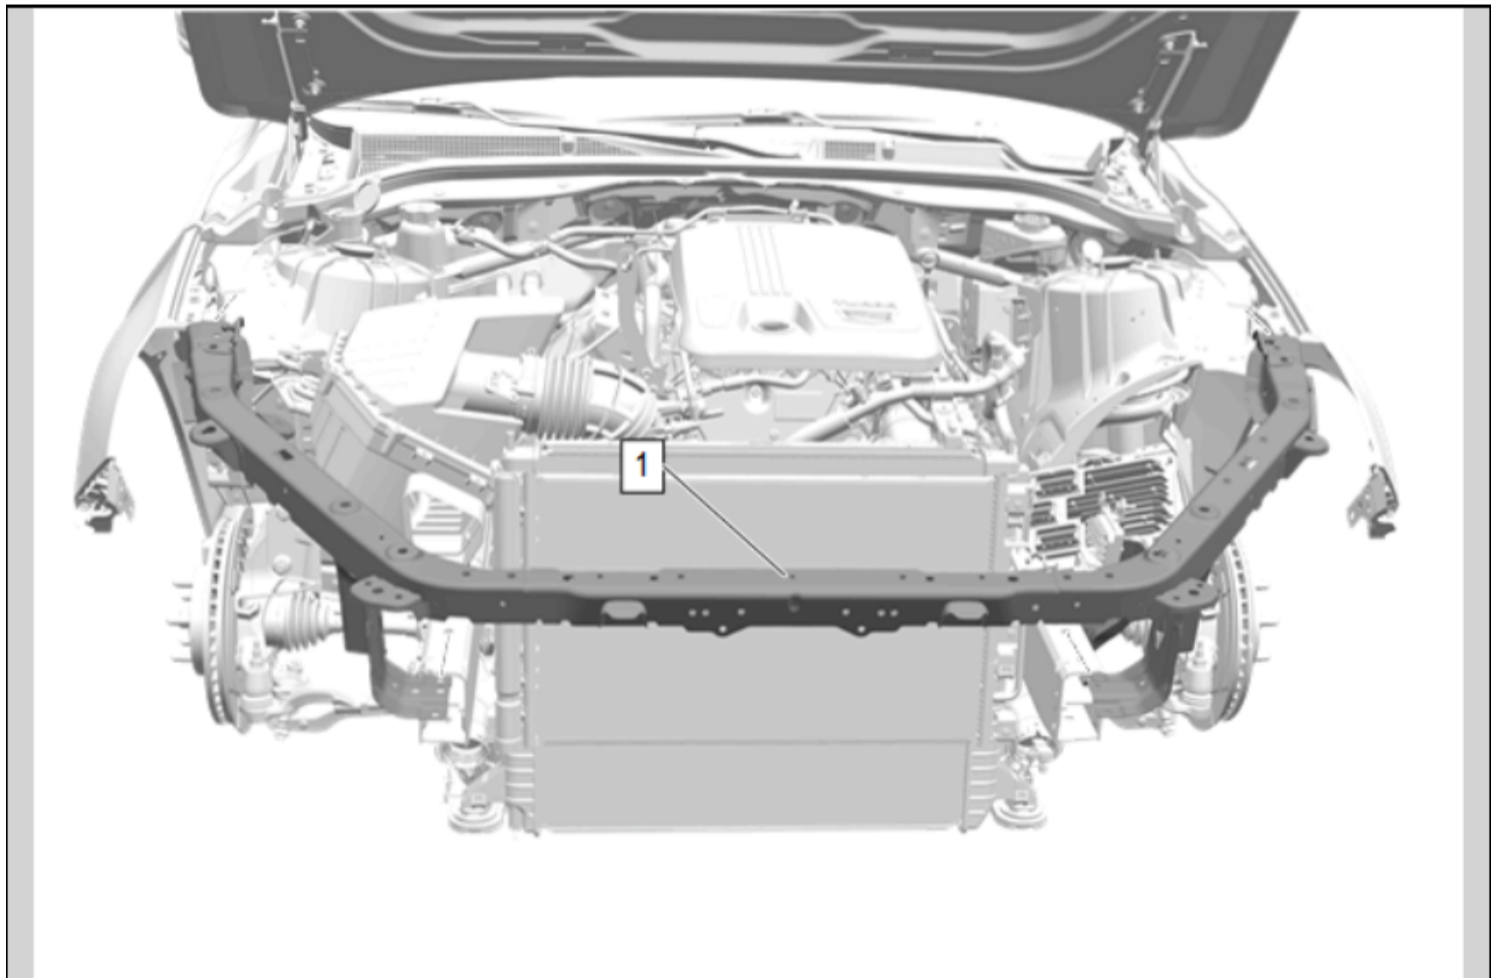
Involved Region or Country	North America
Condition	Vehicle was brought in for a no start no crank condition and/or loss of power steering. Tech may find DTC's U0101, U0131, U0401, U0402, U1611, U1818, U1962, U220F, U3003 sym16, U3003 sym1c.
Cause	Poor ground path thru Front Compartment Front Panel to vehicle body connection.

If the above condition is found and the technician discovers an excessive voltage loss to a module or device on the ground path, the technician should perform a loaded voltage drop test between any of the following ground connections; G103, G107, G108 and, G110 at the Front Compartment Front Panel (1) to the negative post of the battery.
