## Preliminary Information

### PIT6109 Auxiliary Endgate Step Link Contacts Tailgate Paint

Brand:	Model:	Model Years:	VIN:		Engine:	Transmissions:
			from	to		
Chevrolet	Silverado	2023 - 2024	All	All	All	All
GMC	Sierra	2023 - 2024	All	All	All	All

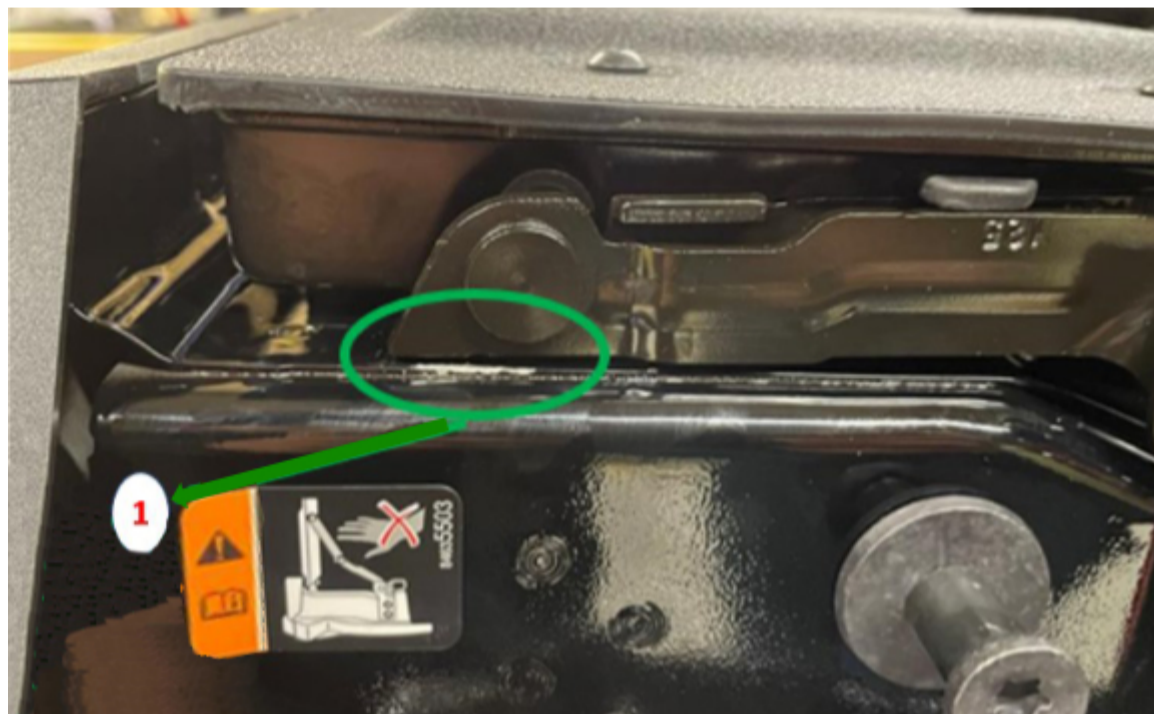
Involved Region or Country	North America
Additional Options (RPO)	QK2 - Multipro / Multiflex Tailgate
Condition	Some customers may comment that the minor / auxiliary endgate step link is contacting the tailgate paint causing a chip in the paint, shown below (1). This condition may occur at either the left and/or right step links.
Cause	The cause of this concern could be build variation in the step link bracket mounting position during assembly.

To correct this condition, reposition the step link bracket (3) up and away to slightly lift the step link off the painted surface, shown below (4). Loosen both step link bracket bolts at the left and right sides of the minor tailgate, left side shown below (2). With the step link bracket bolts loose there will be some play in the bracket to allow for repositioning. Starting with the right side step link bracket, lift up on the bracket to achieve and maintain clearance at call out 4 then tighten both mounting bolts (2) to 40 Nm (30 lb. ft). Repeat the procedure for the left side step link bracket. If necessary, a small pry bar can be used to help lift the step link bracket then tighten the bolts (2). There is no need for rust protection where the paint is damaged because the endgate is made from aluminum but touch up paint can be used to fix the paint chip.
