Preliminary Information

PIT6114 ABS / Traction Control / Stabilitrak / SES MIL DTCs C0511 C0510 C0516 and/or C0517

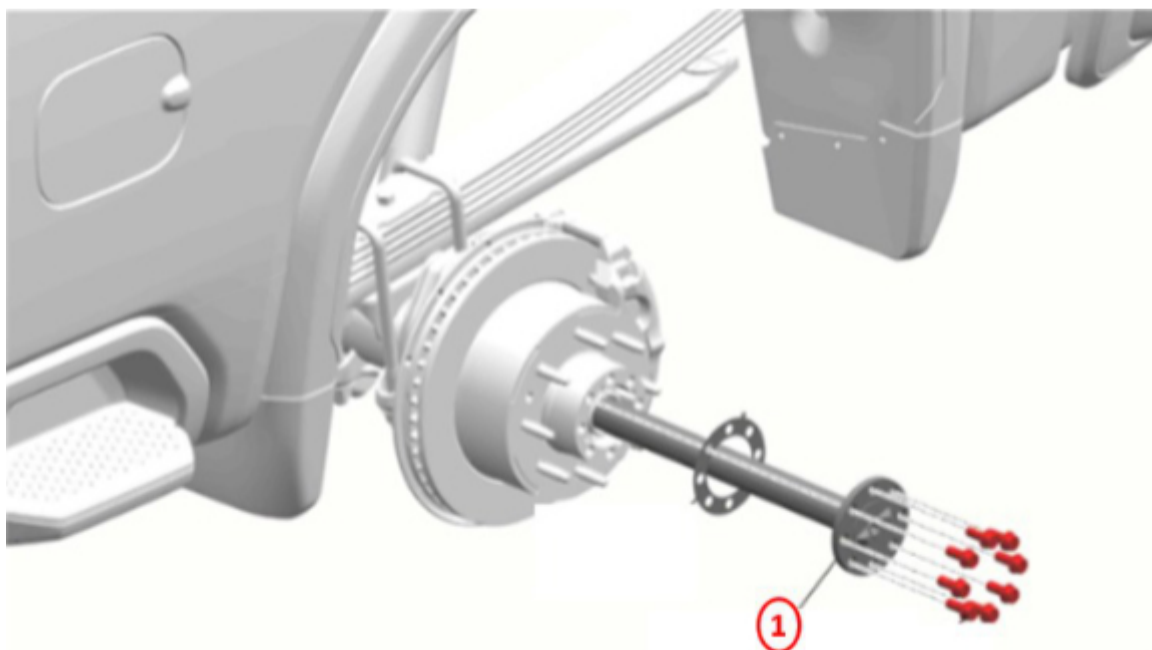
Involved Region or Country	North America
Additional Options (RPO)	With RPO DZW - DUAL REAR WHEEL
Condition	Some customers may comment on an ABS / Brake / Traction Control / Stabilitrak / SES MIL. When checking for DTCs there may be a rear Wheel Speed Sensor (WSS) DTC set for either the left or right side: example C0511, C0510, C0516, and/or C0517.
Cause	The cause of this concern could be a rear axle shaft with excessive runout. The excessive runout causes the air gap between the rear WSS and tone ring to increase and decrease as it turns.

If a repair has not been found after performing SI diagnostics, then perform the following to help determine if excessive runout of the axle shaft is the cause. Use the parts catalog to determine if the rear axle shafts (item 1 shown below) are the same part number for both the left and right sides. If the part numbers are the same for both sides, then swap the axle shafts from left to right and see if the DTC follows the axle shaft. If so, then replace that axle shaft.
