Preliminary Information

PIP5810B Transfer Case Input Seal Installation

| Condition | Transfer case input seal installation tool will not install seal to correct depth causing a leak. |

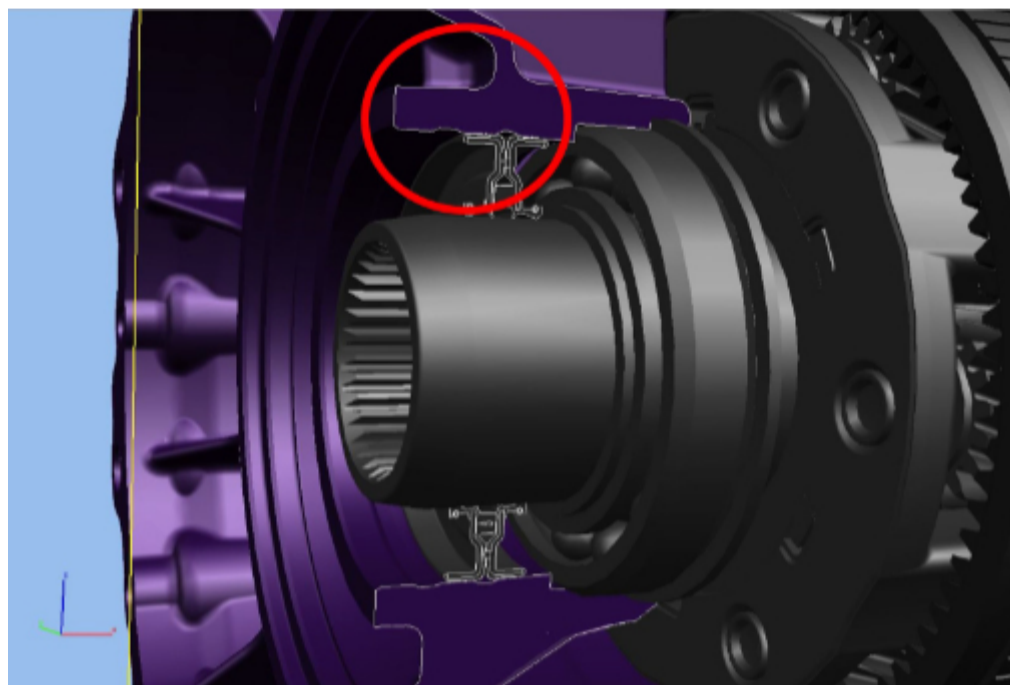
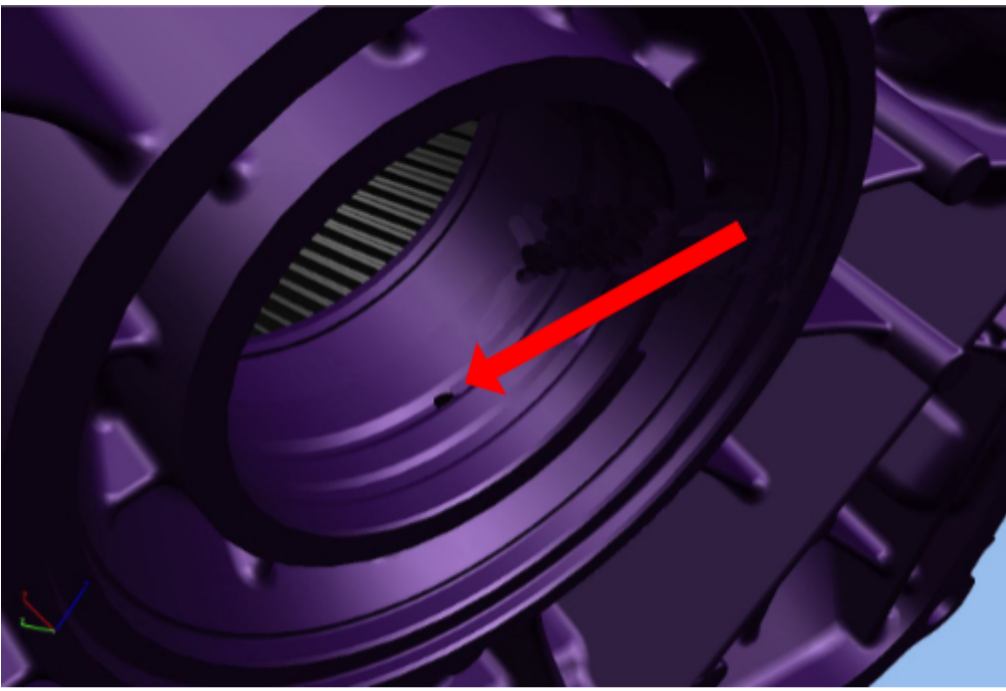
Seal installation depth is critical when replacing the transfer case input seal.

There is a gap around the outer portion of the seal that needs to be centered over a weep hole in the case.

Weep hole is drilled in the center of a groove machined into the case.

Tool # DT-50648-A Seal Installer will not work for these applications.

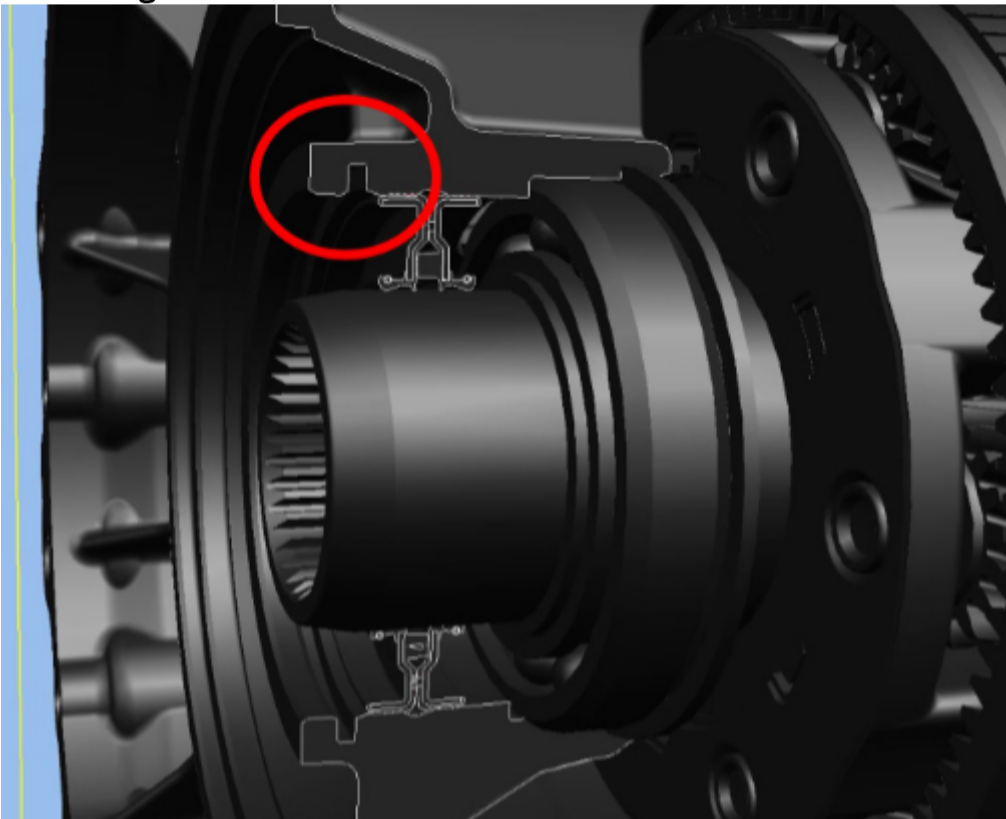
First Design

To identify design level look for a machined groove where the seal is installed (Red circles below).

If there is a defined machined groove in the case then it is a first design case.

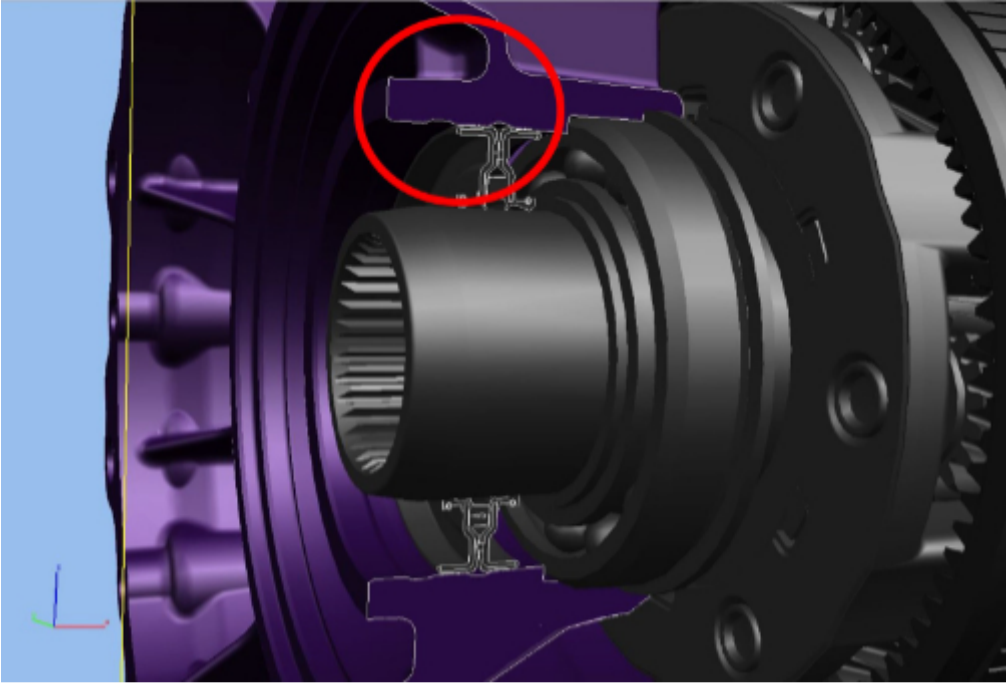
Second Design

If there is not a defined groove machined into the case then it is second design.

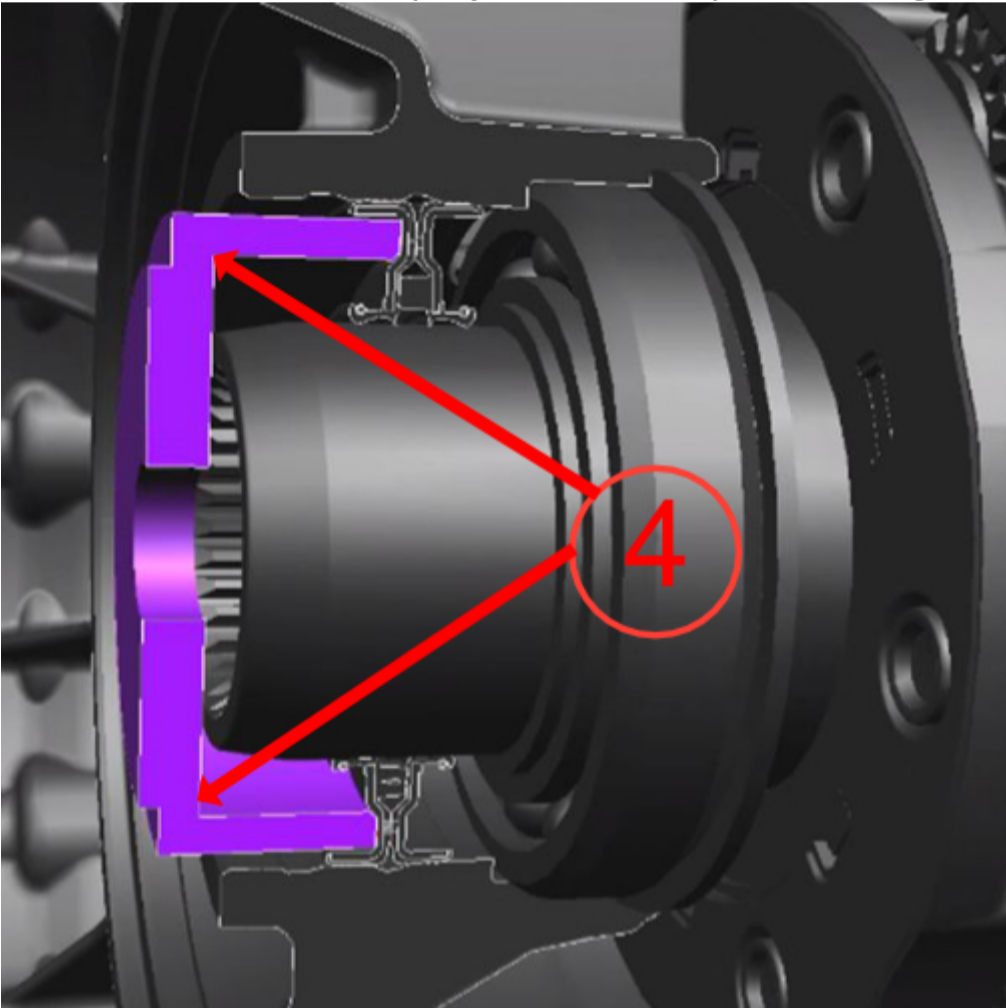
While GM works through the servicing tool strategies, J-45228 (4) can be used to drive the seal in HOWEVER there is no stop at the correct depth.

The seal will have to be driven in slowly and seal installed depth checked.

Be careful not to drive in too deep or you will need to replace the seal again.

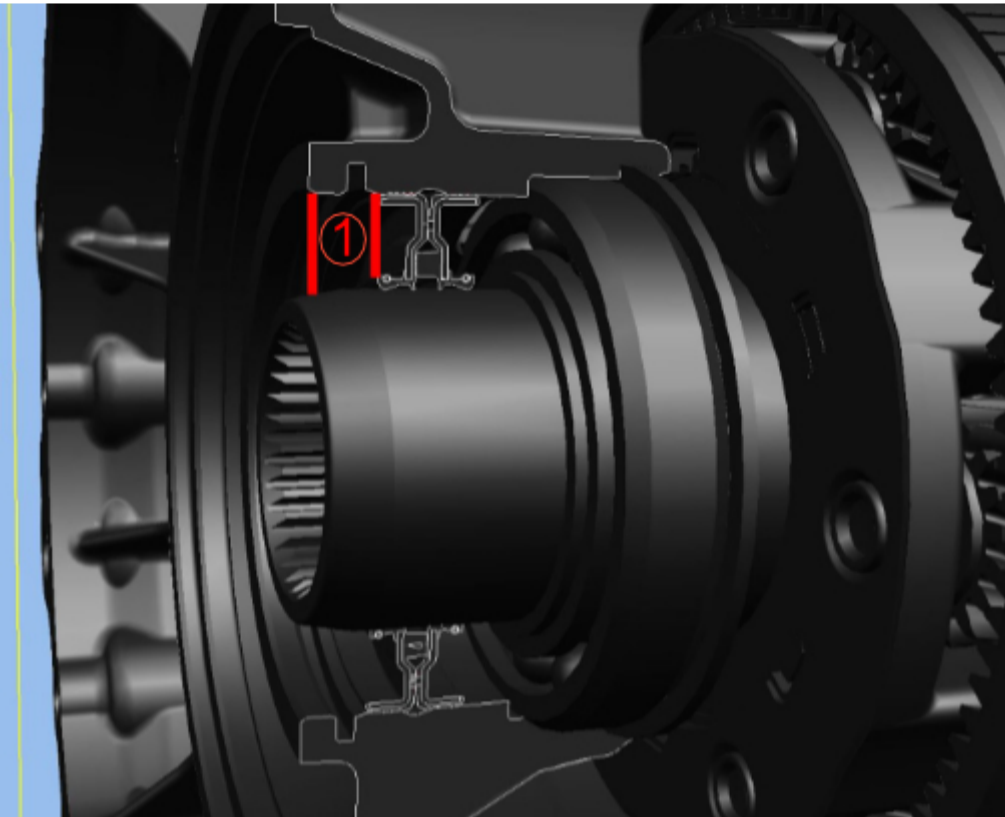
To verify correct installed depth using a vernier caliper check the distance between the case and the outer part of the seal.

First design dimension 1 is 10 mm.

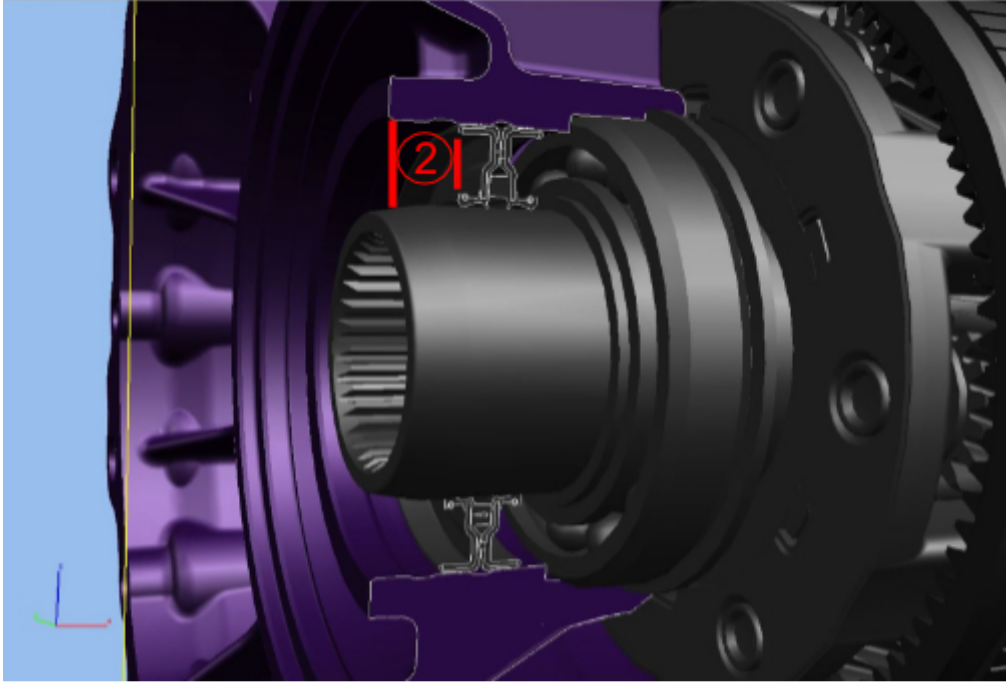
Second design dimension 2 is 13 mm.
