Published date: 01/30/2024

Preliminary Information

PIT6119 Minor / Auxiliary Tailgate Does Not Release

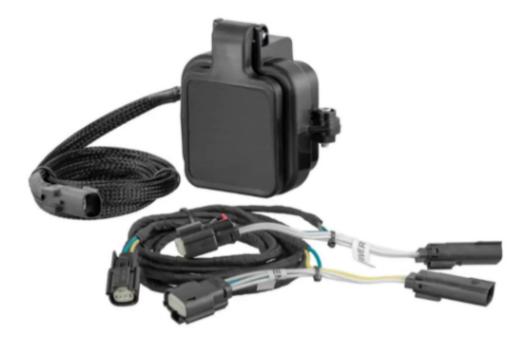
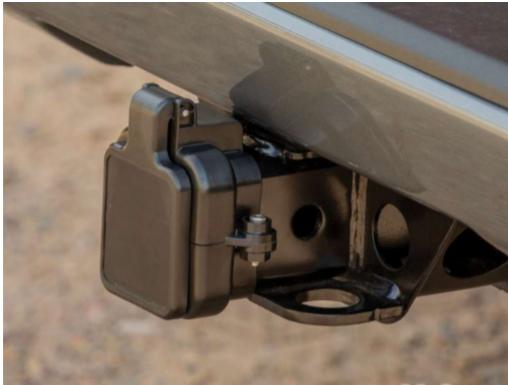
The cause of this concern could be a device, added to the vehicle, that inhibits the
Cause	minor tailgate from opening when it detects a trailer hitch installed into the receiver,
	example shown below.

These devices are not factory installed and before any in depth diagnostics are performed, they should be removed to see if the issue is resolved.
