Technical Service Bulletin

55 Guide to finding water ingress on the rear lid structure

55 24 88 2060265/3 February 1, 2024. Supersedes Technical Service Bulletin Group 55 number 21-55 dated April 7, 2021 for reasons listed below.

Model(s)	Year	VIN Range	Vehicle-Specific Equipment
A6 allroad	2020 – 2024	All	Not Applicable
RS 6 Avant	2021 – 2024

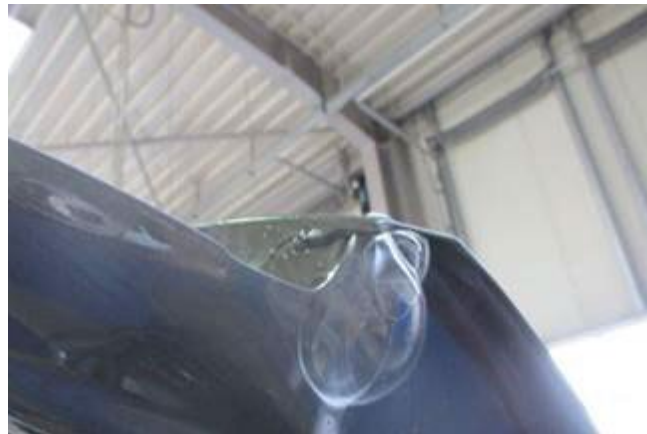
1. Remove the rear lid trim and perform a leak test on the rear lid. With the lid trim removed visual and physical access to the rear lid structure can be gained. Mix a solution of dish detergent and water and add to a spray bottle. Spray the solution on the area shown in Figure 1 while blowing compressed air from the inside of the rear lid structure and watch for bubble formation.

Figure 1. Bubble formation with compressed air applied internally.

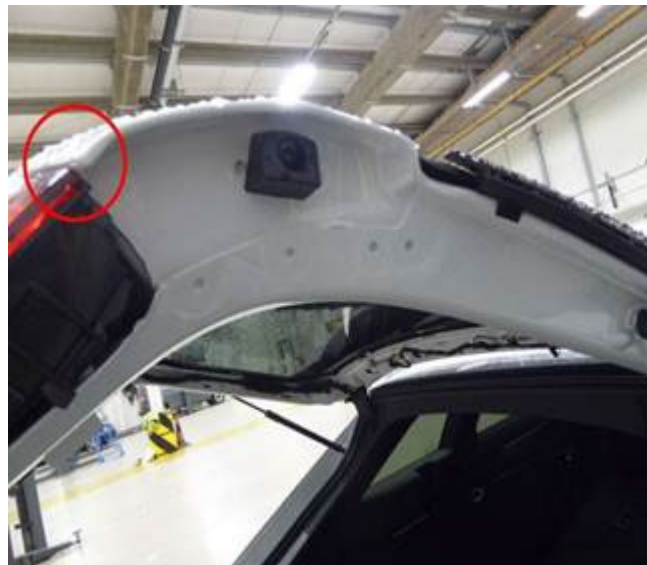
2. Should bubbles form in this area, Figure 2 shows the area where the body sealant may be flawed.

Figure 2. Area where sealer flaw is likely.

7. In cases where the sealer flaw is located in a concealed area (e.g. behind a tail lamp) the openings can be repaired by applying D 476KD1M2 or D 476KD1M3 sealant to the openings with a brush. To the corresponding area on the inside of the rear lid shell apply D 321M16M2 cavity preservative using a brush. Ensure the application area is thoroughly clean and allow the sealant to cure as instructed. Touch up painted surfaces as necessary.

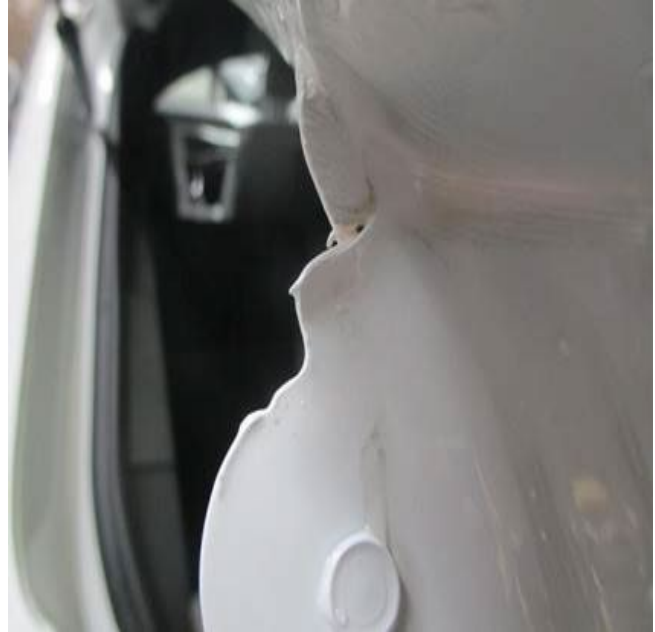
3. When the tail lamp is removed the sealer flaw can be found.

Figure 3. Possible sealer flaw area behind tail lamp.

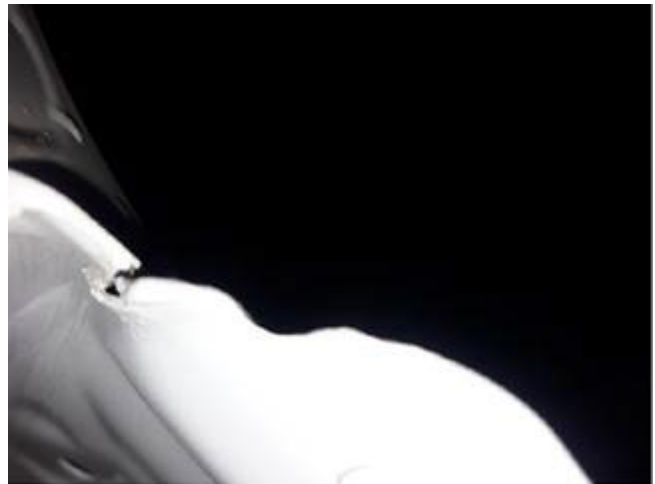
Figure 4. Close up view of sealer flaw.

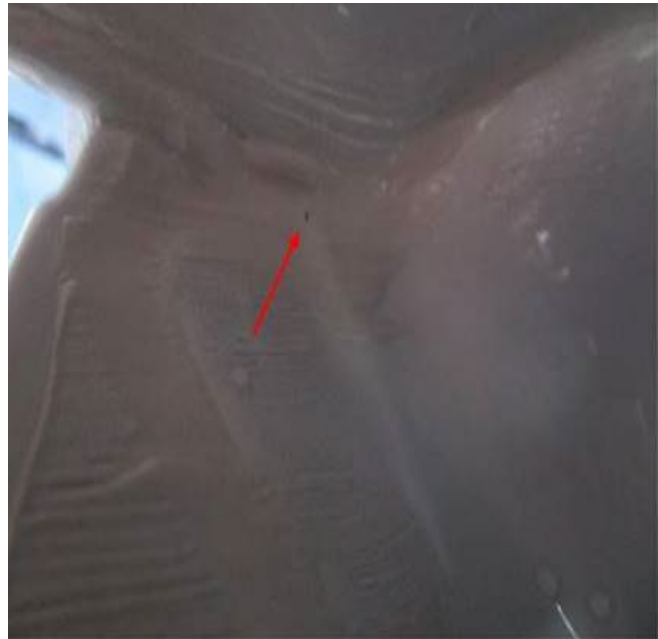
4. Figure 5 shows another possible area where a sealer flaw can be found. The holes or gaps can be very small yet allow water ingress.

Figure 5. Another area of a possible flaw.

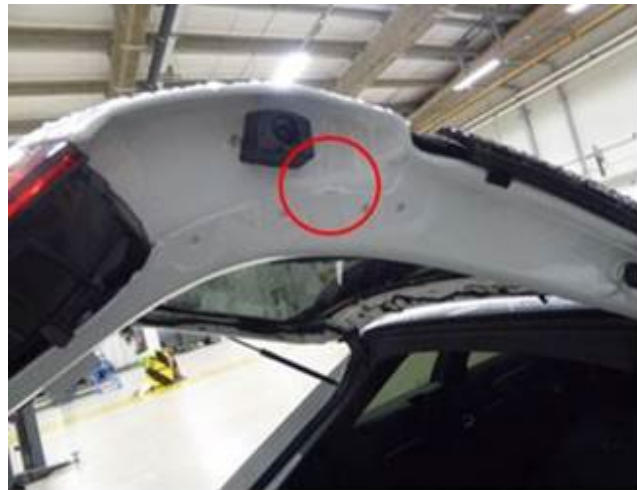
5. The flaws may not be limited to the rear tail lamp recesses but can be found along the side of the rear lid structure.

Figure 6. Sealer flaw on side of rear lid.

8. If the sealer flaw is in a visible area send the vehicle to your bodyshop for repair as finish paintwork will be required.

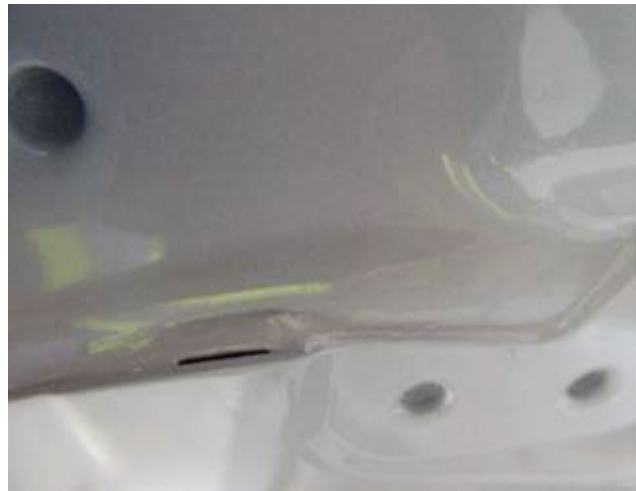
Figure 7. Close up view of the sealer flaw.

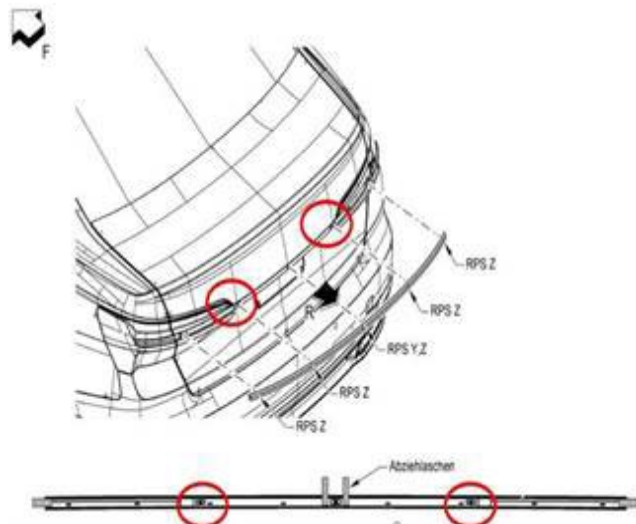
6. Additionally, sealer flaws or incorrect sealing of the rear lid trim can be found in the area where the rear lid exterior trim is mounted. Replace the rear lid trim strip if it is found to be the cause of the sealing issue.

Figure 8. Rear lid trim mounting areas to check for water ingress.

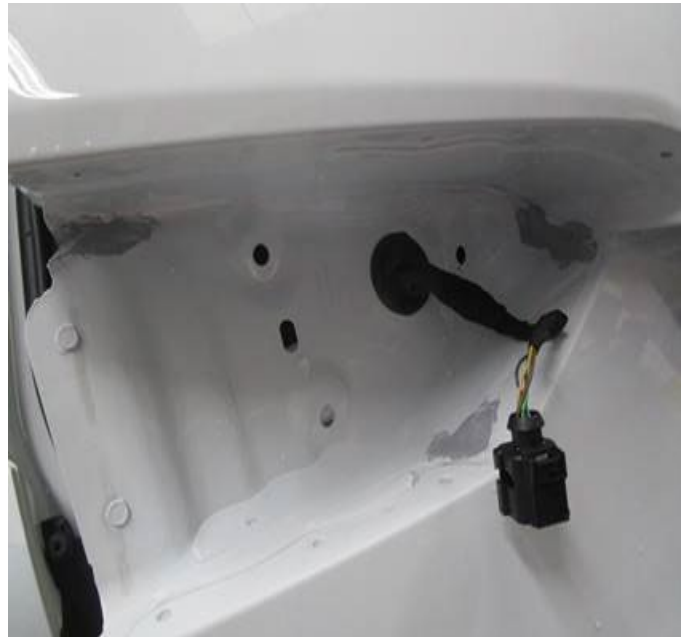
Figure 9. Concealed areas repaired with D 476KD1M2 or D 476KD1M3 sealant.
