# Technical product information

<b>Topic</b>	Right and/or left hand front rearmost lower suspension lever inner hydraulic mount replacement guidelines
<b>Market area</b>	Australia E04 Bentley rest Asia and Australia (6E04),China 723 Volkswagen (Anhui) Automotive CO (6723),China 796 VW Import Comp. Ltd (Vico), Beijing (6796),Germany E02 Bentley rest Europe (6E02),Japan E03 Bentley Japan (6E03),Korea, (South) E08 Bentley South Korea (6E08),United Arab Emirates E06 Bentley Middle East and Africa (6E06),United Kingdom E01 Bentley UK (6E01),United States E05 Bentley USA and rest America (6E05)
<b>Brand</b>	Bentley
<b>Transaction No.</b>	2069493/2
<b>Level</b>	EH
<b>Status</b>	Approval
<b>Release date</b>

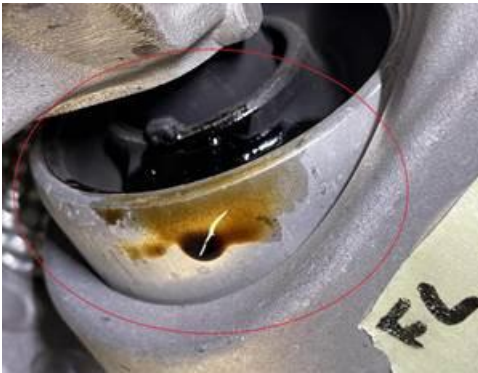
Figure 1

- If a leak is identified by the customer (Figure 1) - Replace the right and/or left hand front rearmost lower suspension lever inner hydraulic mounts as per all instructions within Rep.Gr 40

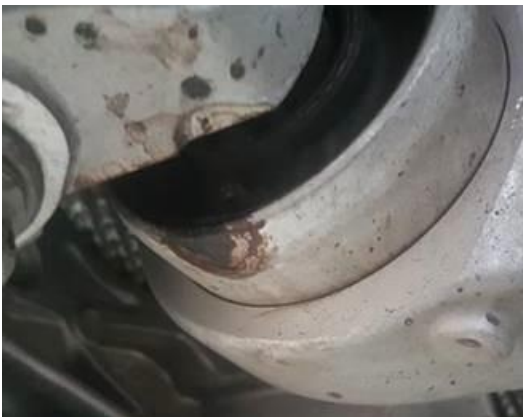
Figure 2

A dry oil stain mark (Figure 2) is evident on the right and/or left hand front rearmost lower suspension lever inner hydraulic mounts

Do not replace the hydraulic mounts
