Technical product information

Topic	Creaking noise from the rear seat cushion edge/rear seat side valance
Market area	Australia E04 Bentley rest Asia and Australia (6E04),China 723 Volkswagen (Anhui) Automotive CO (6723),China 796 VW Import Comp. Ltd (Vico), Beijing (6796),Germany E02 Bentley rest Europe (6E02),Japan E03 Bentley Japan (6E03),Korea, (South) E08 Bentley South Korea (6E08),United Arab Emirates E06 Bentley Middle East and Africa (6E06),United Kingdom E01 Bentley UK (6E01),United States E05 Bentley USA and rest America (6E05)
Brand	Bentley
Transaction No.	2069561/2
Level	EH
Status	Approval
Release date

Bentayga Series - 4 seat configuration only

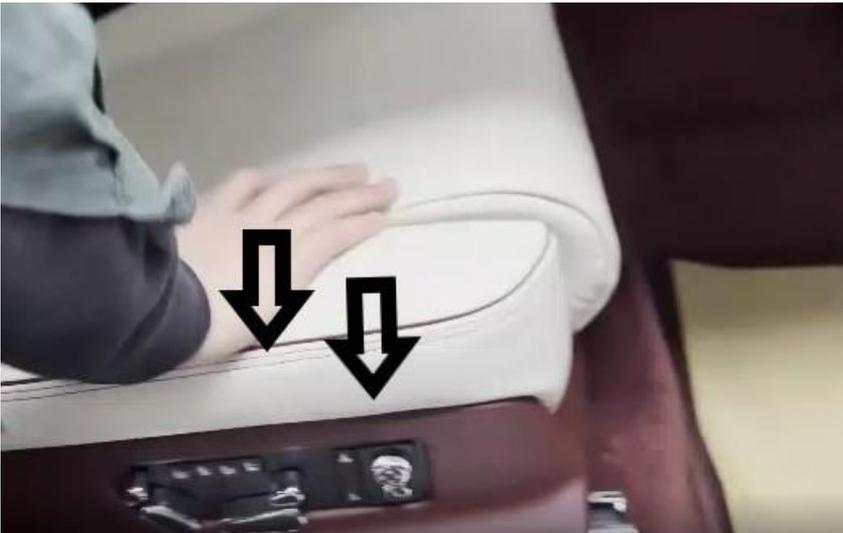
Referring to Figure 1 - When pressure is applied to the points shown, a creaking noise can be heard from the rear seat cushion edge/rear seat side valance

The creaking noise is caused by contact between the side valance pins and the seat frame
