Technical Service Bulletin

90 Audi virtual cockpit display has a white sheen

90 24 77 2065932/2 February 6, 2024. Supersedes Technical Service Bulletin Group 90 number 22-42 dated January 31, 2022 for reasons listed below.

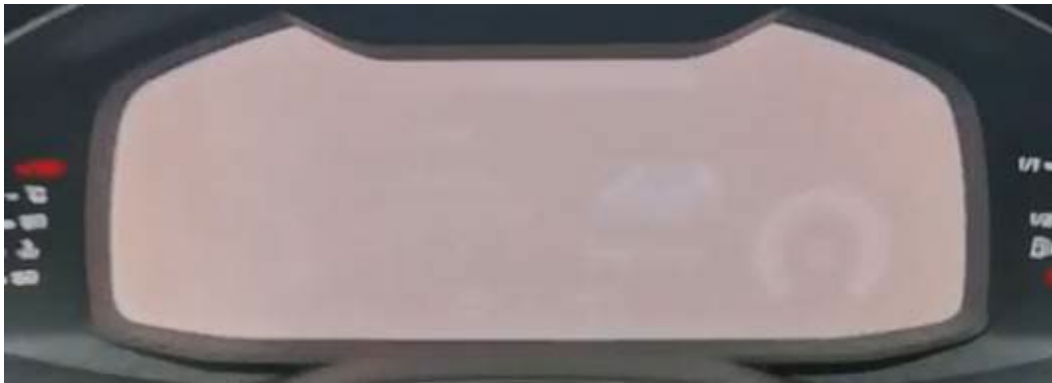
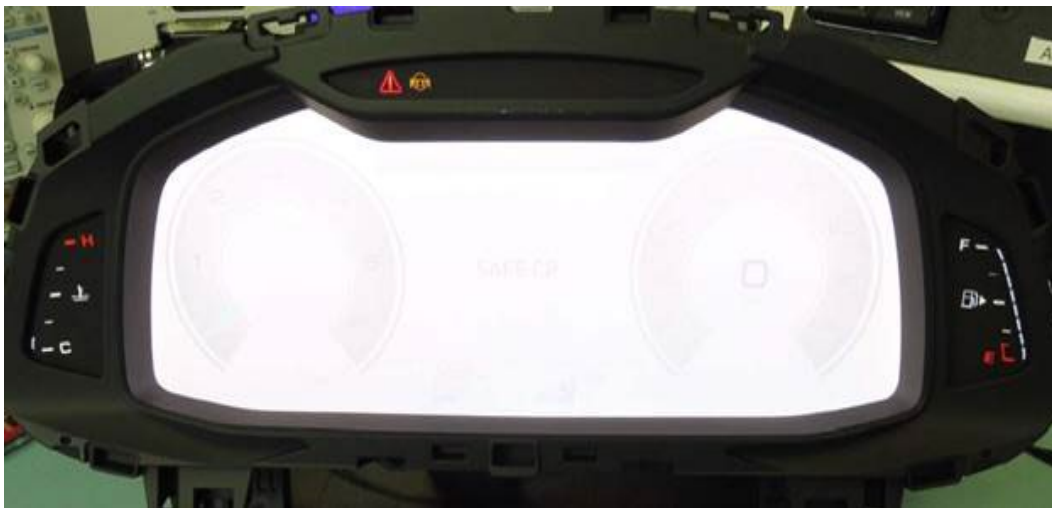
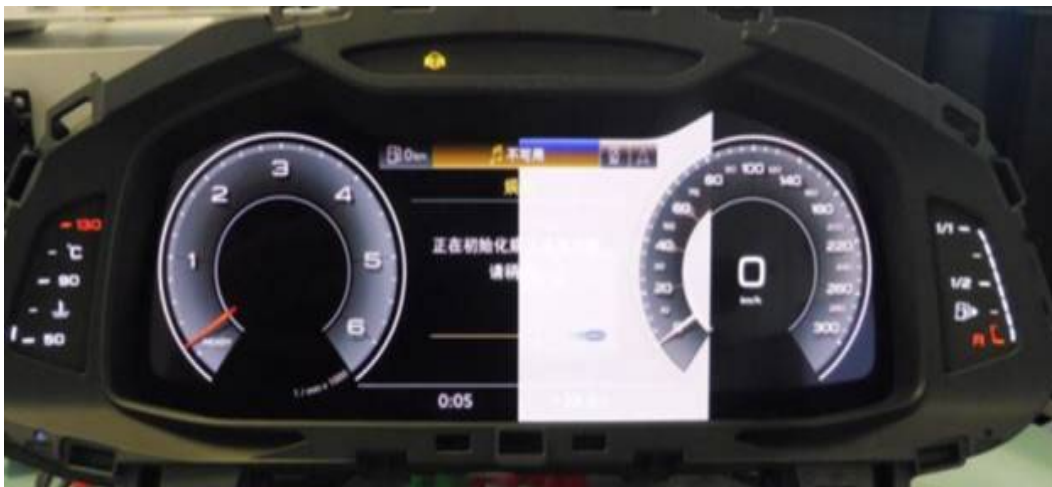
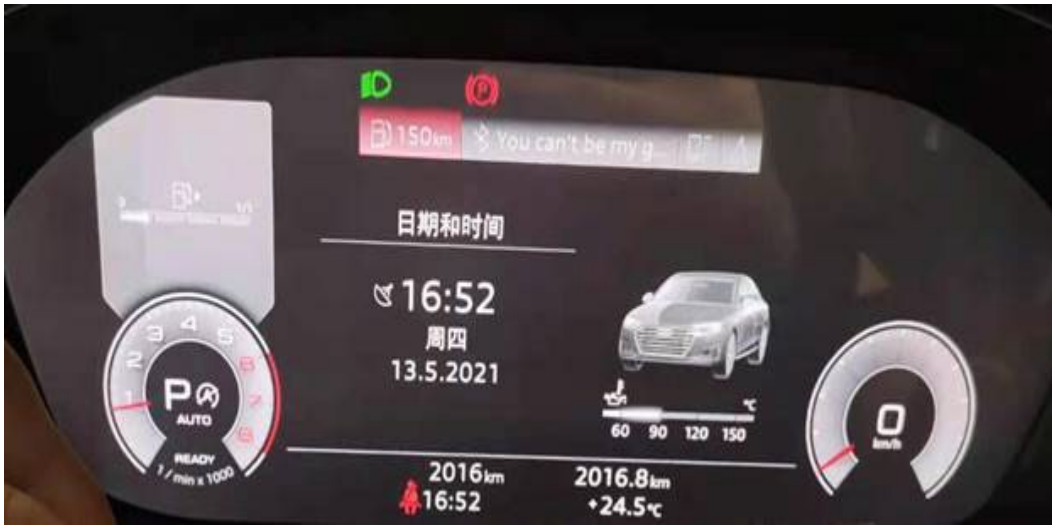
The Audi virtual cockpit has a white sheen over either the complete screen or partial sections.

Figures 1-4. Example pictures of white sheen on the Audi virtual cockpit.

A hardware issue in the Audi virtual cockpit may cause it to have a white sheen. All the display content is still visible and functional through the white sheen.

1. In your warranty claim notes document the production date of the instrument cluster. To do so:
 - a. Using ODIS: Right click diagnostic address 17>>Identification>>Production date
2. Replace the Audi Virtual Cockpit -J285- according to the instructions of the ELSA repair manual.
