Service Bulletin

PRELIMINARY INFORMATION

Subject: Information on Vibration Analysis and Diagnostic

Models: 2014 Chevrolet Silverado 1500
 2015-2018 Chevrolet Silverado 1500
 2019 Chevrolet Silverado LD *
 2014 GMC Sierra 1500
 2015-2018 GMC Sierra 1500
 2019 GMC Sierra Limited *
 EXCLUDES HD Trucks

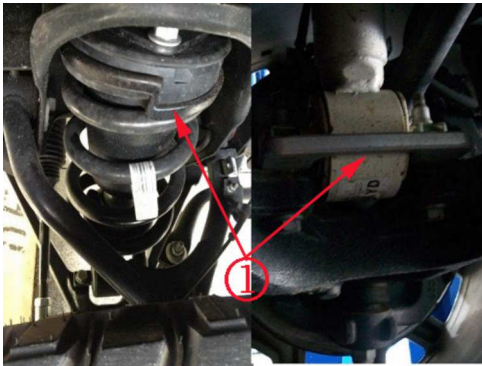
1. Inspect the truck for any aftermarket equipment installations. For example: non factory tires, wheels and/or lift kits or leveling kits – shims (1) installed as shown above. Aftermarket equipment does include running boards, bug deflectors, and window shades, etc. Remove any aftermarket that might cause vibration transmission paths.
2. Mark each tire valve stems location on the tire. This will be utilized to check for tire slippage on the rim.

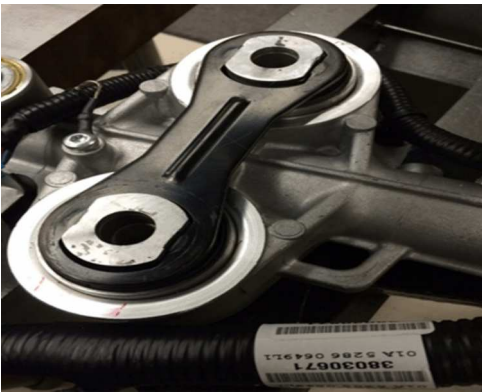
Replace Steering Bushings

Important: The following procedure should only be used after all tire issues have been corrected. Installation of revised steering bushing will have little to no effect on trucks that still have tire conditions. The T1 vibration must be reduced to under 20-25mg's for these bushings to be effective.

A revised steering bushing (2) has been released to address customer vibration concerns. After various testing and measurement of the T1 vibration, a vibration path from the tie rods =>steering rack=>steering bushings=>frame=>Body Mount=>Cabin Floor=>Seat has been identified. To help isolate the steering rack (1), a revised hydraulic bushing has been released and tuned to the T1 frequency. The new steering bushing dampens minor T1 vibrations. This is the reason that the causal part (normally the Tire/Wheel Assembly) must be corrected first. If the T1 vibration is over 20-25m/g's, the bushings will have little to no effect.

For vehicles with T1 vibrations under 20-25m/g's, replace steering bushing per parts catalogue. Utilize SI procedure "Steering Gear Mount Bushing Replacement" for replacement of the steering bushings.

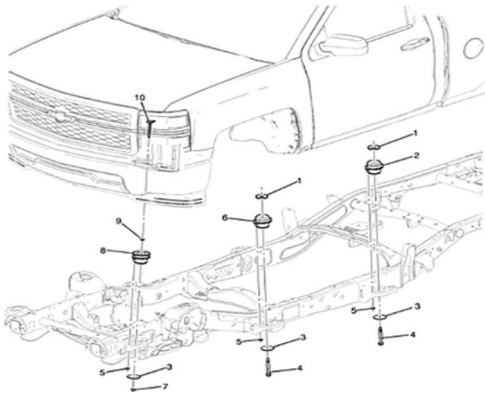
Replace Rear Cab Mounts - Regular Cab Models Built Prior To November 28, 2017

A revised Rear Cab Mount has been released to address customer vibration concerns. After various testing and measurement of the T1 vibration, a vibration path from the tie rods =>steering rack=>steering bushings=>frame=>Body Mount=>Cabin Floor=>Seat has been identified. To help isolate the cab, a revised Cab Mount has been released and tuned to the T1 frequency. The new cab mount dampens minor T1 vibrations. This is the reason that the causal part (normally the Tire/Wheel Assembly) must be corrected first. If the T1 vibration is over 20-25m/g's, the cab mount will have little to no effect.

Correction: Replace Rear Cab Mount with Revised part number.

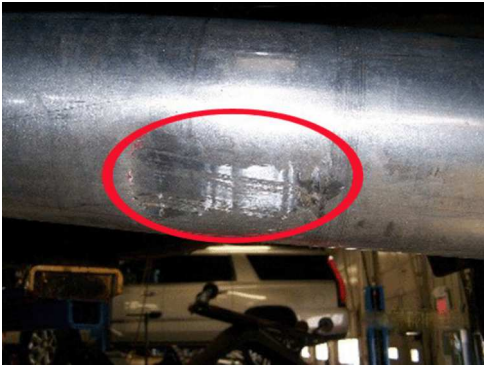
Diagnostic Aid:

- Inspect the propeller shaft for dents or damage. There have been many cases of dented propeller shafts.
- For 4WD Trucks, remove the rear propeller shaft, seal output shaft and drive the vehicle in 4WD. If the vibration is gone, the rear prop shaft could be the problem.
- For vehicles with a 3:08 with a one-piece steel shaft, this can be replaced with a one-piece aluminum one that is utilized on all 3:42 and 3:73 ratios (K15543 and K15753 Models only).
- PIP5140: Low Speed Vibration 30-35 mph (48-56 km/h).
- Inspect the transmission output shaft bushing for irregular wear.

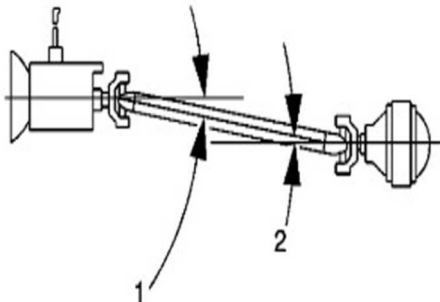
Measurement	Notes:
Yoke to Shaft		The first (forward most) U-joint action on a two piece driveshaft system is not canceled out by another U-joint. Because of this, the first U-joint working angle should be between 0.5 and 0.75 degrees.
Front Shaft to Center Support Bearing (if equip)		U-joint pairs cancel each other. Neither U-joint working angle should exceed 4 degrees, nor the allowable range of difference between cancelling U-joint working angles is 0.00 to 1.0 degrees.
Shaft to Diff Yoke

Propeller systems containing only 1 U-joint: The U-joint working angle should be between 1/2 and 3/4 degrees.

Allowable range of difference between cancelling U-joint working angles: 0.25 to 1.0 degrees.
