Service Bulletin

Bulletin No.: 23-NA-072

Subject: Shudders or Shakes at Low Speeds

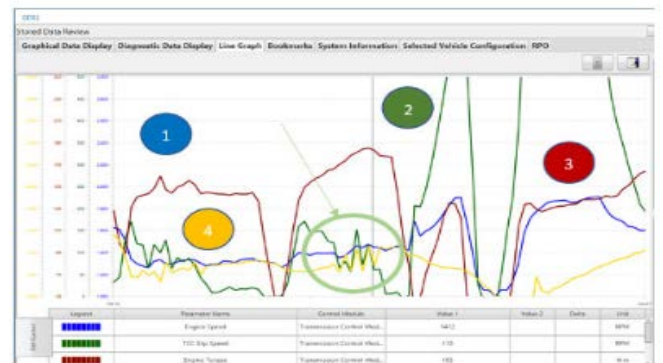
6325119

TCC Shudder: (Typically seen on 4th-5th Upshift as ISS Oscillation)

Record GDS2 Session Log and look for ISS oscillation when driveline disturbance occurs.

Diagnose by performing launch from 0 mph speed at 15-20% pedal up to 30 mph.

Condition present when TCC Slip less than 150 rpm maximum.

TCC Shudder	ISS (Peak-Peak)	Action	Comment
Normal	<50 rpm	Do Nothing	Not a Torque Converter/ ATF Issue
Degraded	>50 rpm <200 rpm	Proceed with ATF Drain and Refill	ATF Degradation has occurred. Check Fluid Condition (Instructions below "Fluid Condition Check")
Damaged	>200 rpm	Replace Torque Converter	Hardware damage has likely occurred.

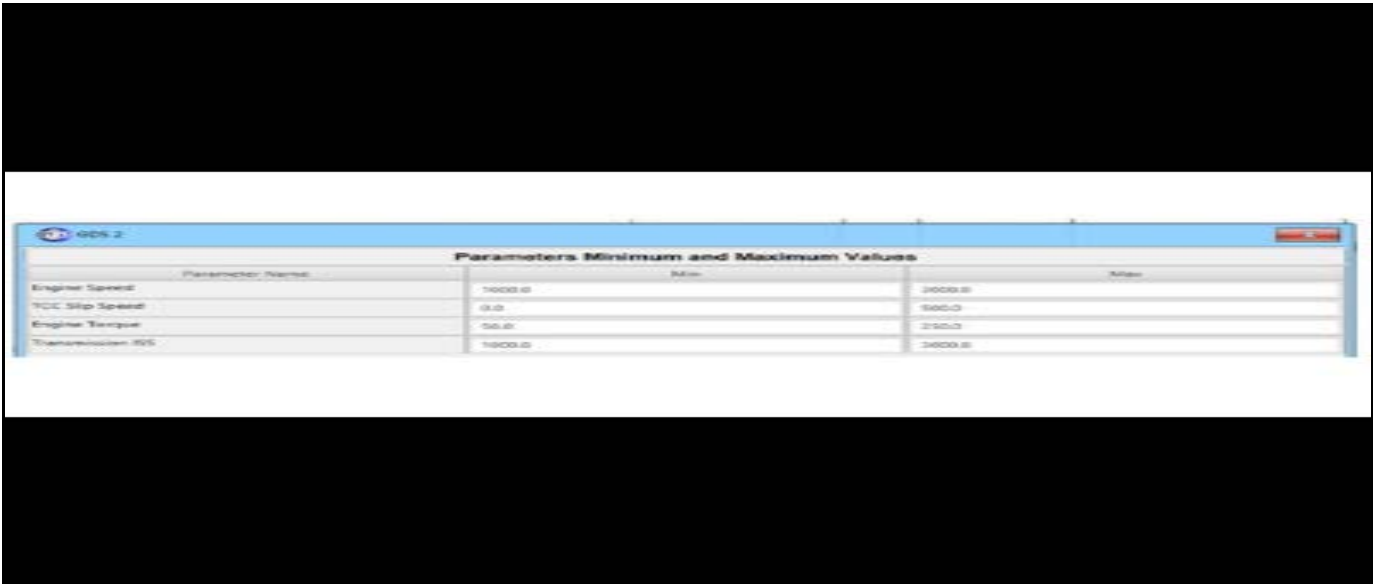
6357390

1. Engine Speed
2. TCC Slip Speed
3. Engine Torque
4. ISS (Turbine Speed) will show oscillation

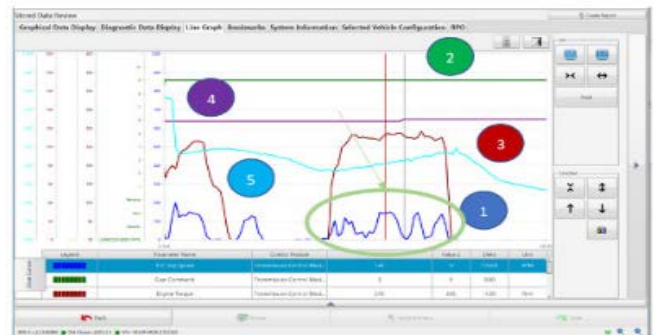
6325122

Poor TCC Control: (Typically seen in higher gear 8th-9th) Steady-State Torque (50-70kph)

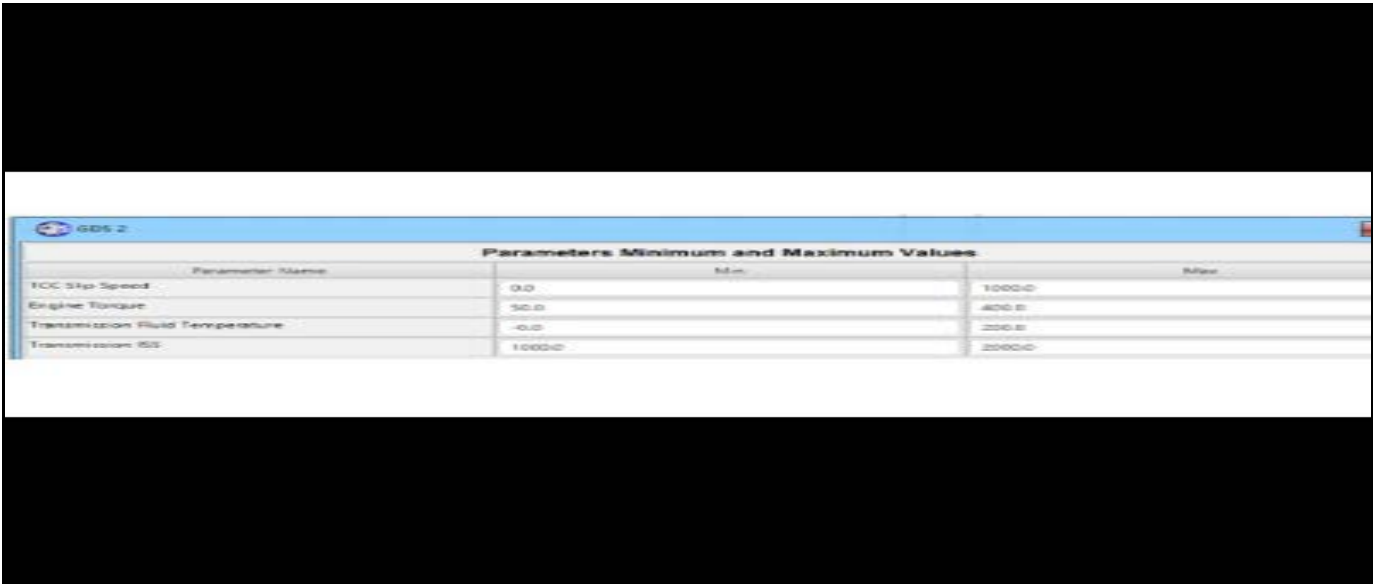
6357391

1. TCC Slip
2. Gear
3. Engine Torque
4. ATF Temp
5. ISS

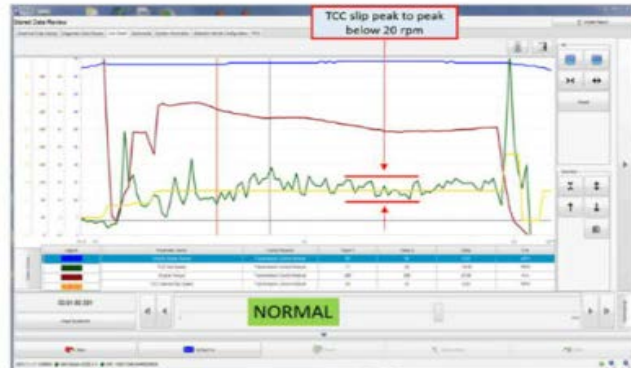
Figure 2 Parameter Normal Test Result

TCC SLIP	CONTROL TEST RESULT	TCC RPM Slip Peak to Peak, at Steady Throttle	ACTION
Figure 2 Normal	Below 20 RPM	Do nothing	
Figure 3	Degraded	Near 60 RPM - repeating	ATF Degradation has occurred. Check Fluid Condition (Instructions below "Fluid Condition Check")
Figure 4	Damaged	Near 100 RPM- erratic	Hardware damage has likely occurred. Replace Torque Converter

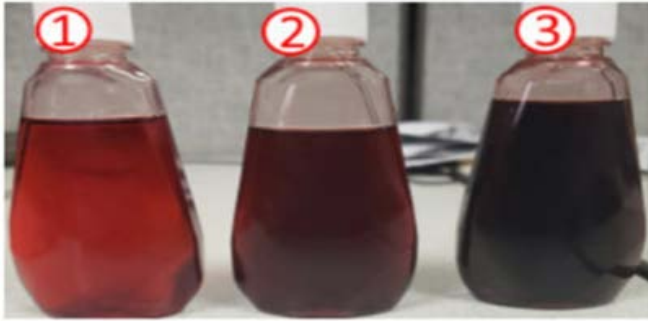
6325134

- The fluid should be red or brown.
- The fluid should be transparent so that objects or writing can be seen through it. Sample #1 is an example of acceptable fluid. Sample #2 is an example of very dark fluid. Sample #3 is an example of black fluid. Samples 1, 2, or 3 would be acceptable to perform the fluid drain and fill if sample does not also have one of the following three conditions.

- In addition to checking the fluid color and transparency, the fluid should be checked for an odor of burnt fluid. If the fluid is very dark (Sample #2), black (Sample #3), and has a burnt odor it would indicate clutch damage has occurred internally in the transmission and it would need to be removed from the vehicle and investigated.

- Fluid that is cloudy or milky or appears to be contaminated with water indicates engine coolant or water contamination. Refer to the latest version of Service Bulletin 08-07-30-035 for testing and, if confirmed, find the source of the coolant/water and repair. Then follow service manual instructions “engine coolant/water in transmission” to repair the transmission.

- Inspect the fluid for excessive metal particles or other debris:
 - A small amount of “friction” material is a “normal” condition.
 - A small amount of “metal” from the manufacturing process is a “normal” condition. This is observed as fine silver streaks floating in the fluid.
 - If large pieces and/or metal pieces are noted in the fluid, or the fluid when rubbed between fingers feels gritty/sandy, it would indicate hardware damage has occurred internally in the transmission and it would need to be removed from the vehicle and investigated.

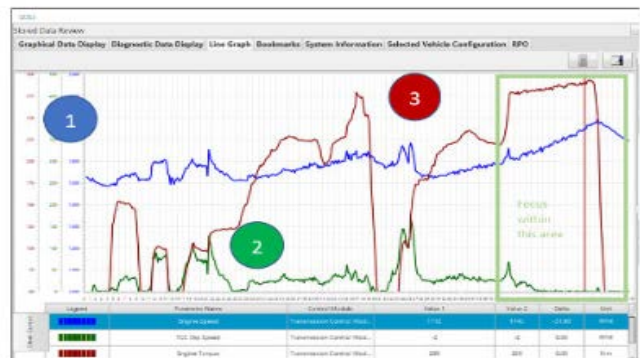
6325131

High Torque Locked Condition — If complaint exists at engine torques >287 Nm, where the measured TCC Slip is ~0 rpm, then this is operating as designed. In order to protect the clutch, we must lock it up at these higher engine torques. Commanding TCC Locked should provide same performance as this condition.

1. Engine Speed
2. TCC Slip
3. Engine Torque
