Service Bulletin

Bulletin No.: 23-NA-207

Subject: Ticking, Rattle and/or Buzzing Noise Heard from inside Passenger Side

Brand:	Model:	Model Year:		VIN:		Engine:	Transmission:
		from	to	from	to		
Chevrolet	Camaro ZL1	2017	2024			LT4	
	Camaro ZL1 1LE

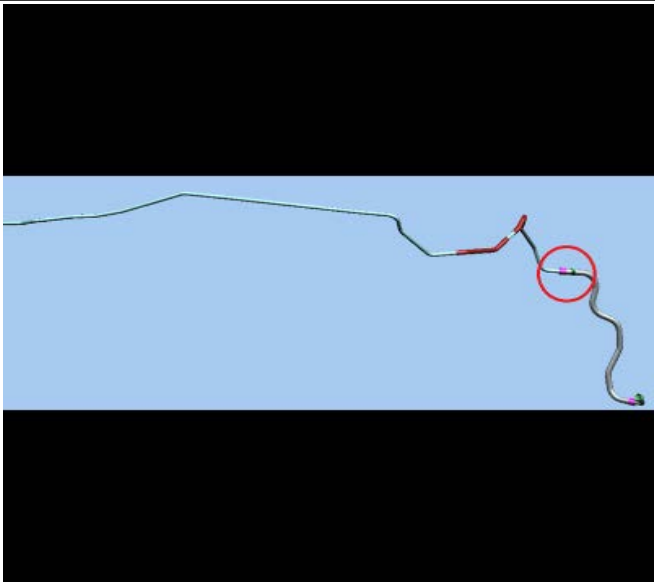
Involved Region or Country	North America, Europe, Russia, Middle East, Israel, Palestine, Argentina (Mercosur), Brazil (Mercosur), Bolivia (West), Chile (West), Colombia (West), Paraguay (West), Peru (West), Uruguay (West), Japan, GM Korea Company, China - SGM, Thailand (ASEAN), Other Africa
Condition	Some customers may comment on a rattle, tick or buzz noise coming from the passenger side. – The noise may be louder inside of the vehicle rather than on the outside.
Cause

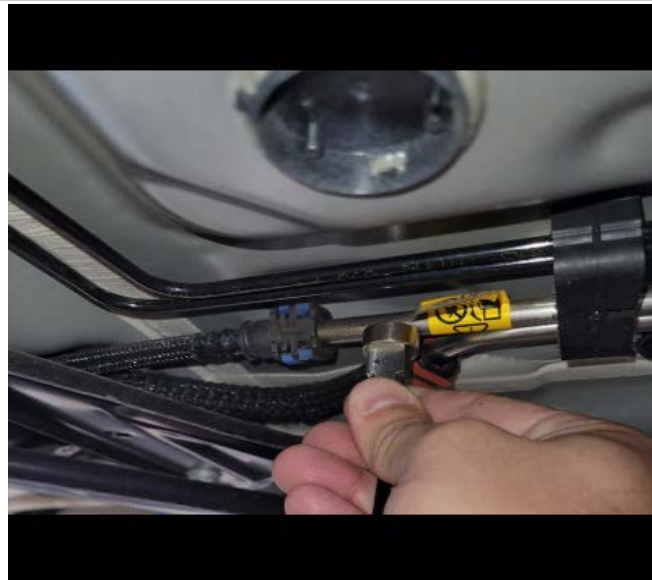
6483325

<p style="text-align: right; margin-right: 20px;">6483330</p> <p>This condition may be caused by the fuel feed pipe between the high-pressure fuel pump and chassis fuel line allowing high pressure pulsation back to the low side of the fuel system. – This may be due to a faulty pulse dampener internal to the part.</p>

Note: There is not a good way to test this pulse dampener. Following the line underneath the vehicle, a sound check can be made in this location indicated in the graphic above, to confirm the noise is present within the fuel line.

If the pulse dampener has been validated to be the cause of the noise, replace the fuel feed pipe.

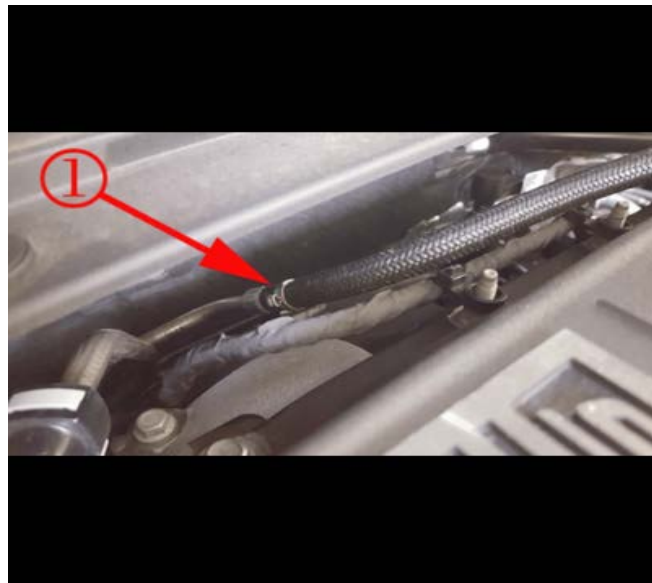
6483334

These graphic above shows the location of the chassis fuel feed pipe on the LT4 engine. This line will run along the firewall and below the vehicle. It will have a jumper line with quick disconnects at both ends. One end will connect to the chassis line and the other to the high-pressure pump feed line.

Refer to *Fuel Feed Pipe Replacement in SI*.
