# Service Bulletin

Bulletin No.: 23-NA-209

**Subject: Oil Can and/or Pop Noise from Roof Area During Car Wash**

Brand:	Model:	Model Year:		VIN:		Engine:	Transmission:
		from	to	from	to		
Chevrolet	Colorado	2023	2023	-	-	All	All
GMC	Canyon

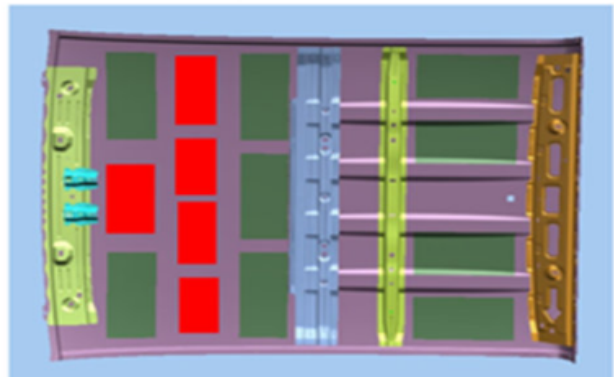
6484170

<b>Involved Region or Country</b>	North America
<b>Additional Options (RPOs)</b>	<b>Excluding</b> all vehicles equipped with Sunroof (RPO -CAC)
<b>Condition</b>	Some customers may comment on a oil canning or popping noise originating from the roof area during or after a automatic car wash.
<b>Cause</b>	The cause of the condition may be force from some air dryers at a automated car wash can cause flex in the roof panel, causing a loud oil canning type sound.
<b>Correction</b>	Repair any damage done during the event and apply stiffening patches to the underside of the roof panel following the procedure listed below.

- Once the headliner is dropped (but not removed) apply the 5 stiffening panels to the underside of the roof panel in the **RED** locations in the illustration above.
