Service Bulletin

Bulletin No.: 24-NA-013

Subject: Steering Pull While Driving and/or Uneven Tire Wear Noticed

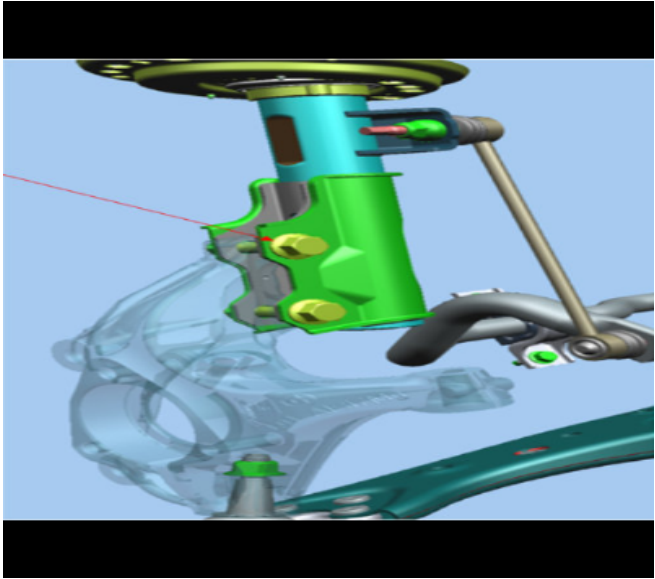
Involved Region or Country	North America, Europe, Kazakhstan, Middle East, Israel, Japan, Cadillac Korea (South Korea)
Condition	Some customers may comment on steering pull while driving and/or uneven tire wear noticed.
Cause	The condition may be caused by the camber is out of spec and does not align with $-0.6^{\circ} \pm 0.5^{\circ}$.
Correction	<div style="text-align: center;">

</div> <p style="text-align: right; font-size: small;">6523918</p> <p>Install the new service bolt, as shown in the picture above, to bring camber back to spec.</p>
