94-23-01 - Headlamp: Rubber lip-seal (between headlight and fender) loose

Release date: 2/12/2024

Applicable Vehicles					
Model(s)	Year	Eng. Code	Trans. Code	VIN Range From	VIN Range To
Golf R, GTI	2022 - 2024	All	All	All	All

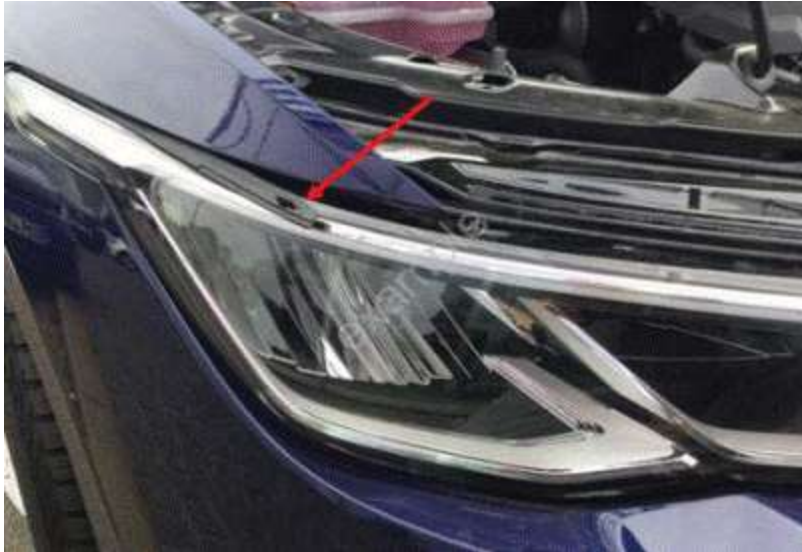
Figure 1.

Incorrect assembly of the rubber lip/seal in the assembly process. This can result in damage to the locking lug. As a result of the damage to the locking lug, the rubber lip/seal comes loose or protrudes.

The rubber lip/seal (see Figure 1, red arrow) between the headlamp and the fender (left/right) is loose/detaching/is off.

Glue the rubber lip/seal
