Technical Service Bulletin

13 MIL on with corrosion marks on the cylinder walls, DTC P030000 is stored in the ECM

13 24 23 2060876/2 February 9, 2024. Supersedes Technical Service Bulletin Group 13 number 20-09 dated October 16, 2020 for reasons listed below.

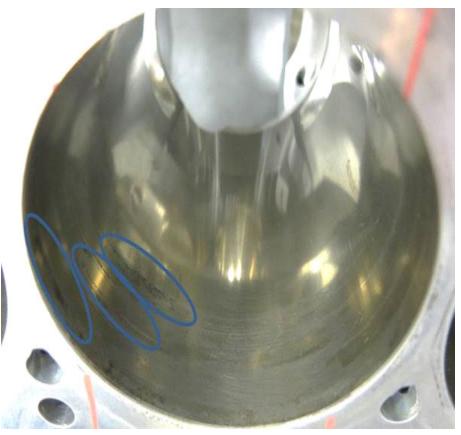
• The cylinder wall of the affected cylinder(s) show corrosion marks.

The cylinder walls of the EA825 V8TFSI have an APS coating (atmospheric plasma spraying). The marks are not affecting the APS coating.

Partial, light corrosion observed on the surface of one or several cylinder walls have no influence on the operation of the engine (Figures 1 - 2). The APS coating is unaffected.

Figure 1. Corrosion marks on cylinder walls.

An engine replacement is not justified. The cause for the MIL or the customer concern needs further diagnosis.

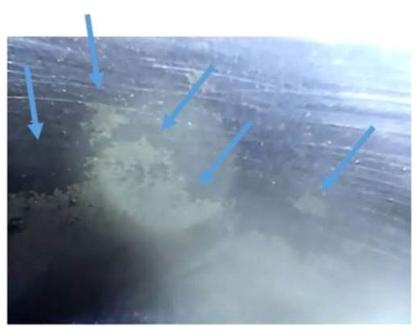
Figure 2. Corrosion marks on cylinder walls (close-up).
