Technical Service Bulletin

19 Low coolant light is on but the coolant level is within specifications

19 24 49 2061918/5 February 7, 2024. Supersedes Technical Service Bulletin Group 19 number 21-26 dated December 22, 2021 for reasons listed below.

Model(s)	Year	VIN Range	Vehicle-Specific Equipment
All Audi Vehicles	2017 – 2022	All	Not Applicable

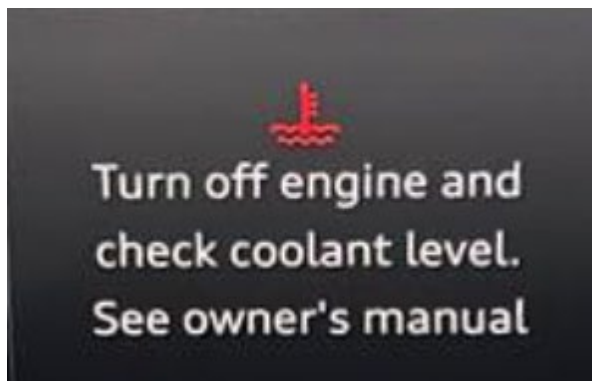
Figure 1. Coolant light.

- The coolant warning light appears in the instrument cluster.

- Please confirm the light that the customer is referring to is the coolant light (Figure 1) and not the distance warning light (Figure 2).
