Technical Service Bulletin

66 Wheel arch trim on front fender loose

66 24 05 2067881/2 February 9, 2024. Supersedes Technical Service Bulletin Group 66 number 22-91 dated August 30, 2022 for reasons listed below.

Model(s)	Year	VIN Range	Vehicle-Specific Equipment
Q3	2019 – 2024	All	Not Applicable

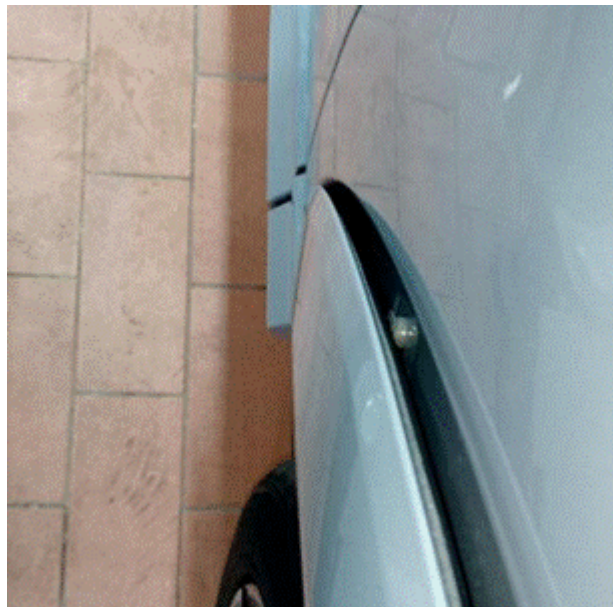
During the trim installation process in production the female grommet that retains the male clip on the trim engages the male clip before it is fully seated to the fender surface creating a visible gap between the front wheel arch molding and the fender surface (Figures 1 & 2).

Figure 1. The front wheel arch trim is not flush to the fender surface.

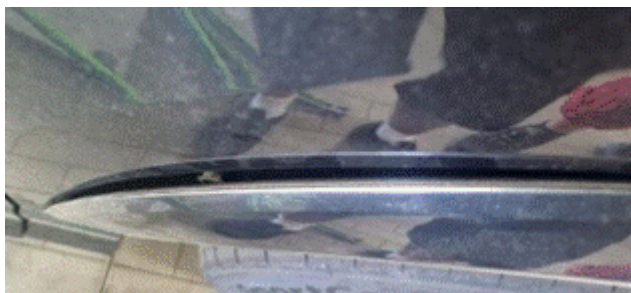
Figure 2. The front wheel arch trim with the retaining clips only partially engaged.

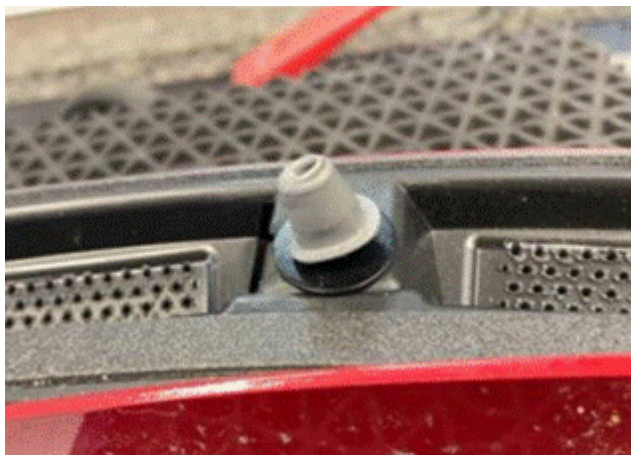
When the front wheel arch trim is removed damage to the female clip grommet is apparent (Figure 3).

Figure 3. Front wheel arch trim with retaining clip grommet damaged.
