# Technical Service Bulletin

## 70 Noises in instrument panel

70 24 88 2039016/2 February 9, 2024. Supersedes Technical Service Bulletin Group 70 number 14-40 dated November 18, 2014 for reasons listed below.

Model(s)	Year	VIN Range	Vehicle-Specific Equipment
R8	2008 – 2015	All	Not Applicable
R8 Spyder	2011 – 2015

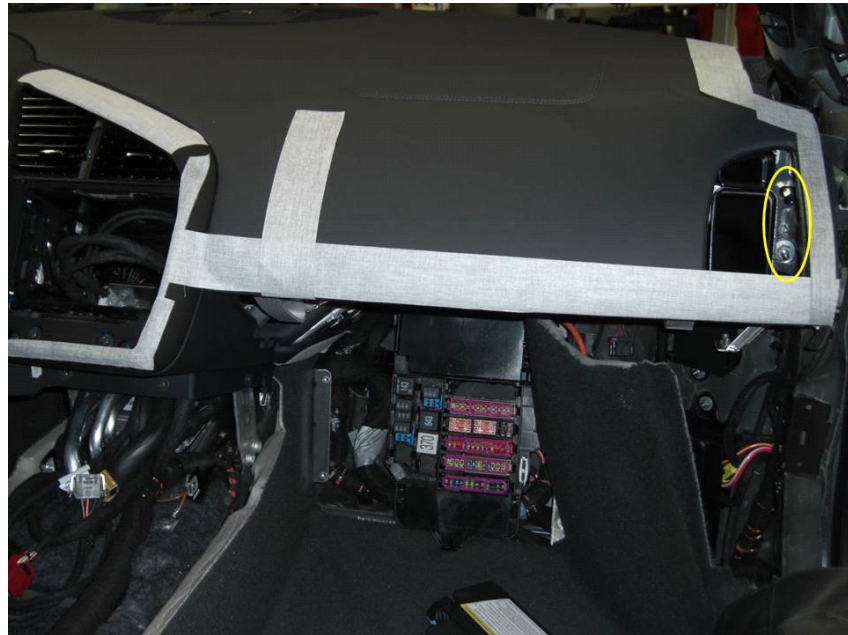
**Figure 1.** Right instrument panel vent removed.

1. Remove the right instrument panel vent (Figure 1).

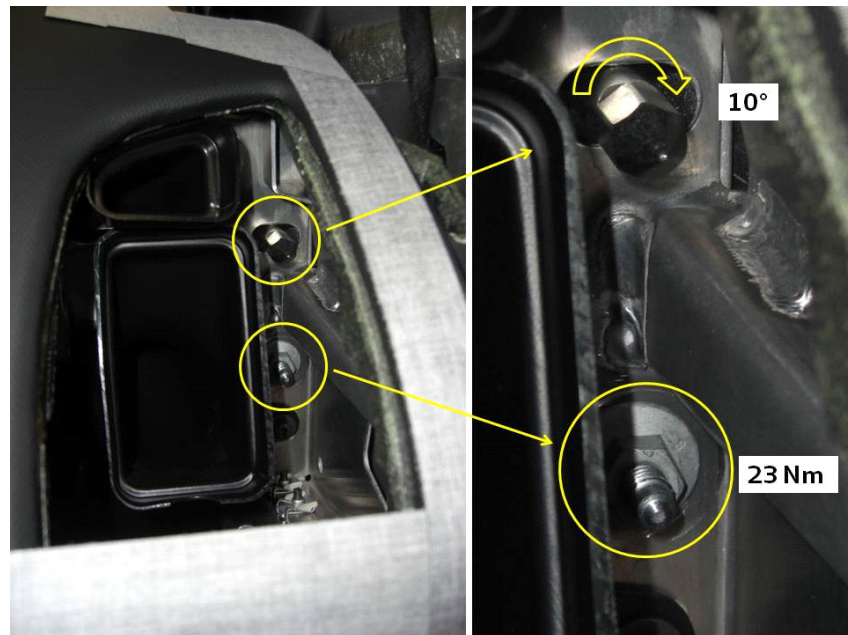
These noises may be caused by contact between the instrument panel carrier and an adjustment cam used in the assembly process in production.

**Figure 2.** Location of adjustment cam and instrument panel carrier nut.

2. Check the torque of the instrument panel carrier nut to ensure that it is not loose. It should be torqued to 23 Nm. Check the adjustment cam. If it is making contact with the carrier, it can be turned  $\sim 10^\circ$  to the right so that there is clearance around the eccentric (Figure 2).

The eccentric pin is a production aid used to precisely align the instrument panel in the production process. It has no fastening function, therefore it can be turned 10° to create clearance from the instrument panel carrier.

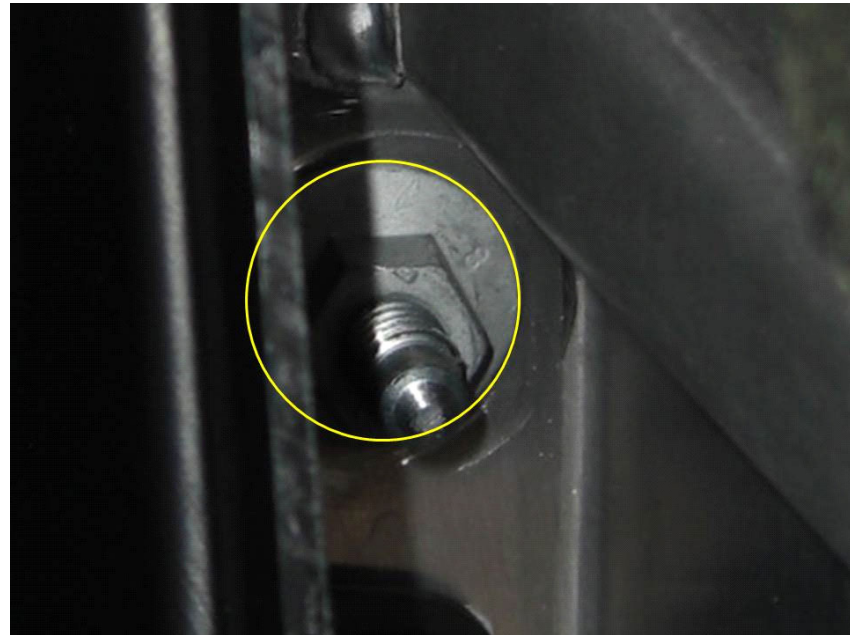
Figure 3. Instrument panel carrier nut to be marked.

- Because the adjustment cam eccentric will be moved out of the original position, mark the outside of the instrument panel carrier nut with a marker (Figure 3). This will aid in repositioning the instrument panel should it need to be removed in the future.
