# Technical Service Bulletin

## 91 Noises from rear shelf when playing music or driving on rough roads

91 24 64 2044318/3 February 9, 2024. Supersedes Technical Service Bulletin Group 91 number 16-52 dated June 27, 2016 for reasons listed below.

Model(s)	Year	VIN Range	Vehicle-Specific Equipment
A3, and S3	2015 – 2020	All	Not Applicable
RS 3	2017 - 2020

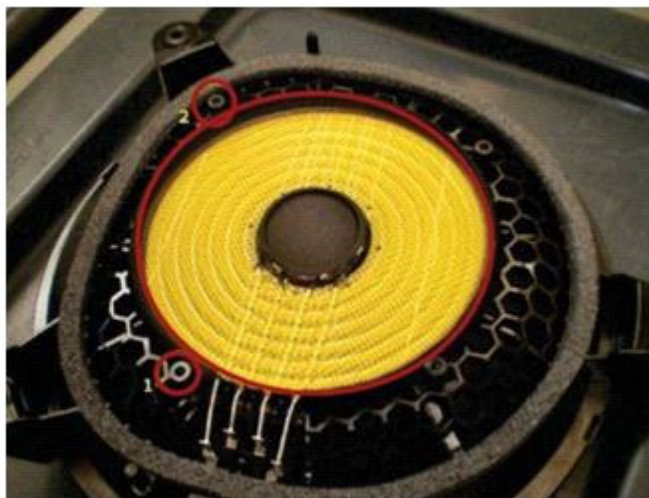
*Figure 1. Areas on the speaker body on which to apply textile tape.*

1. Remove the rear D-pillar trim, rear speaker trim, and parcel shelf trim to gain access to the rear subwoofer speaker. Remove the rear cover of the speaker and apply fleece adhesive tape (D 373125A2) to the areas shown in the illustration (Figure 1). Apply tape to both the speaker body and the protective grille.

**Avoid the electrical contacts of the speaker when applying the tape.**

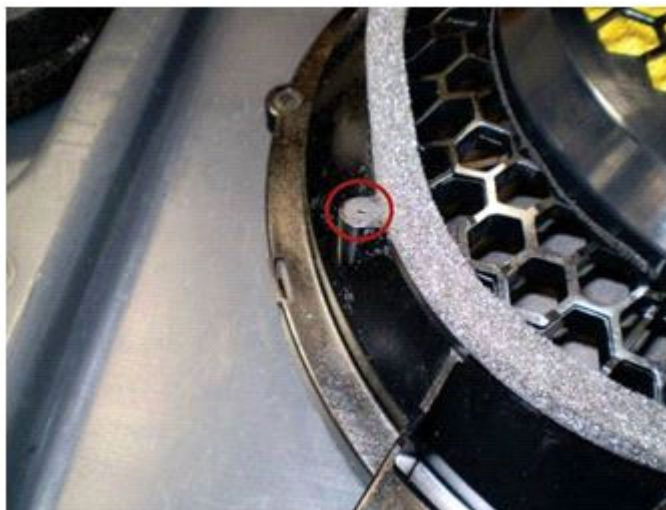
*Figure 2. Positioning pin removed.*

2. The subwoofer speaker has two positioning pins in the housing that must be cut off and ground flat (Figure 2).

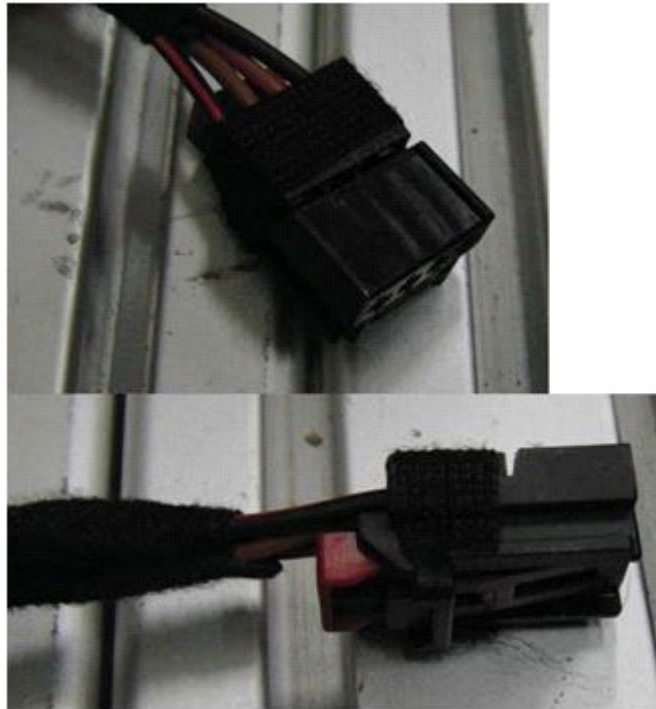
*Figure 3. Subwoofer electrical connection isolated with textile tape.*

3. Apply tape to the electrical connector as shown (Figure 3). Avoid the area of the release tang as tape in this area could compromise a sound electrical connection.

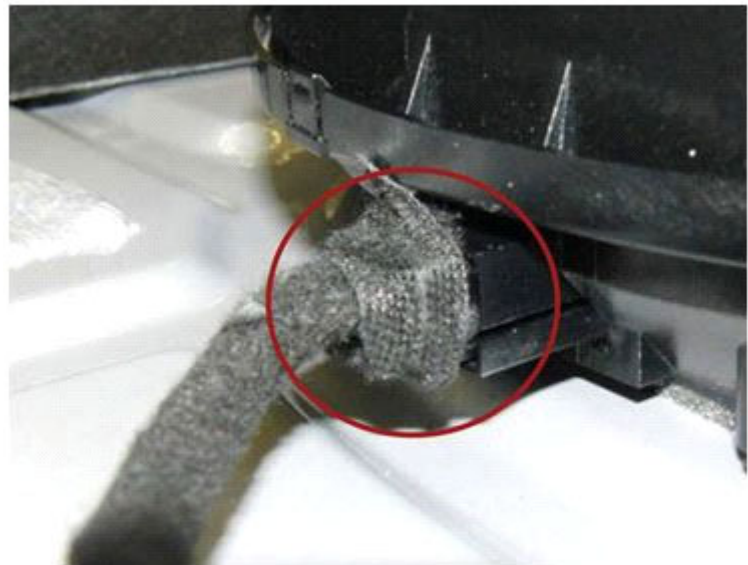
*Figure 4. Subwoofer connector isolated.*

4. After connecting the plug, isolate further as shown in the illustration (Figure 4).

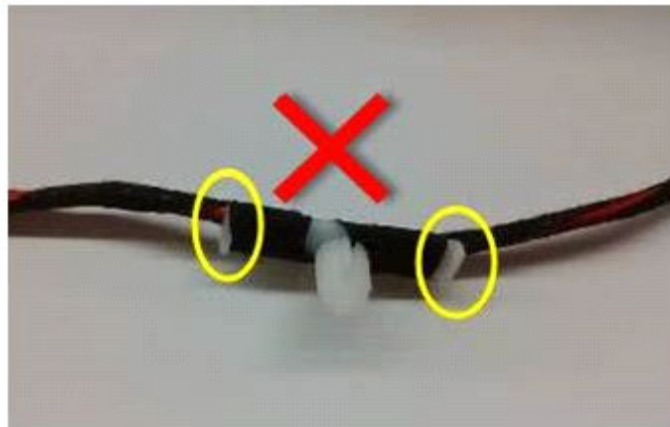
*Figure 5. Harness mounting clip insufficiently isolated.*

5. Wrap the harness mounting clips in the rear shelf area, ensuring that the clip ends are sufficiently isolated (Figure 5 and Figure 6). It is important to completely wrap the clips so that no plastic is in direct contact with the body.

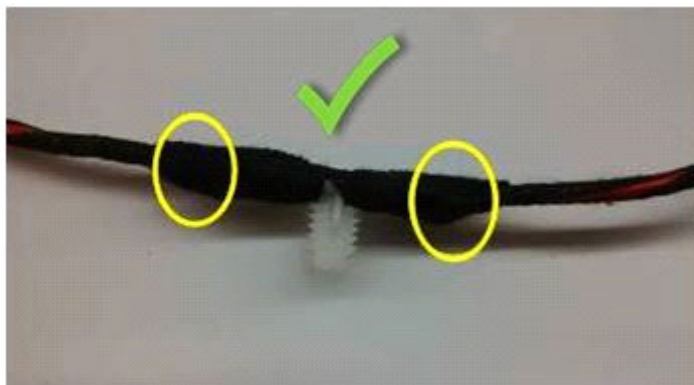
*Figure 6. Harness mounting clip properly isolated.*

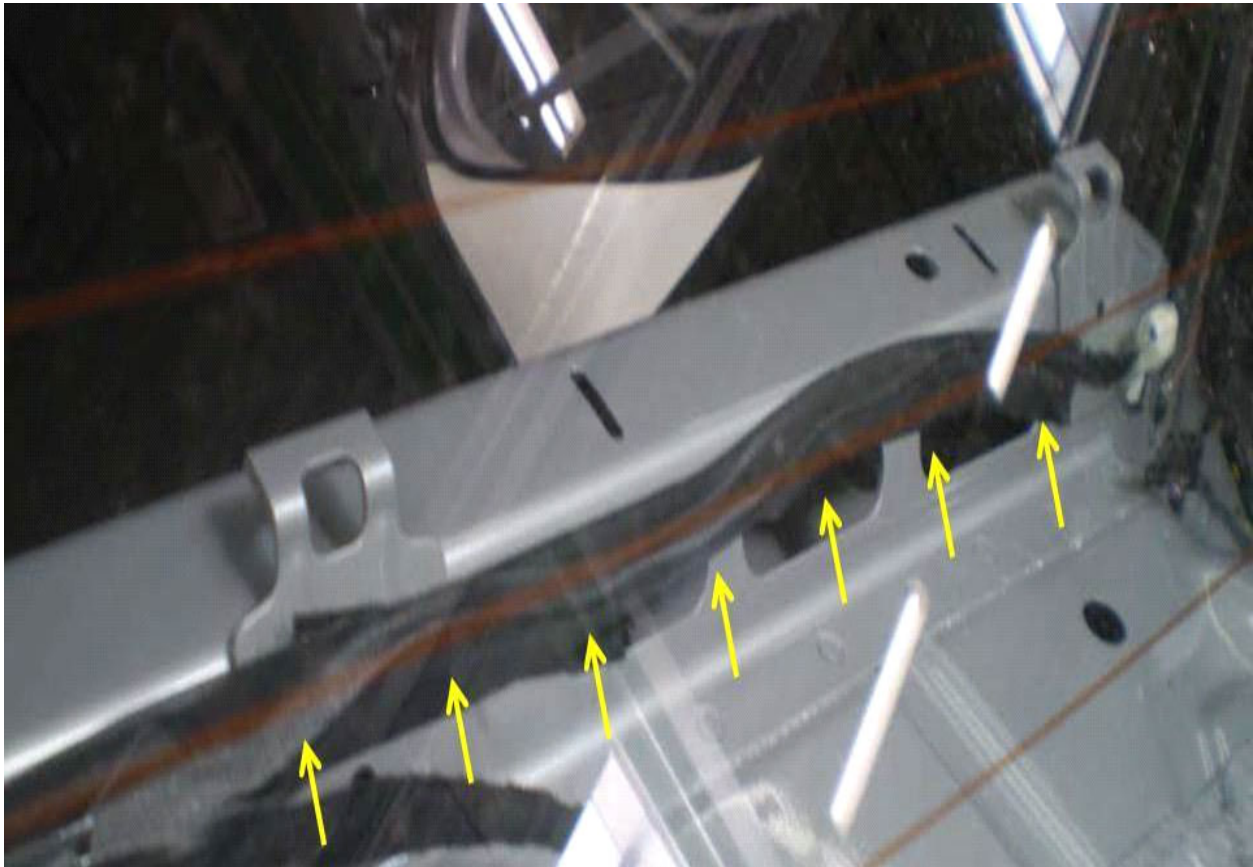
*Figure 7. Antenna cable taped to rear shelf.*

6. Using a wide textile tape, tape down the antenna cable across the rear shelf (Figure 7).

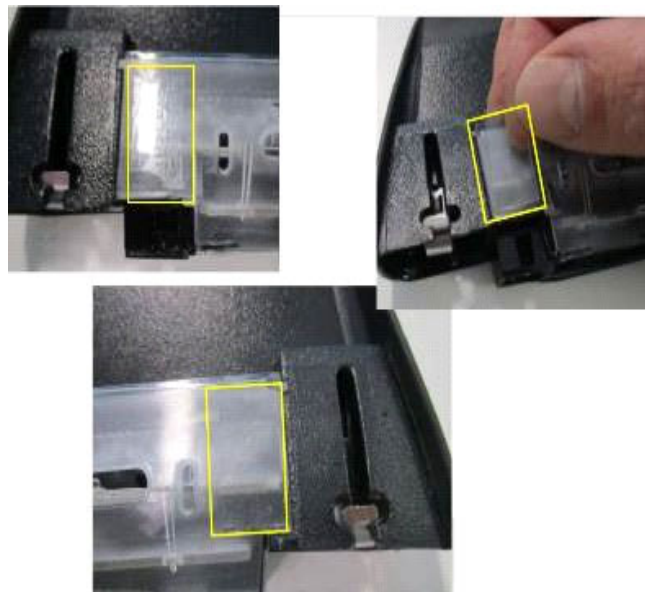
**Figure 8.** Protective foil applied to contact points of the third brake light assembly.

7. Remove the third brake light assembly and apply protective foil (part number AKL44803005) to the points of contact with the body (Figure 8). After reassembly, inspect the third brake light for a secure fit. Repair if found to be loose and/or a possible source of noise during audio playback.
