Technical Service Bulletin

87 Heat from rear vent insufficient - DTC B108911

97 24 06 2072931/1 February 9, 2024.

Model(s)	Year	VIN Range	Vehicle-Specific Equipment
Q4 e-tron, and Q4 Sportback e-tron	2022 – 2024	All	Not Applicable

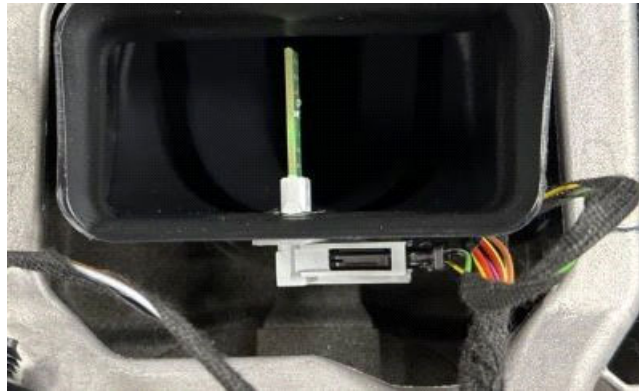
With the rear vent removed the rear vent temperature sensor G174 can be visually inspected. The G174 vent temperature sensor is found to be in place and undamaged. The electrical wiring to the rear sensor, however, is discovered pinched or chafed causing a short to ground against the center tunnel structure.

Figure 1. Harness routing prone to damage in assembly.

1. Remove the rear vent and inspect the wiring harness routing. Figure 1 shows the incorrect harness routing that can cause the wiring damage.

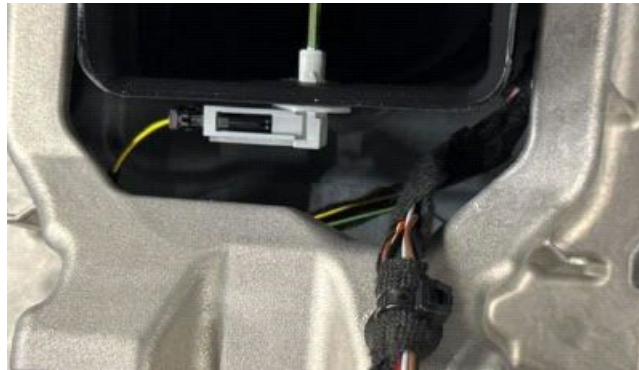
Figure 2. Corrected rear vent temperature sensor position and harness routing.

2. Rotate the rear vent temperature sensor 180° and route the harness wiring as shown in Figure 2. This will reduce the harness exposure and possible wiring damage when the rear vent is installed.

3. Repair any damaged wiring found using the VAS1978C Wiring Harness Repair Set and the wiring repair processes in ElsaPro.
