Service Action

Code: 87H9

Subject	Pressure & Temperature Sensors				
Document History	Date		Summary		
	02/13/2024		Original publication		
Affected Vehicles	Country	Beginning Model Year	Ending Model Year	Vehicle	Vehicle Count
	USA	2021	2022	E-TRON QUATTRO	7,387
	USA	2020	2022	E-TRON SPORTBACK QUATTRO	3,307
	CAN	2021	2022	E-TRON QUATTRO	391
	CAN	2020	2022	E-TRON SPORTBACK QUATTRO	423
Problem Description	<p>On vehicles manufactured within a specific period, the pressure and temperature sensors in the air conditioning system may fail. If this happens, the air conditioning system will no longer function.</p>				
Corrective Action	Inspect and, if necessary, replace the affected pressure & temperature sensors.				
Code Visibility	On or about February 13, 2024, the campaign code will be applied to affected vehicles.				
Owner Notification	Owner notification will take place in February 2024. Owner letter examples are included in this bulletin for your reference.

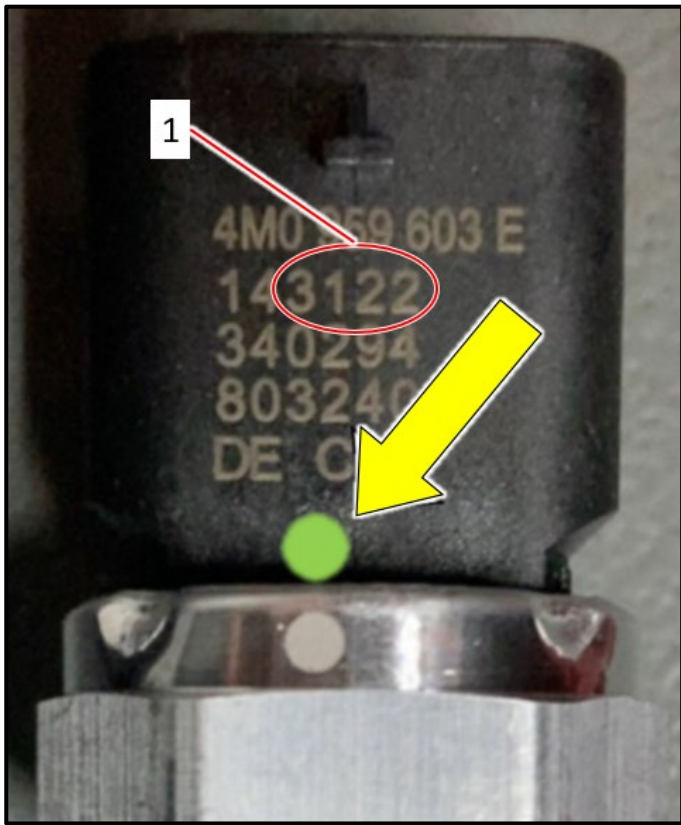
- Check for a green dot <arrow> on the connector housing of the G395 and G826.
- If the green dot is present on both sensors:
 - The sensors do not require replacement.
 - Continue with the reassembly instructions in this section.
- If the green dot is **NOT** present on the sensor(s):
 - Check the production date <1> of the affected sensor.
 - If the affected sensor was produced calendar week 23 of 2020 through calendar week 30 of 2021, the sensor must be replaced.

The production date <1> of the sensor pictured is calendar week 31 of 2022. This sensor does not require replacement. The date format is week/year.

- If a sensor requires replacement:
 - Proceed to section C.
- If both sensors are ok and do not require replacement:
 - Continue with the reassembly instructions in this section.

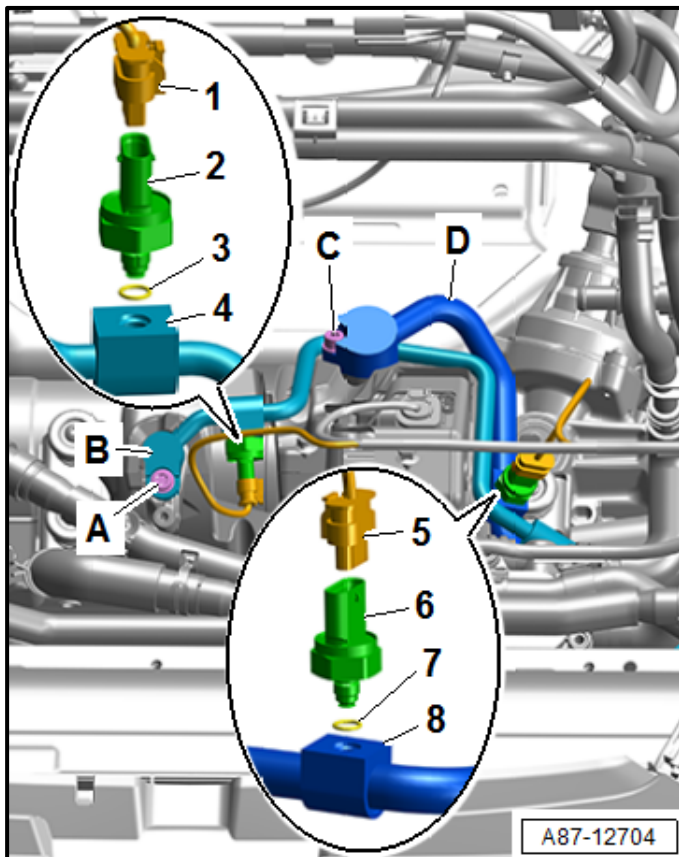
Replace the affected sensor(s):

- Refer to the ELSA repair manual for sensor replacement instructions.
- If the G395 sensor requires replacement:
 - *Repair manual > Heating, Ventilation & Air Conditioning > Heating Ventilation and Air conditioning > 87 Air Conditioning > Refrigerant Circuit > A/C Pressure/Temperature Sensor G395, Removing and Installing.*
- If the G826 sensor requires replacement:
 - *Repair manual > Heating, Ventilation & Air Conditioning > Heating Ventilation and Air conditioning > 87 Air Conditioning > Refrigerant Circuit > A/C Pressure/Temperature Sensor 2 G826, Removing and Installing.*
