Service Bulletin

Bulletin No.: 24-NA-022

Subject: SUV Second-Row Bolt Torque Pattern

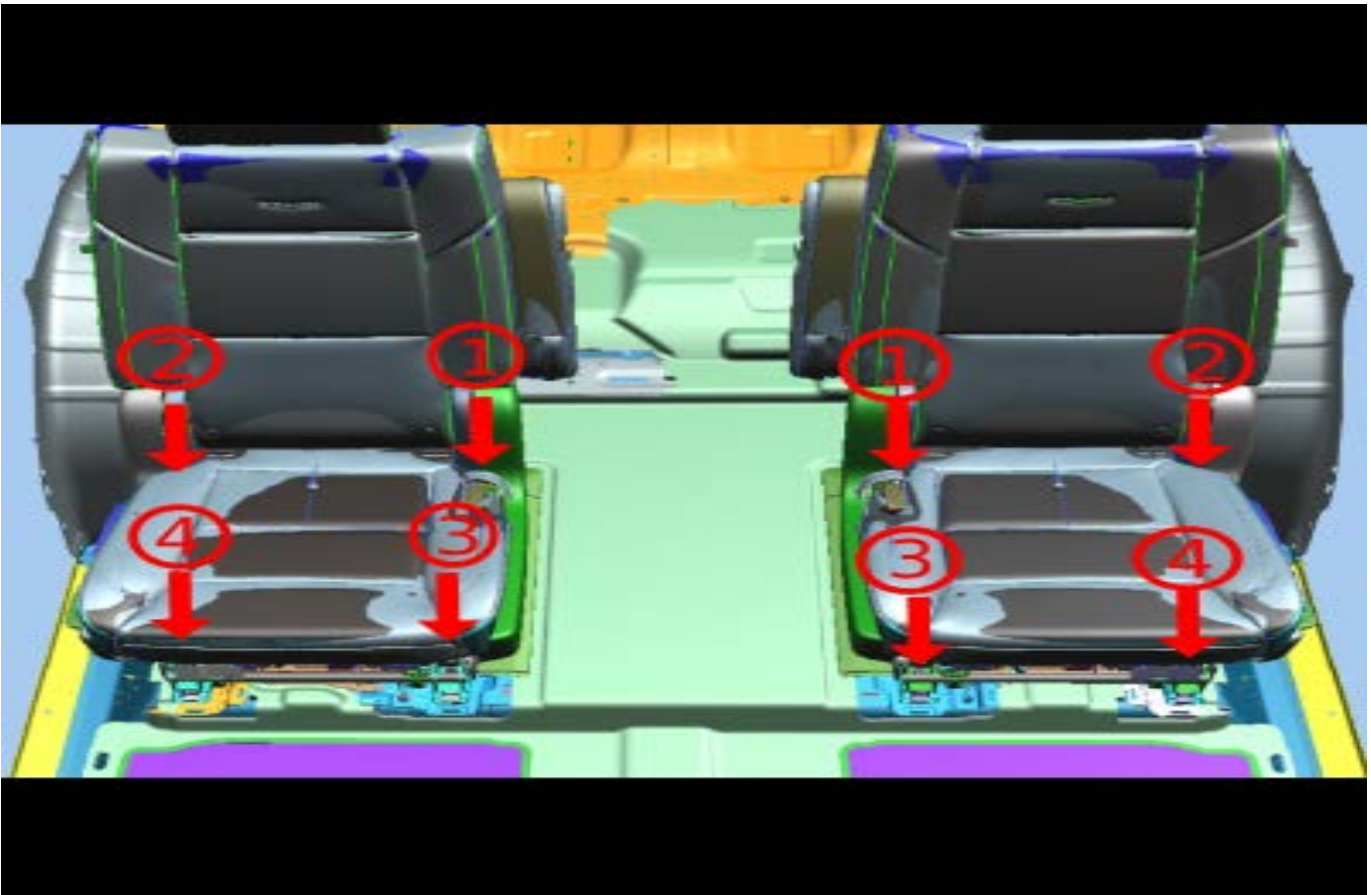
6535673

Captains Chairs

1. Refer to document *Rear Seat Removal and Installation* in the Service Manual for instruction on how to reuse fasteners or install new ones.
2. Remove the front fasteners.
3. Loosen but DO NOT remove fasteners (1) and (2).
4. Leave fastener (2) loose and retighten inboard fastener (1), refer to the document on how to reuse fasteners.
5. Remove fastener (2).

6. Reinstall all remaining bolts referring to the pattern shown.
7. Refer to the document for instruction on how to reassemble trim

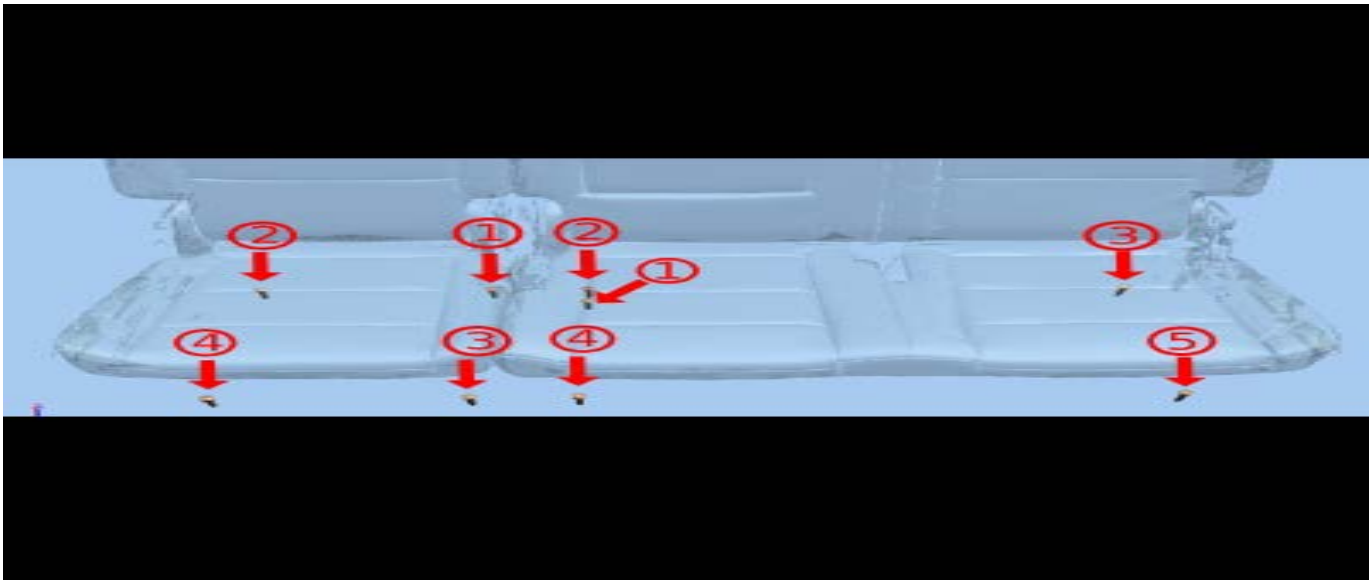
6535676

Bench Seats

1. Refer to document *Rear Seat Removal and Installation* in the Service Manual for instruction on how to reuse fasteners or install new ones.
2. Remove the front fasteners.
3. Loosen but DO NOT remove fasteners (1), (2), and (3).
4. Leave fastener (3) loose and retighten inboard fastener (1) and (2), refer to the document on how to reuse fasteners.
5. Remove fastener (3).

6. Reinstall all remaining bolts following the pattern shown.
7. Refer to the document for instruction on how to reassemble trim.
