**SIB 64 04 22**

2024-02-16

INTERFERENCE NOISE IN THE HEATING AND AC UNIT

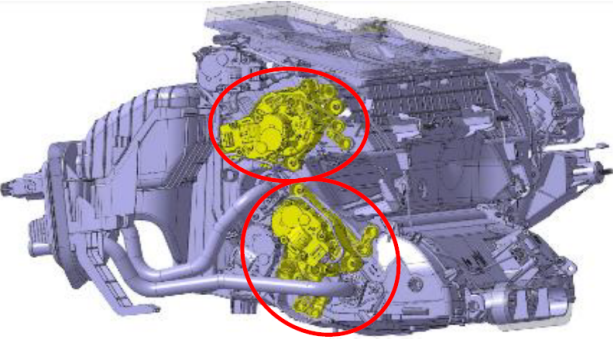
<p>The heating and air-conditioning unit in F97 / F98 / G01 / G02 / G20 / G22 / G23 / G26 / G42 / G80 / G82 left-hand drive (LHD) vehicles contains 3 servomotors total. Driver Side view</p>

1. Remove the instrument panel support.
Follow repair instructions "**51 45 075** Removing and installing the instrument panel support".
2. Remove all ventilation flap/stratification flap/recirculated air flap servomotors once the instrument panel support has been removed.

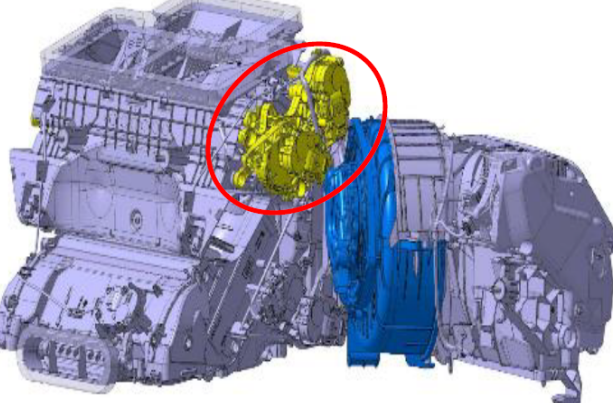
<p>The heating and air-conditioning unit in F97 / F98 / G01 / G02 / G20 / G22 / G23 / G26 / G42 / G80 / G82 left-hand drive (LHD) vehicles. Passenger Side view</p>

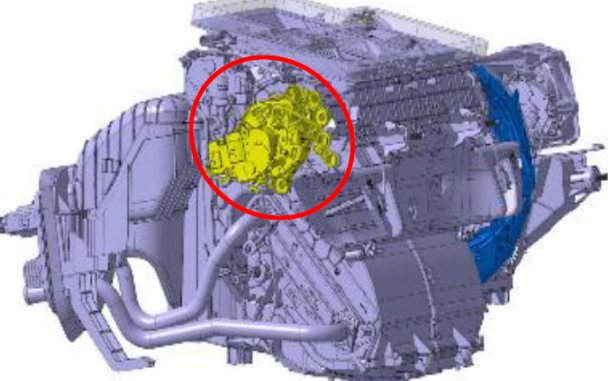
<p>The heating and air-conditioning unit in the G29, left-hand drive (LHD) vehicles contain 2 servomotors total. Driver Side view</p>

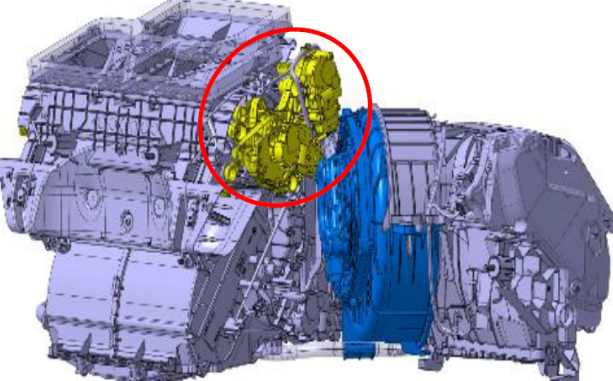
<p>The heating and air-conditioning unit in the G29, left-hand drive (LHD). Passenger Side view</p>

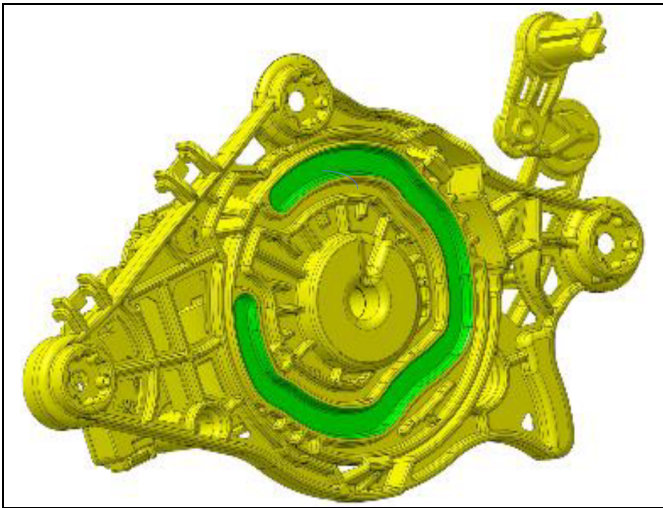
- Contamination may cause a decrease in lubrication of the kinematics unit (behind the servomotor) on the ventilation flap, air stratification flap, and the recirculated air flap.
- Incorrect tolerances on the kinematics unit

3. The relevant kinematics unit, which must also be removed, is located directly behind the removed servomotors.

The kinematics are clipped into the heating and air-conditioning unit.

4. Remove the old grease on the gate disc of the kinematics (green area) with a clean cloth and use Unisilikon TK M1011 to regrease.

5. Then reassemble the vehicle and test for noises.
