MAS003953 RU 24-03

Rapid Update 698

Ghibli - Trunk lid Bump Stop Check

DATE: JANUARY 30, 2024

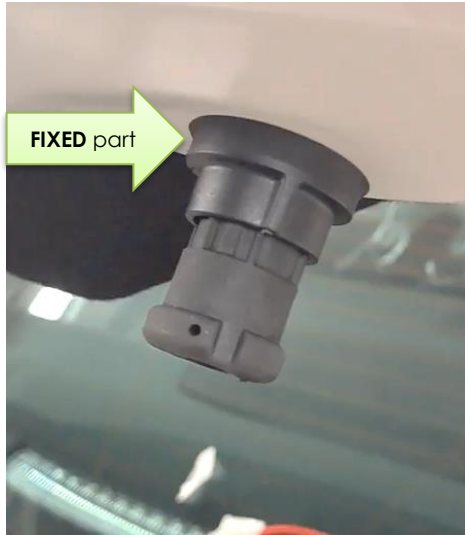
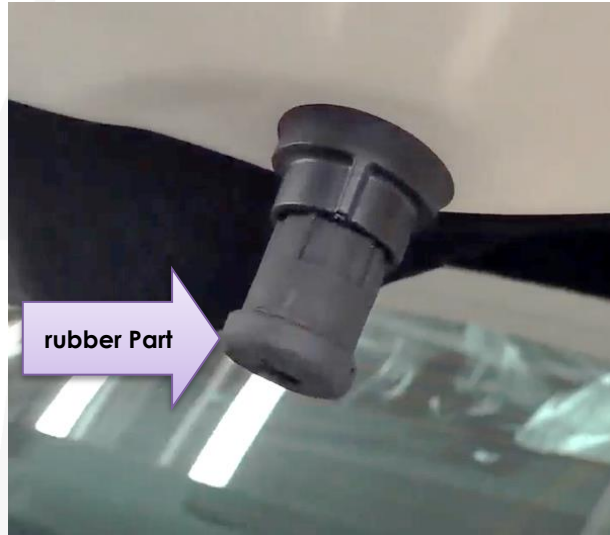
On a limited number of vehicles, the bump stops may not have been correctly registered during the assembly phase.

1. Always check ModisCS+ to see if the vehicle is involved in this action and if it has not been previously performed.
2. Open the rear trunk and locate the self-adjusting bump stops, located on the right and left edges of the lid.

3. Check whether or not the rubber parts are free to move by pushing them in by hand.

- **OK ► Rubber pad is fixed (secured)** and is not free to move, no further action is required. Release the vehicle.
- **NOT OK ► Rubber pad moves freely.** It is necessary to “re-register” **BOTH** bump stops. This procedure must be carried out even if only one of the pads is not correctly set/registered.
