Service Bulletin

Bulletin No.: 17-NA-357

Subject: Noise or Malfunction of Trim Door on Broken Quarter Upper Trim Panel, Possible Convertible Top Inoperative

Brand:	Model:	Model Year:		VIN:		Engine:	Transmission:
		from	to	from	to		
Chevrolet	Camaro Convertible	2016	2024	—	—	All	All

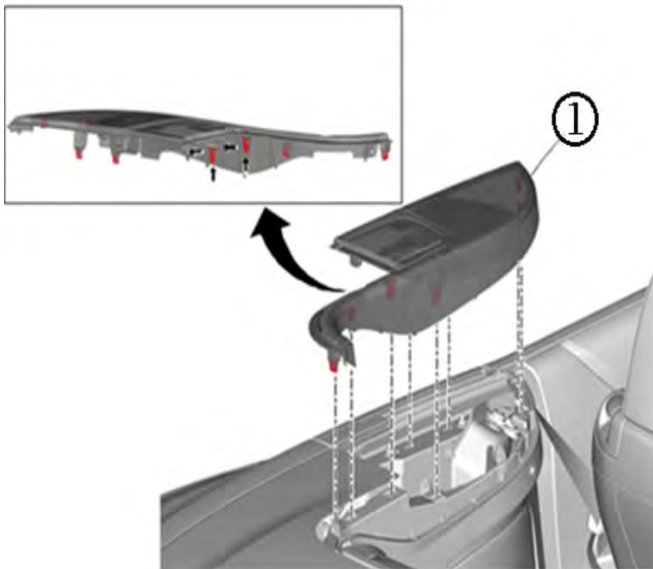
4889569

Involved Region or Country	North America, Argentina, Brazil, Bolivia, Chile, Colombia, Ecuador, Paraguay, Peru, Uruguay, Europe, Russia, Middle East, Israel, Japan, China, Taiwan, Philippines
Condition	Some customers may comment on a noise or malfunction of the trim door on a quarter upper trim panel. Upon inspection, the technician may find the quarter upper trim panel broken. Upon inspection, the rear side rail link assembly underneath the trim cover may also be found damaged. Continued use, or an increased interference, may eventually render the convertible top inoperative.
Cause	The cause of the condition may be various reasons the quarter upper trim panel and/or rail link assembly may break or fail.
Correction	<div style="text-align: center;"> </div> <p style="text-align: right; font-size: small;">4889567</p> <p>Note: As shown circled in the graphic above, the quarter upper trim panel design has been improved to include a 3rd retaining clip.</p> <p>Verify the condition, replace the affected quarter upper trim and possibly the quarter window regulator on that same side. Follow the vehicle build date breakpoint information noted in the Service Procedure below.</p> <p>Follow the vehicle build date breakpoint information noted in the Service Procedure below.</p>

Note: For vehicles built prior to February 14, 2017, it will also be necessary to replace the window regulator in addition to the quarter upper trim panel to accommodate the added 3rd clip design.

Important: Under no circumstances should the 3rd clip be removed from the quarter upper trim panel.
