Service Bulletin

Bulletin No.: 23-NA-177

Subject: Setting for Hands Free Liftgate (Open-Close) is Setting to 'Off' During Ignition Cycles

Brand:	Model:	Model Year:		Build Date:		Engine:	Transmission:
		from	to	from	to		
Cadillac	XT4	2024	2024	SOP	December 2, 2023

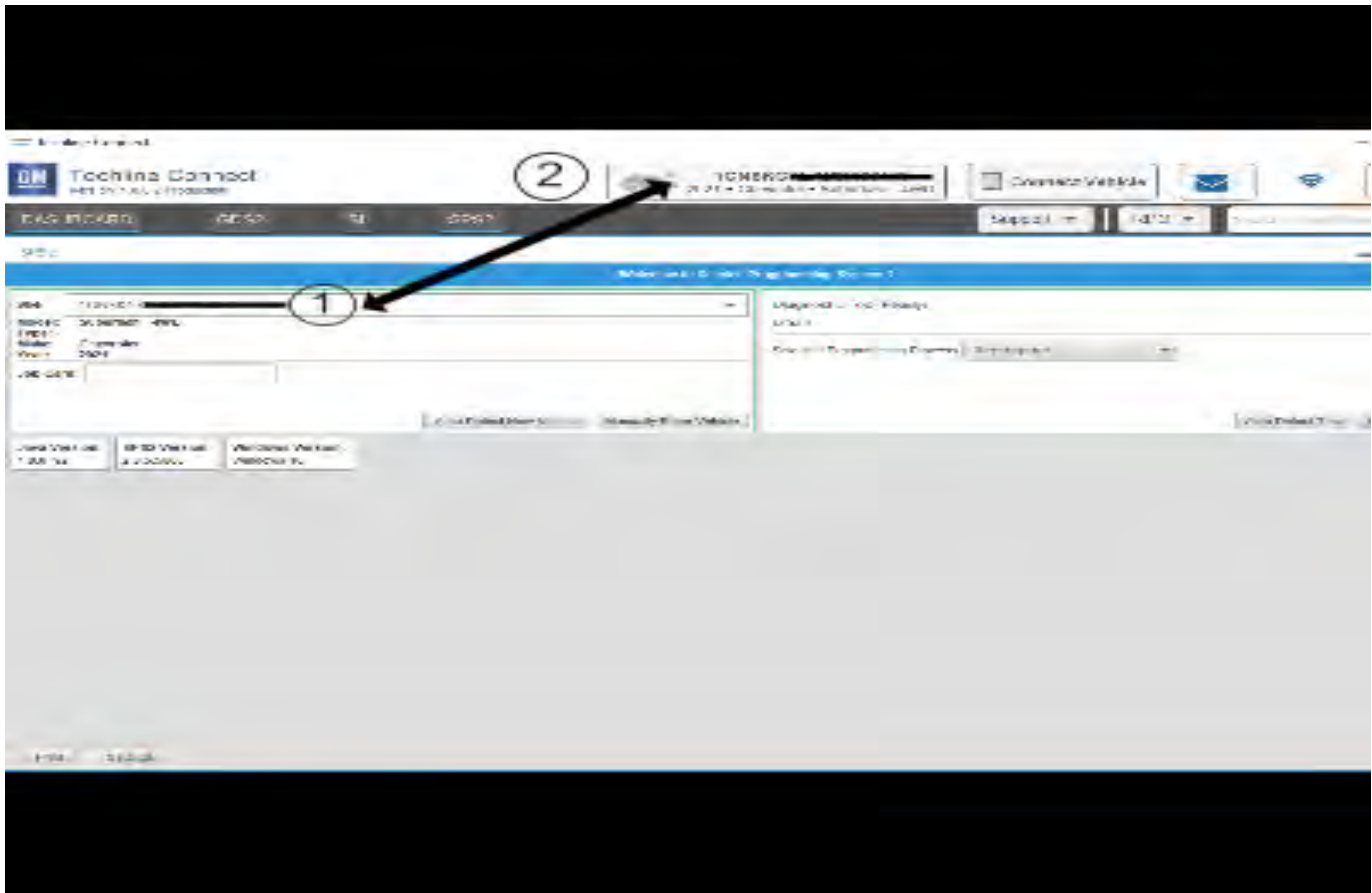
Caution: Be sure the VIN selected in the drop down menu (1) is the same as the vehicle connected (2) before beginning programming.

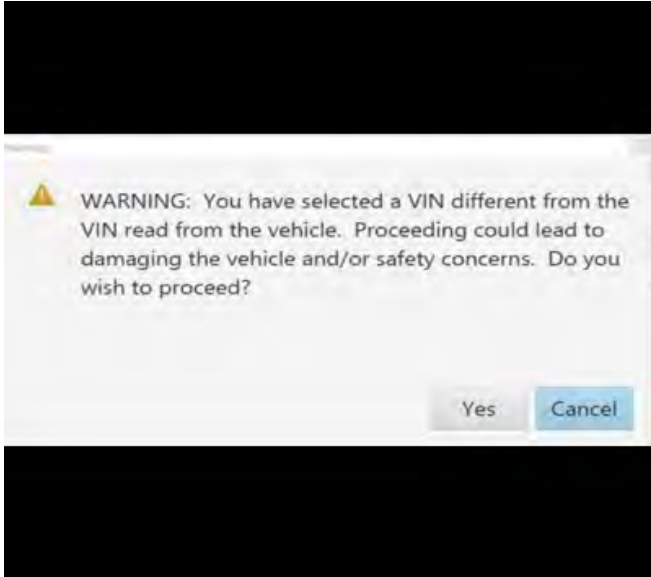
5877000

Important: If the vehicle VIN DOES NOT match, the message below will be shown

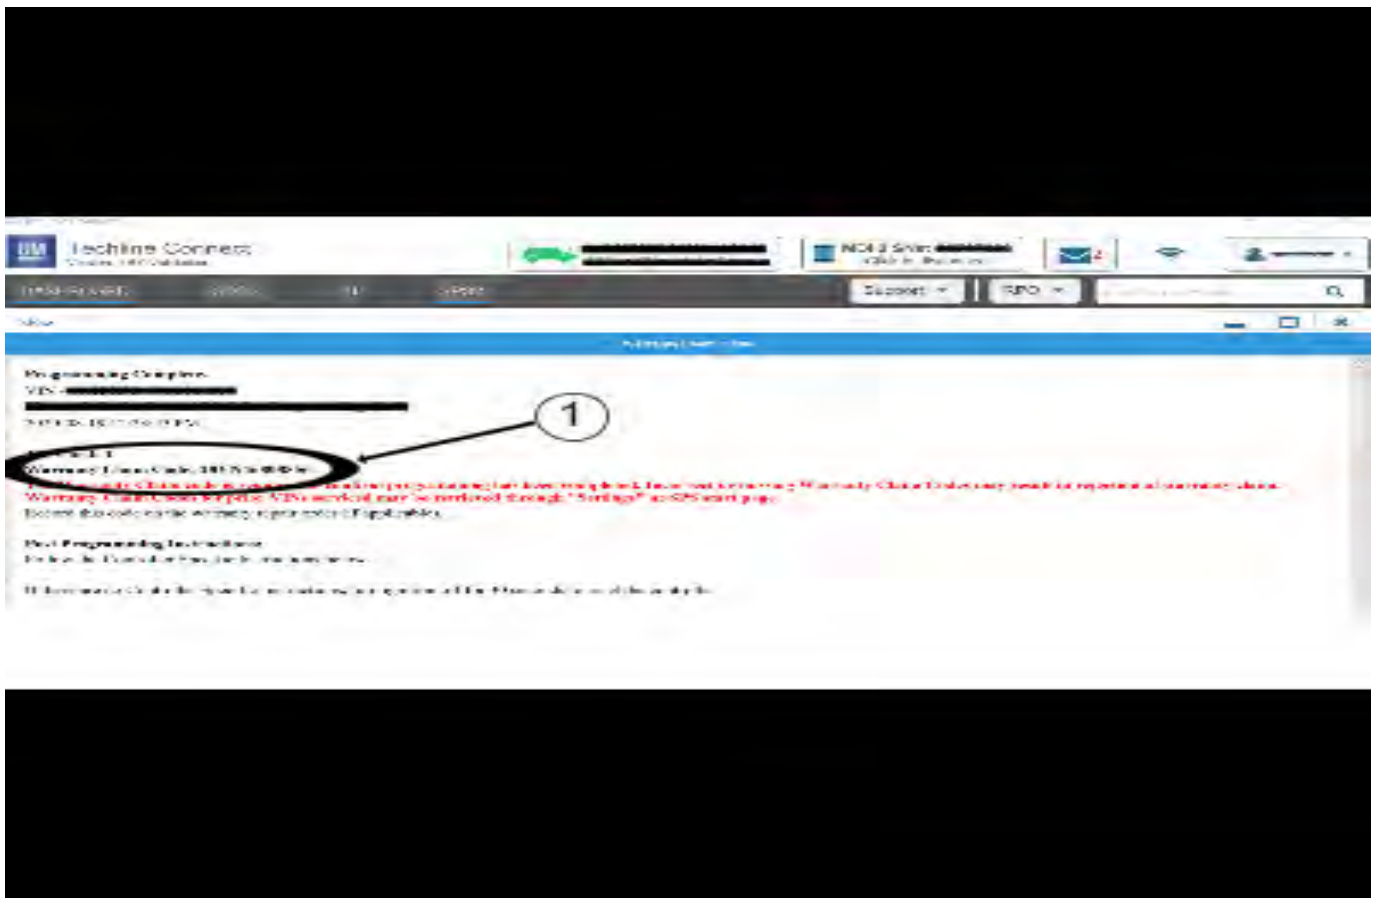
5644478

Important: To avoid warranty transaction rejections, you **MUST** record the warranty claim code provided on the Warranty Claim Code (WCC) screen shown above on the job card. Refer to callout 1 above for the location of the WCC on the screen.

2. Record SPS Warranty Claim Code on job card for warranty transaction submission.
