Service Bulletin

Bulletin No.: 24-NA-028

Subject: Power Tonneau Cover Diagnostic Tips

Brand:	Model:	Model Year:		VIN:		Engine:	Transmission:
		from	to	from	to		
GMC	HUMMER EV Pickup	2022	2024	-	-	All	All

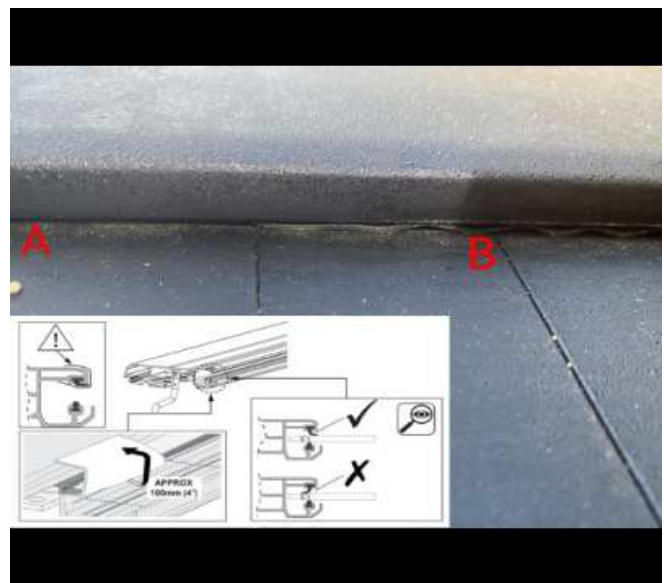
6544195

- Use tape to hold the top lip seal of the side rail during the installation of the side rail to the canister. Folded over side rail lip seal will cause the system to go into an unwanted anti-pinch mode.

Note: The above illustration shows what happens when the lip seal is under the cover during installation (A). The lip seal (B) is wavy due to incorrect assembly. The seal must be on top of the cover, not the cover. This will cause binding resulting in anti-pinch mode activation.

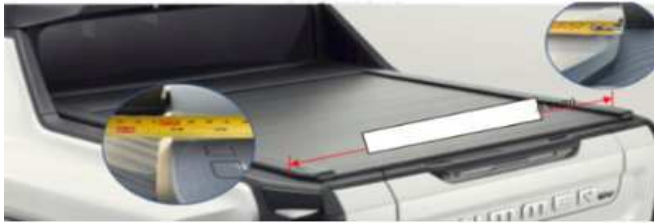
6540966

Note: During initial installation on a flat surface or protected table, tape back the seal surfaces on the front 4in. (100mm) of each rail using masking tape, as shown. This will protect them from damage during install.

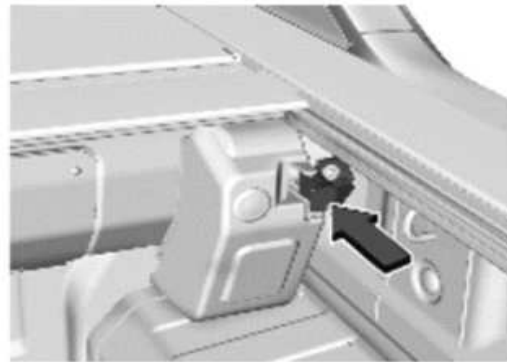
6540967

- Begin by manually sliding the cover in both directions. Pressing the clutch button on the motor allows for the tonneau cover to slide freely. Do this to aid with inspecting for binding. The clutch button should be checked to be fully extended prior to calibration/operation.

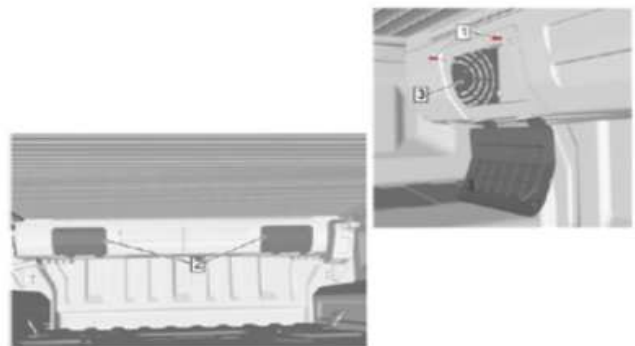
6540968

- Keep side rail tracks clean and apply silicon spray as needed.
- Add silicon spray to drum springs as directing in the owner's manual or SI DOC 6152455.

- Tonneau cover will make more noises during electric operation, especially in cold weather, compared to manual inspection. If noise is combined with noticeable binding, lubricate tracks and drum springs with silicon spray.

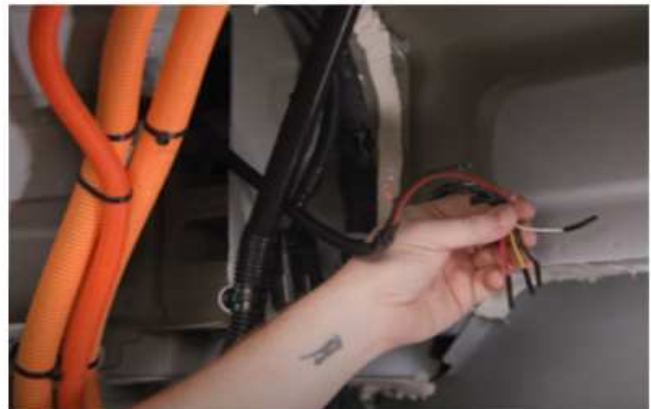
6540970

- Inspect the motor for any leakage. If any visible brown substance is found, replace the motor p/n 85597137.
- Check for power and ground at the X1 connector located at the power tonneau cover control module. Refer to SI DOC 6012295. If necessary, inspect the 4 wires connected to the main body wire harness under the left rear wheel well. Poorly installed and sealed splice connectors have been discovered and will cause electrical issues.

Showing the location of 4 wires in the main body wire harness that must be connected to the power tonneau cover asm. Inspect the wire-to-wire splice connectors for proper sealing and crimping.
