# Service Bulletin

Bulletin No.: 24-NA-029

**Subject: HUMMER EV Water Leak Diagnostic Tips**

Brand:	Model:	Model Year:		VIN:		Engine:	Transmission:
		from	to	from	to		
GMC	HUMMER EV Pickup	2022	2024	-	-	All	All
	HUMMER EV SUV	2024	2024

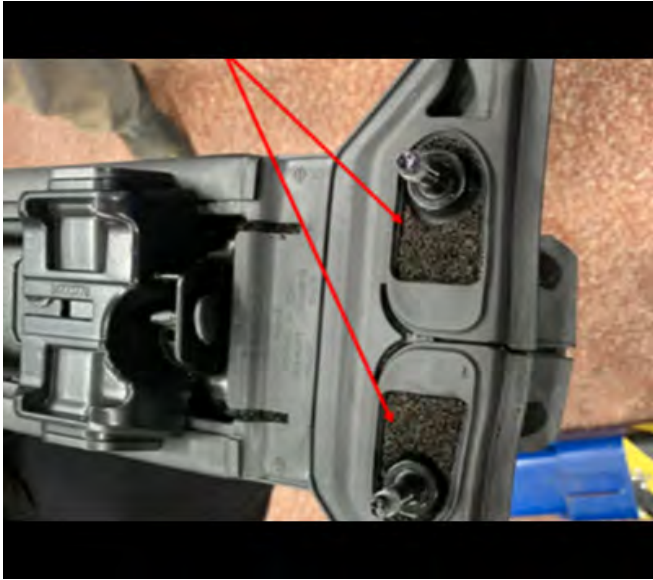
6541873

This design is from 2022 ONLY. If the open cell foam is discovered, check the vehicle for open field action and replace the I-Bar per Service Update Bulletin N222378440.

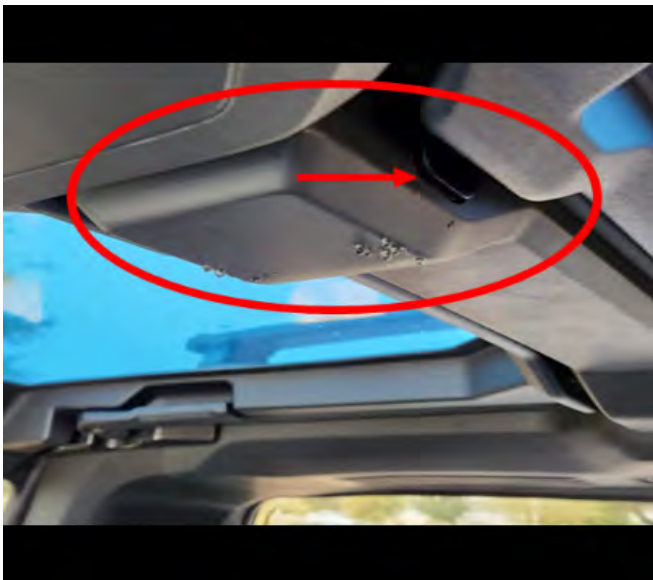
6542034

<b>Condition</b>	Water pours out of the lower I Bar trim cover as it collects in the sump created by the contour of the trim, especially when turning a corner.
------------------	--

Easiest way to diagnose this complaint is to remove the lower trim panel, water test, and watch for the leak.

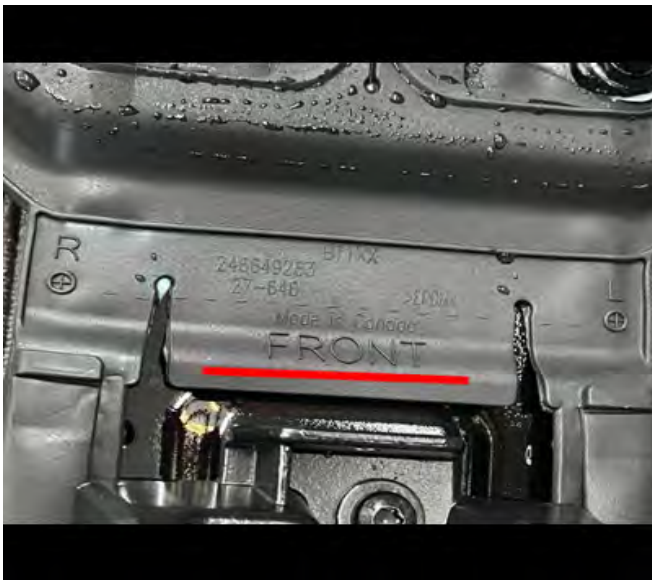
6542125

The front I Bar is designed to be removed by the customer. If the front I bar is installed backward it will leak. When removing the I Bar, inspect the orientation of the I Bar to ensure the "front" is in fact pointing towards the front of the vehicle. Inform the customer on proper installation if this condition is found.

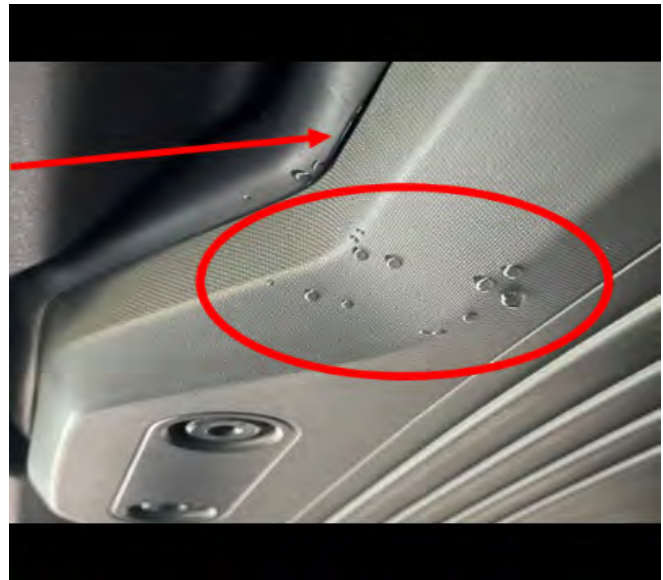
6542146

Water leaking near the front or rear of the I Bar in this zone is usually not caused by the I Bar. Water droplets coming past the weather strip and roof headliner panel are due to excessive water building up in the drain system. If any sky panel is out of alignment, excessive water can get past the sealing surfaces and allow too much water to enter into the drain system, thus allowing water to exist in unwanted locations. Inspect the sky panels for proper alignment and adjust as necessary. Refer to SI DOC ID 6339878 (pickup) or 6341146 (SUV).

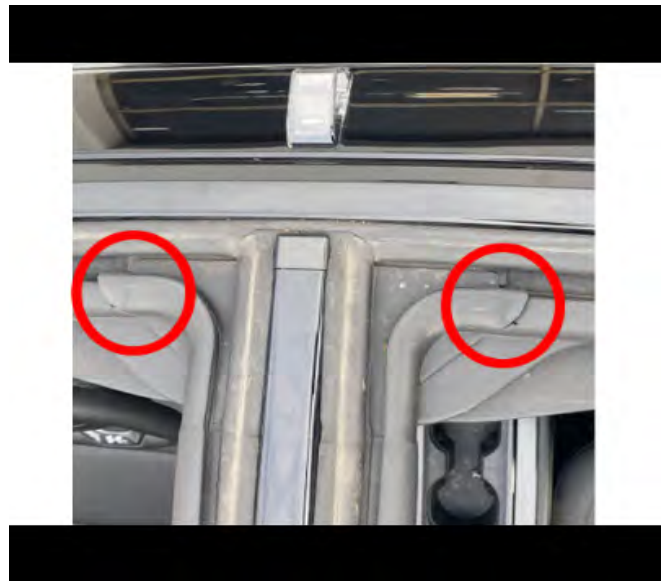
6542173

Another possible cause of water droplets in this area can be caused by creased I Bar weather strips.

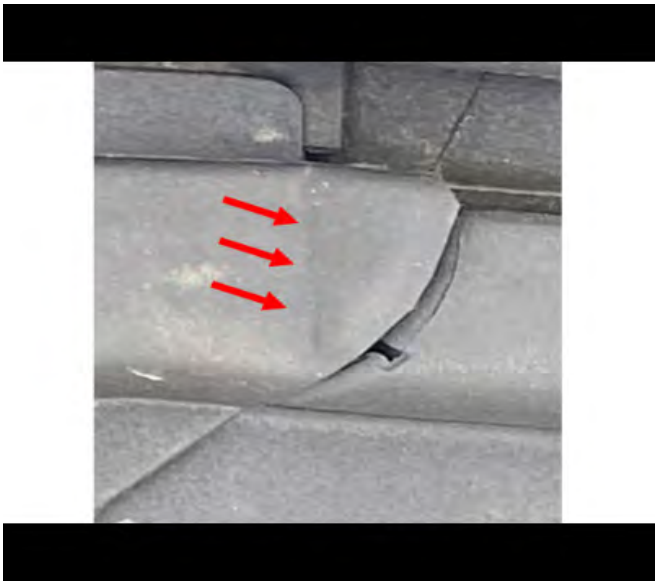
6542199

<b>Cause</b>	Folded over weather strips on the I-Bar due to improper sky panel installation. Pay close attention to these areas when first removing the sky panel. If the outboard weather strip ends are folded over this will cause the sky panel to raise up preventing a good seal. If the crease is permanently set as shown below, this will also prevent the weather strip laying flat even with the sky panel installed pushing the sky panel upwards causing a gap and leak.
<b>Correction</b>	Replace the I-Bar – educate customer on proper sky panel installation.

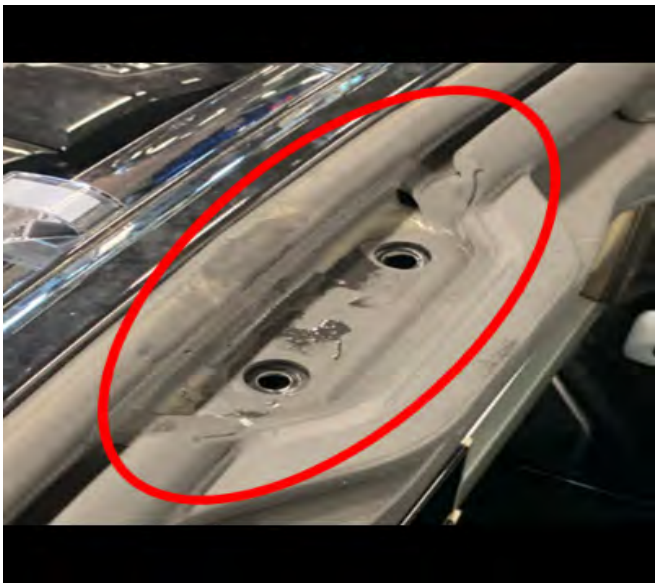
6543780

It is normal to have presence of water as shown.

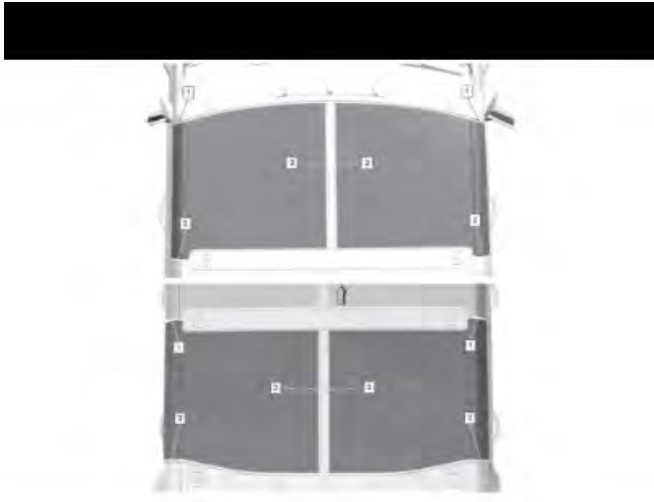
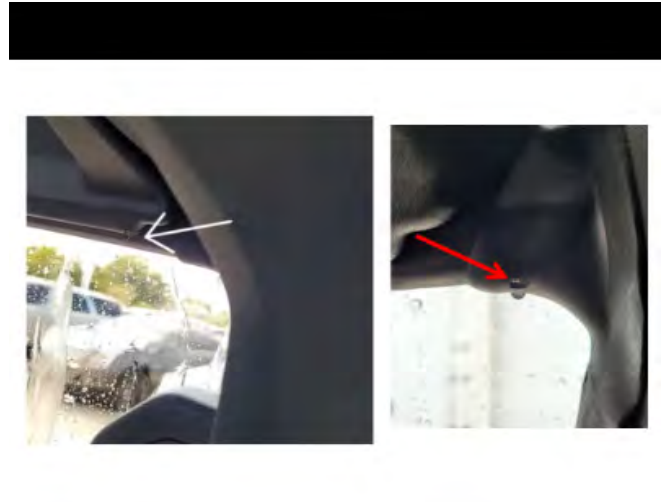
<b>Condition</b>	Leaks near the top of any of the side windows, weather strips, or sky panel weather strip.
<b>Cause</b>	If any sky panel is out of alignment such as being shifted too far forward or rearward, or too high, this will causing excessive water to enter into the water management system in the weather strips. This causes water to back up over the sealing surfaces creating a leak inside the cabin near the corners of weather strips near the weather strip drain holes.
<b>Correction</b>	Perform top down, side to side, visual inspection of all 4 sky panels installed, with the I-bar installed. If any sky panel appears to be not square in the opening or sitting high – verify the dimensions and adjust as necessary following SI DOC ID 6339878 (pickup) or 6341146 (SUV)

Verify the dimensions and adjust as necessary following SI DOC ID 6339878 (pickup), 6341146 (SUV).

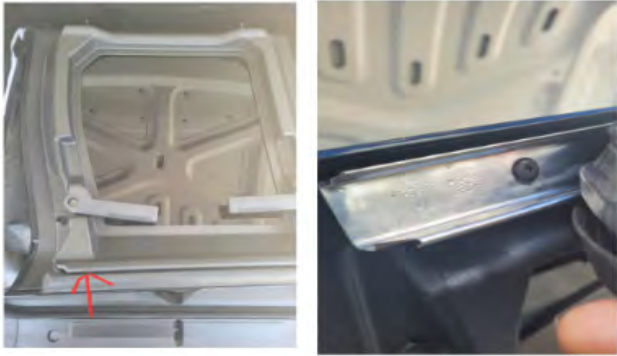
6542346

<b>Condition</b>	Water dripping into the cabin from between the sky panel and its seal (front corner of the LR panel pictured), especially when stopping.
<b>Cause/Correction</b>	This was due to the left rear sky panel being too far rearward allowing poor seal along the front edge of the left rear sky panel to weather strip. Essentially overwhelming the water drain management system. To adjust the sky panel, refer to SI DOC ID 6339878 (pickup) or 6341146 (SUV).

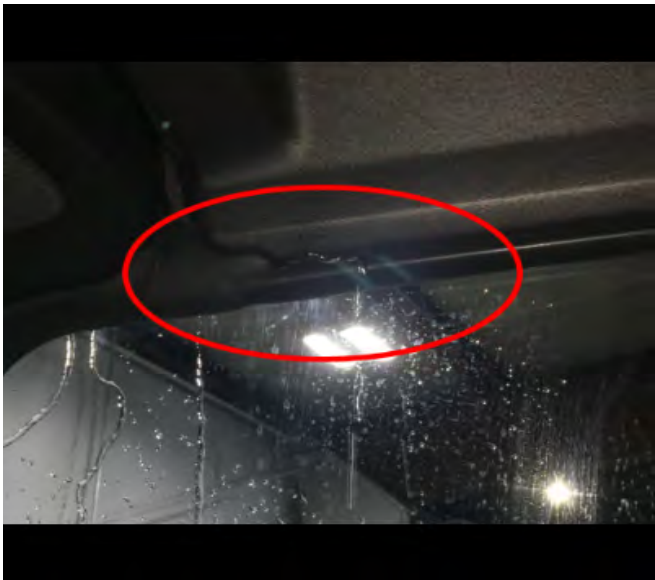
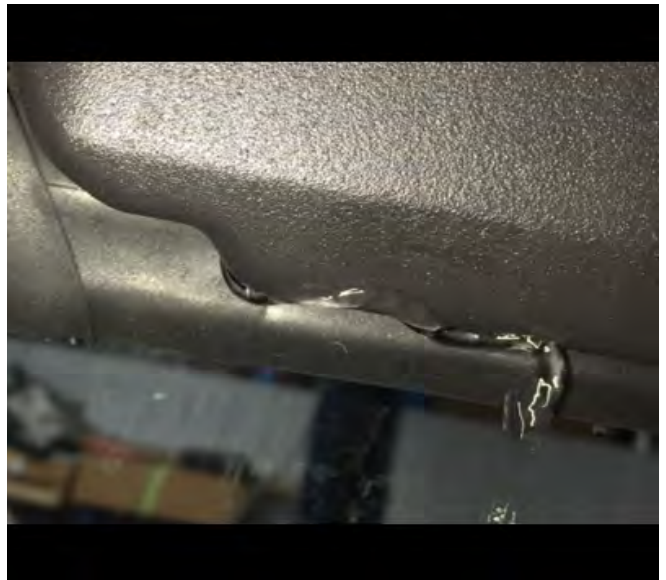
<b>Condition</b>	Water drains into the cabin from between the sky panel and its seal (front corner of the RF panel pictured).
<b>Cause/Correction</b>	Adjusting the sky panel strikers down resolved the leak. To adjust the sky panel strikers, refer to SI DOC ID 6339878 (pickup) or 6341146 (SUV).

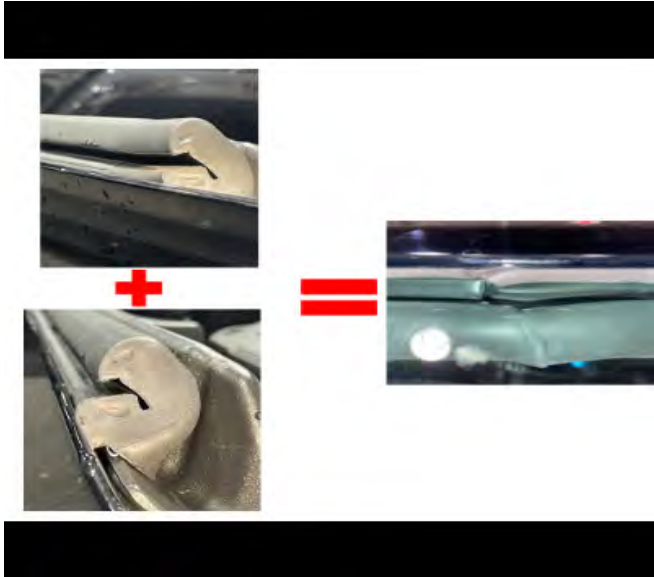
6542379

<b>Condition</b>	Water leaking past the top of the window, and onto the door trim panel.
<b>Cause</b>	Sky panel weather strip was not properly seated to the metal u-channel. The weather strip will have an uneven appearance on the end. Further inspection should reveal the weather strip is not properly seated onto and under the metal u-channel. Water will leak at the overlap joint between the sky panel weather strip and roof bow weather strip.
<b>Correction</b>	Inspect the sky panel weather strip to ensure it's properly seated onto the metal u-channel retainer. If necessary, pull the weather strip up and away, then gently re-seat the weather strip over the u-channel. Verify the weather strip lays flat on the ends.

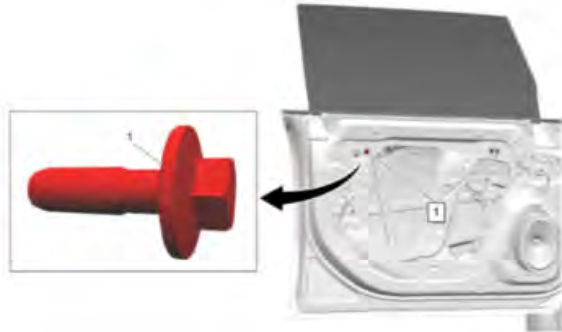
6542380

<b>Condition</b>	Water leaks between the side windows and weather strips.
<b>Cause</b>	Side glass is out of position, including being too low or tilted at an angle, the glass will not seal properly to the door opening weather strips or the top weather strip on the sky panel.
<b>Correction</b>	Inspect the side door glass ensuring it's square in the body opening and covering the weather strip evenly on both sides. Compare the height and orientation from side to side. Adjustments are made by loosening the window regulator to door glass clamps. Refer to applicable SI procedure for regulator replacement for proper steps to access these attachment points. <b>Note:</b> Side Glass out of adjustment can also cause wind noise.

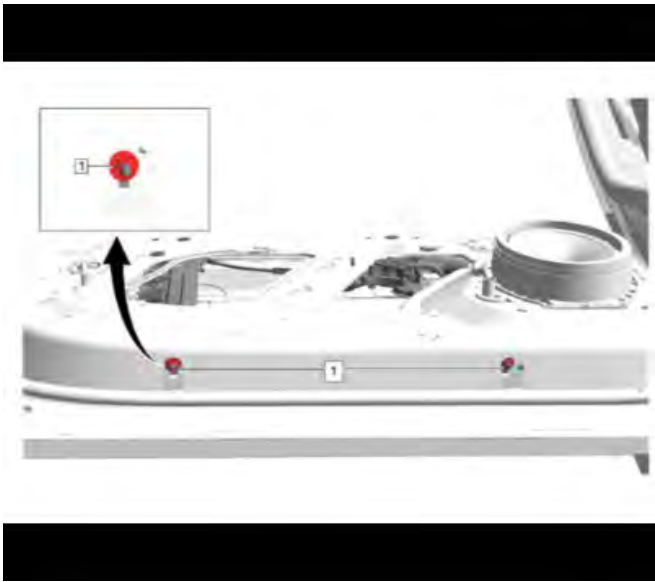
6542381

<b>Condition</b>	Water leaks between the side windows and weather strips.
<b>Cause</b>	Side glass out of position, including being tilted outwards causing a lack of pressure between the side glass and the weather strip.
<b>Correction</b>	Inspect the side door glass ensuring that it's compressing onto the door opening weather strips. Tilting the glass inwards will help push the glass onto the door opening weather strips making a tighter seal. Adjustments are made by loosening the window regulator to door bottom mounting bolt and tilting the entire window and regulator asm as needed. Refer to applicable SI procedure for regulator replacement for proper steps to access these attachment points.

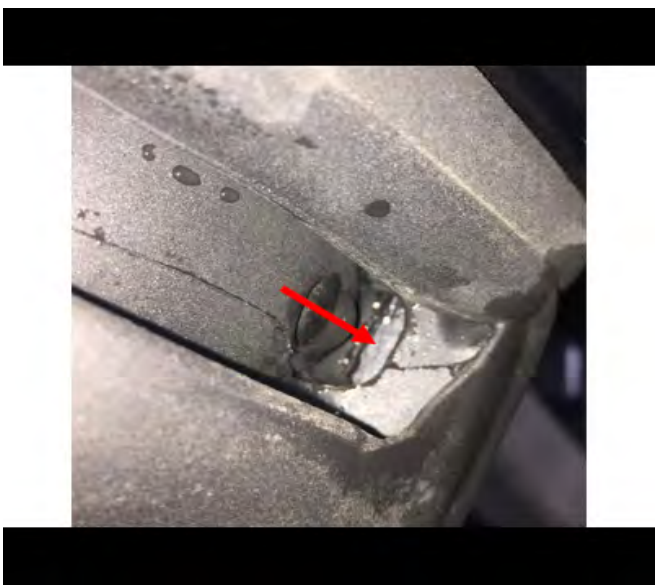
6542383

<b>Condition</b>	Water leaks between the side windows and weather strips
<b>Cause</b>	Plugged drain(s)
<b>Correction</b>	Inspect the drain hole closest to the location where the leak is occurring. Look for any rubber flashing that might be partially covering the drain hole(s). Remove debris or rubber flashing as required. <b>Tip:</b> With the top removed, close the door, fully raise the window check the drain hole to ensure it's not being pinched closed when the side window is all the way up.

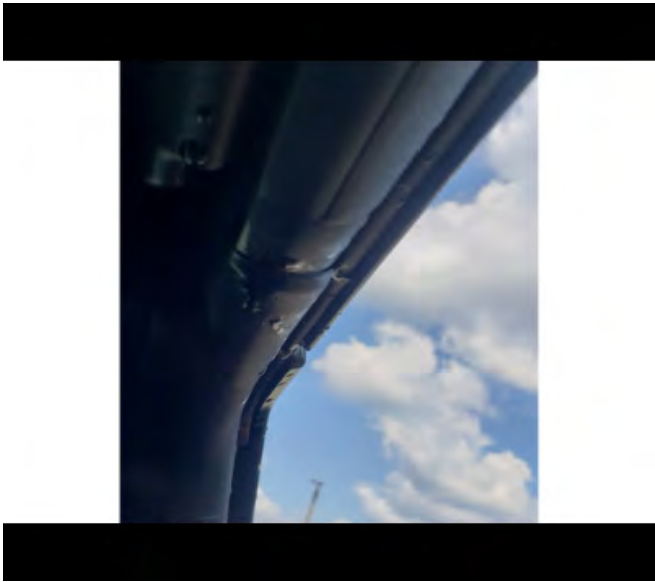
6542384

<b>Condition</b>	Water leaks between the side windows and weather strips
<b>Cause</b>	Plugged drain(s)
<b>Correction</b>	<p>Inspect the drain hole closest to the location where the leak is occurring. Look for any debris or rubber flashing that might be partially covering the drain hole(s). Remove flashing if required.</p> <p><b>Tip:</b> With the top removed, close the door, fully raise the window check the drain hole to ensure it's not being pinched closed when the side window is all the way up.</p>
